AVIATION OCCURRENCE REPORT

RISK OF COLLISION

CANADA 3000 AIRBUS SA320-212 C-GVXF

SEMITOOL INC. ROCKWELL INTERNATIONAL 690C N48BA
CALGARY, ALBERTA

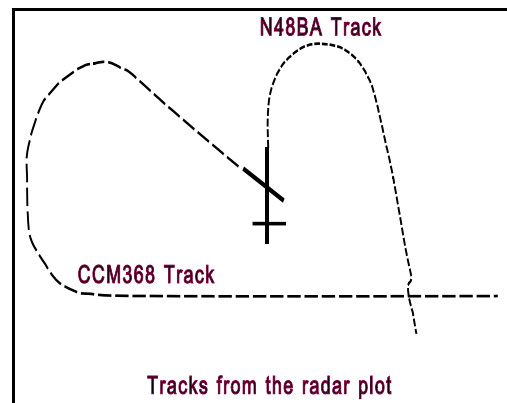
At 1939:50¹, 1 minute 20 seconds before CMM368 communicated a TCAS descent, CMM368 was about 10 nm south-west of the airport in a left turn climbing through 10,100 feet at 230 KIAS and N48BA was about 4 miles north-east of the airport in a right turn climbing through 7,200 feet. The air traffic controller assessed that the vertical and lateral spacing would remain adequate for the intended tracks. He then turned his attention to other aircraft under his control. He recalls that it was not until CMM368 called a TCAS descent that he looked at the two aircraft targets on his radar screen.

Flight CMM368 operated from Calgary International Airport at the same time each weekday. With exposure and experience, air traffic controllers gain knowledge of aircraft climb profiles and are able to predict, with a high level of confidence, climb rates and ground speeds for various types of aircraft. However, where more than one flight profile is available to the pilot, such as is the case for the A320 aircraft, and when the pilot has not received any restrictions based on altitude, airspeed, or geographic location, the air traffic controller may not be aware of the pilot's intentions.
