AVIATION INVESTIGATION REPORT

A99A0036

CONTROLLED FLIGHT INTO TERRAIN

DE HAVILLAND DHC-6-300 TWIN OTTER C-FWLQ

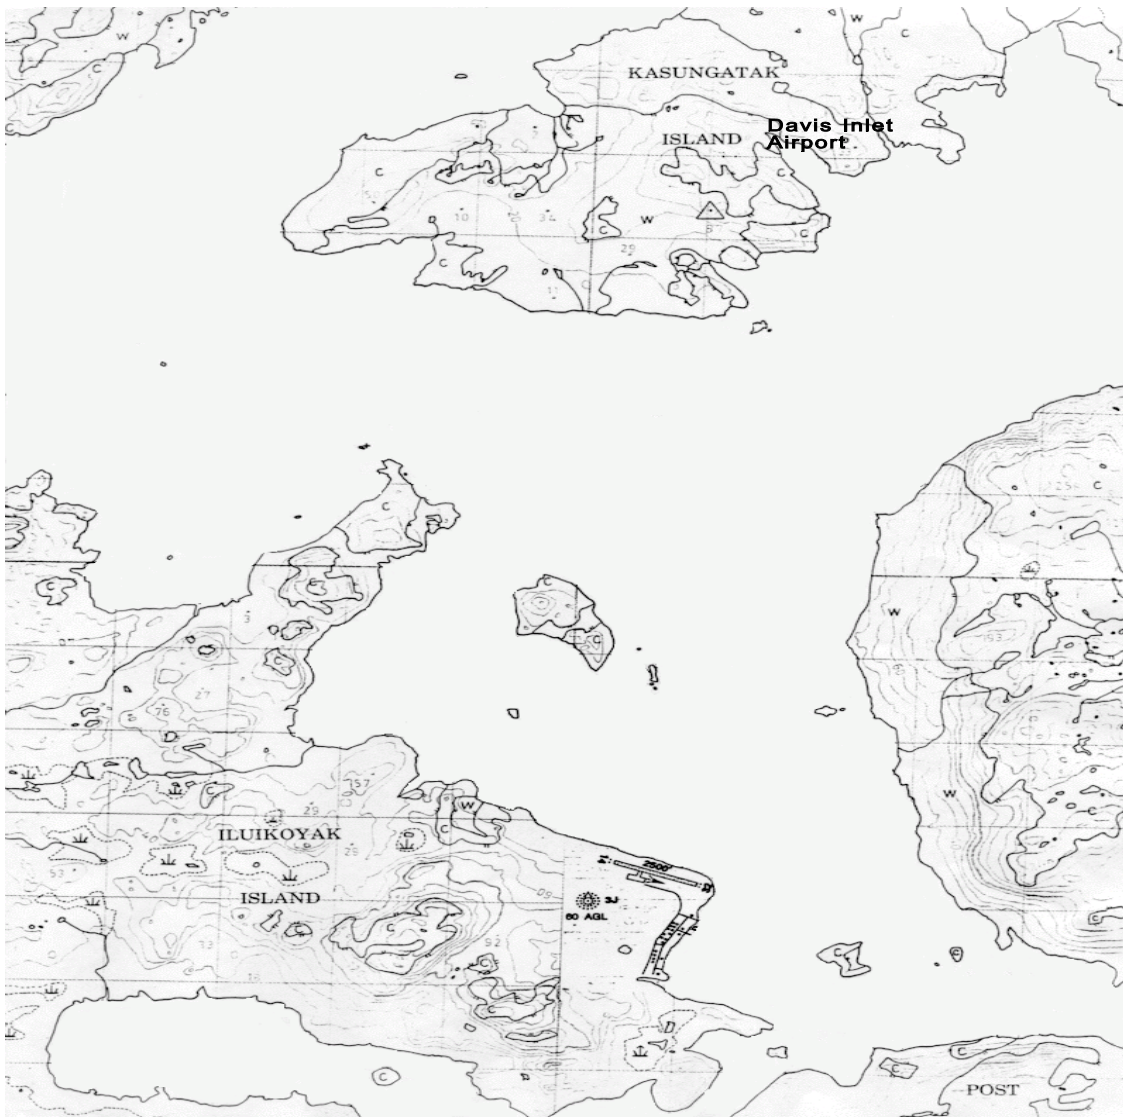
**Crash Site**

The aircraft struck snow-covered ice on a heading of 222 degrees magnetic in a slightly nose-down, wings-level attitude. The wreckage trail was approximately 600 feet long by 180 feet wide: the nose landing gear was near the beginning of the trail; the instrument panel was at the end of the trail; and the fuselage, engines, left wing, empennage, and cargo were strewn along the trail between these points. The wreckage pattern observed was consistent with a controlled, shallow descent.
