AVIATION INVESTIGATION REPORT

A99P0136

COLLISION WITH BOAT

DE HAVILLAND DHC-2 BEAVER C-GSUE

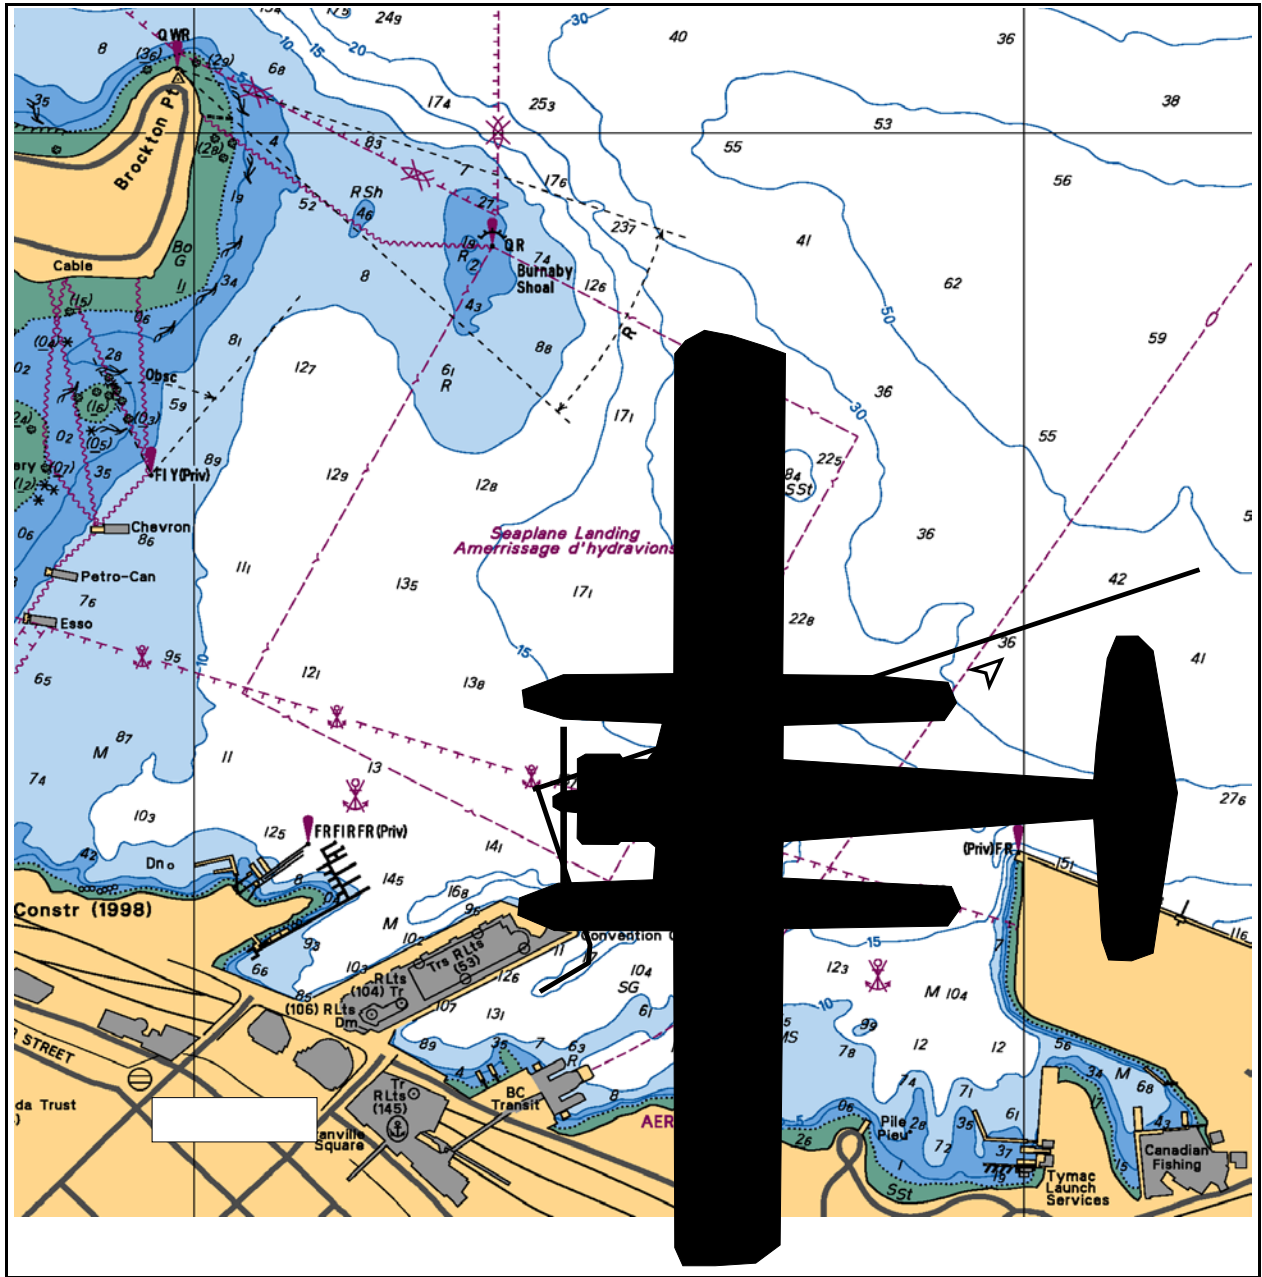
Appendix A - Vancouver Harbour / Collision Diagram

The diagram at Appendix A illustrates the collision paths of the two objects. Positions for the boat and aircraft are depicted at 25 seconds before impact. Thereafter, speed of the aircraft is depicted as 80 knots for the first 8.33 seconds, 60 knots for the second 8.33 seconds, and 40 knots for the final 8.33 seconds. A uniform speed of 8 knots is depicted for the boat.

From the pilot's perspective, the boat was located within the area of sun glare on the water during the 25-second period prior to impact. To distinguish the light-coloured boat out of the area of glare would have been difficult. In addition, the cabin structures on the left side likely obstructed the pilot's view of the boat at various stages during the approach. These factors accentuated some of the limitations of the human eye. The obstructions or limitations likely would have been overcome by continually moving the eyes and head, thus changing the location of the blind spots. However, in the moments preceding landing it may not be practical for
