AVIATION INVESTIGATION REPORT

A99P0168

IN-FLIGHT COLLISION

Between
ERCO Aircoupe 415C C-GHFB
and
Pacific Flying Club
Cessna 152 C-GPFE
Cloverdale, British Columbia
20 November 1999

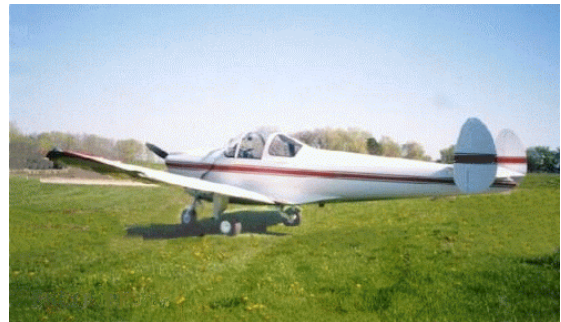
The yellow ERCO Aircoupe 415C was a single-engine, two-place, low-wing monoplane of metal and fabric construction. Standard equipment includes one fixed landing light mounted in the leading edge of the left wing. Witnesses revealed that the Aircoupe did not have its landing light on immediately before the midair collision, but the red, belly rotating beacon was on.

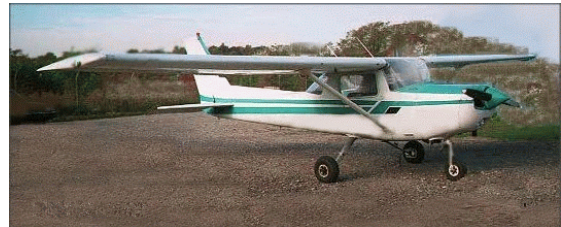
The white Cessna 152 was a two-place, single-engine aircraft with a cantilevered high-wing and fixed tricycle landing gear. Standard equipment includes one fixed landing light mounted in the nose. Some witnesses confirmed that the Cessna had its landing light on before the midair collision.

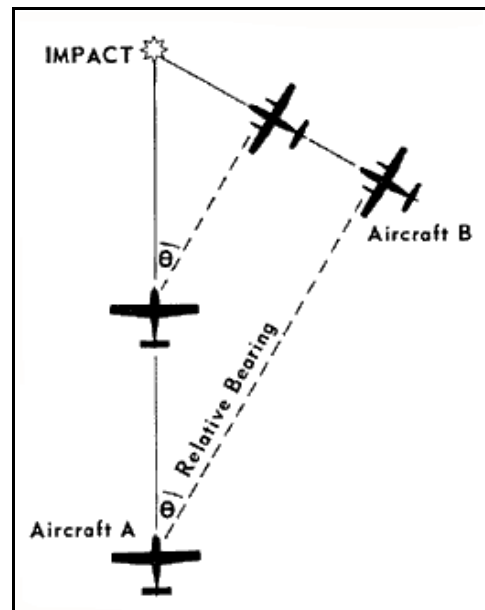
When a pilot conducts a right turn in a low-wing aircraft, the pilot's view to the left is largely blocked by the rising left wing. The pilot of an Aircoupe would therefore have increased difficulty seeing conflicting traffic to the left. The view to the right, however, would be unobstructed, although the pilot would have to conduct a search across the cockpit and around any passenger in the right seat. The reverse is true for a left turn.

Conversely, when a pilot conducts a right turn in a high-wing aircraft, the pilot's view to the right is largely blocked by the right wing. The pilot of a Cessna 152 would therefore have increased difficulty seeing conflicting traffic to the right. In addition, the pilot would have to conduct a search across the cockpit and around any passenger in the right seat. The pilot would, however, have an unobstructed view of traffic to the left.

The Aircoupe is a low-wing aircraft with the pilot's seat over the wing. During the right bank in the turn, the left wing would have restricted the pilot's field of view to his left, the direction from which the Cessna approached. It may therefore have been physically impossible for the occupants of the Aircoupe to see the Cessna until just before the aircraft collided.
