AVIATION INVESTIGATION REPORT

A99Q0062

LOSS OF CONTROL

MYRAND AVIATION  
CESSNA 335 C-GMZV

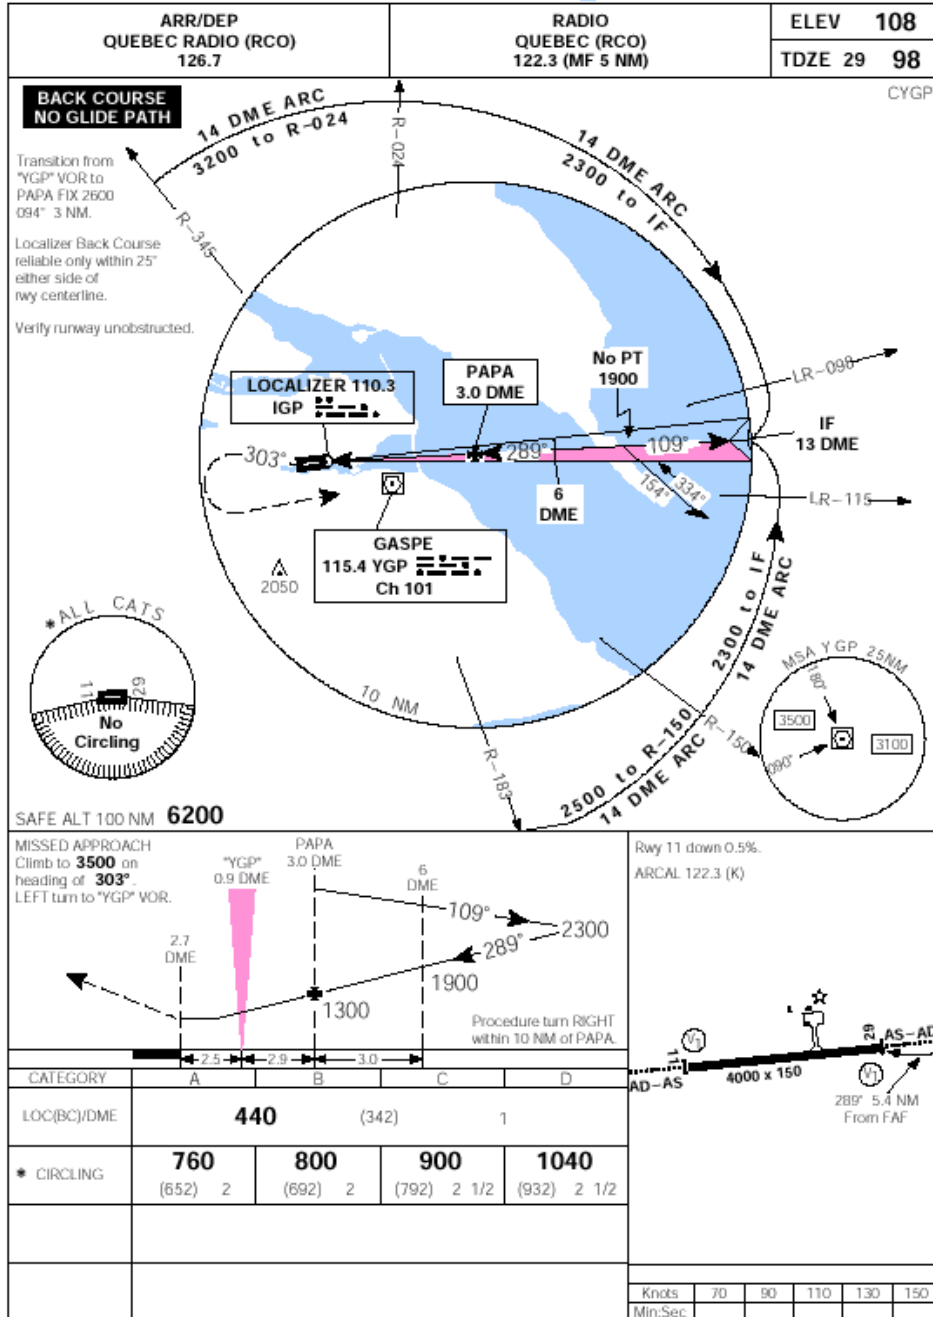
# Appendix A—LOC(BC)/DME Approach Chart for Runway 29 at Gaspé Airport

According to the instrument approach chart LOC(BC)/DME RWY 29, the minimum altitude is 440 feet above sea level (asl), 336 feet above ground level, and the minimum horizontal visibility must be 1 nautical mile (nm). The pilot advised the Québec FSS specialist that he was going to make a back course (BC) approach on runway 29 at Gaspé. This approach brings the aircraft successively to an altitude of 2300 feet asl on the 14 nm DME (distance-measuring equipment) arc and to 440 feet asl, the decision height that must be maintained until 2.7 nm DME, the threshold of runway 29. If the crew has not established visual contact with the runway or the runway lights at this height and distance, they must make a missed approach. A missed approach involves climbing to 3500 feet asl on a magnetic heading of 303 degrees and then making a left turn to the Gaspé VOR (very high frequency omnidirectional radio range). (See Appendix A.) All the navigation systems required for the approach were serviceable on the day of the accident.
