MARINE INVESTIGATION REPORT

M00W0044

CAPSIZING

THE FISHING VESSEL "LORI CATHLYNN"

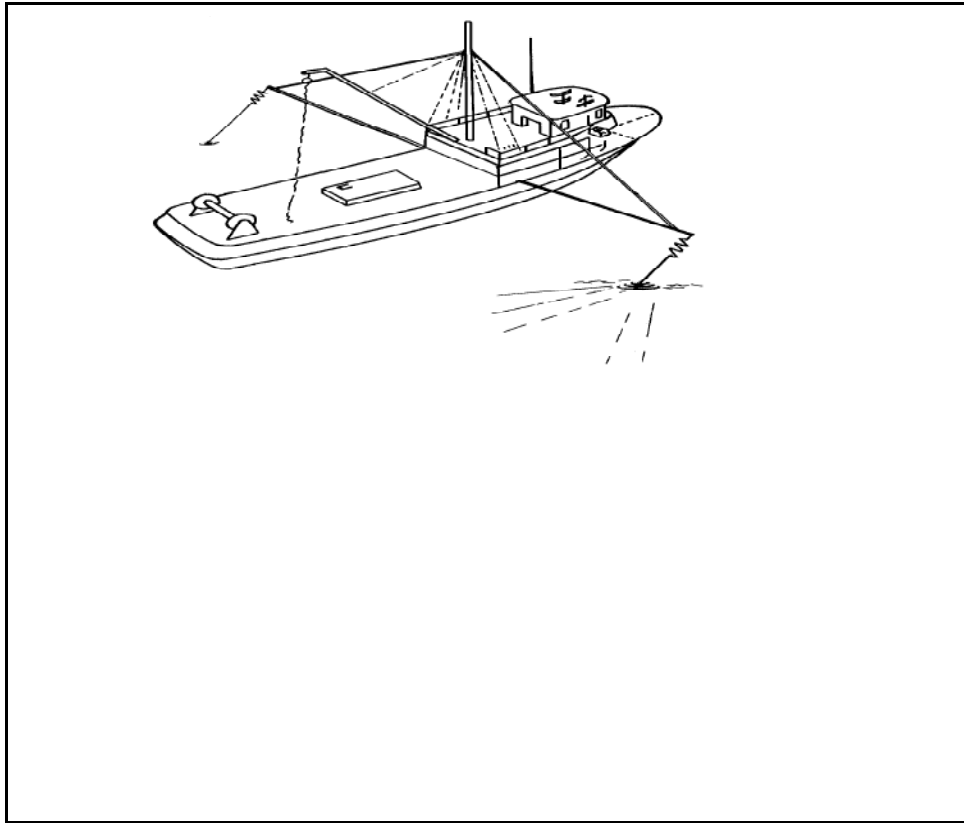
Roll-dampening paravanes were fitted to the "LORI CATHLYNN" on port and starboard outriggers attached to the bulwarks. The paravanes were in use at the time of the occurrence. Post-occurrence inspection of the vessel showed that the cable to the starboard paravane stabilizer was ruptured at the eyelet's extremity. The paravane could not be found on the vessel. It could not be ascertained if it was lost at the time of the occurrence or while towing the upturned vessel the following day.

When both paravanes are deployed, they are lowered into the water—port and starboard—from the extended outriggers. When dragged through the water, each paravane exerts a downward force by the diving effect of its fin. This balanced downward pulling force at the end of each outrigger makes the moving vessel more resistant to heeling forces, and dampens roll (see Figure 2).

The use of roll-dampening paravanes is not without risk. The safe functioning of the submerged delta-shape is largely dependent on the towing speed and on their complementary operation—to port and starboard—such that the righting moment caused by the downward force generated on one side is synchronized with the upward roll of the vessel on that same side. If the port and starboard synchronization is disturbed or lost, an athwartships moment can be applied to the vessel when she is rolling toward the paravane generating the most downward force, and the vessel's roll may actually be increased on that side. The synchronous and complementary operation would be significantly disturbed if one paravane became fouled on an obstruction. In addition, the skipper's action of steering to port when the vessel was heeling to starboard would have unfortunately affected the heeling to starboard.

3. The roll-dampening paravanes were being used at the time of the occurrence.
4. A combination of the dynamic heeling effect of the paravane on the starboard side, free surface effects of the liquids and a load of herring spawn on deck reduced the vessel's righting ability, causing it to roll to starboard and to heel rapidly.

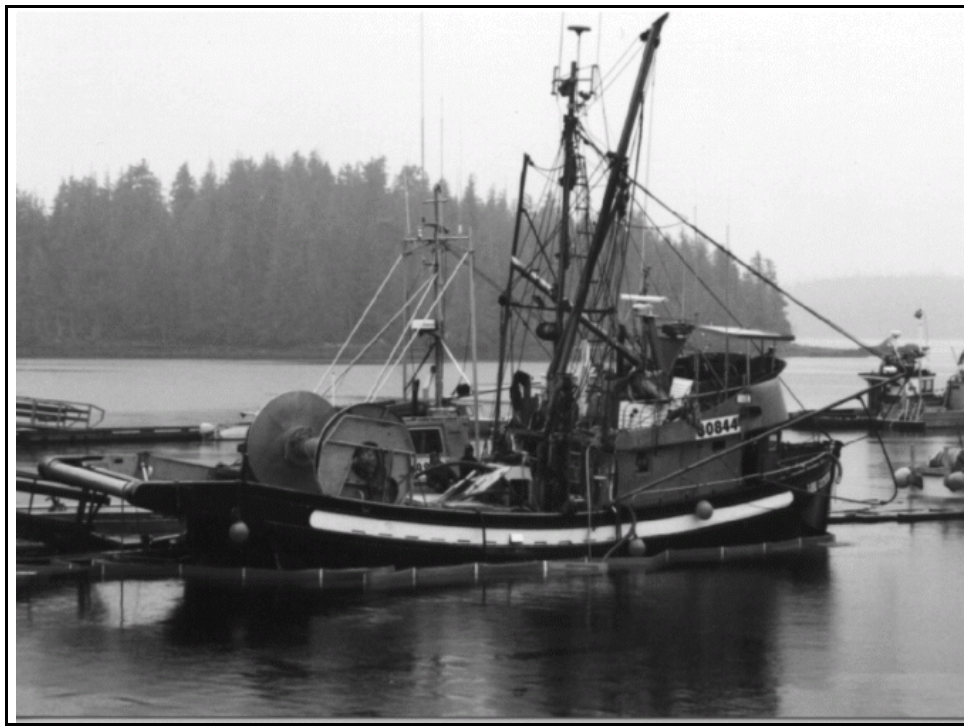
Appendix C - Photos

The "LORI CATHLYNN" was taken in tow to Shearwater, B.C., for salvage, inspection and repairs (see Appendix C, Photos 1 and 2).

The flush deck scuttles of the lazarette and of the port fish hold were missing and the main hatch of the fish holds was not in place when the vessel was recovered. The deck scuttles were lost, indicating that they had not been secured. Although required by regulations, the deck scuttle cover was neither hinged nor secured by a chain to the vessel's structure. The sudden heeling and the action of sea water swamping the vessel's deck would have dislodged them from the hatch coamings, allowing the ingress of water. The resultant downflooding of the lazarette and of the fish hold would have increased the heel and hastened the capsizing.
