MARINE INVESTIGATION REPORT

M00W0059

ACCIDENT ABOARD SHIP – ALONGSIDE

FISHING VESSEL – SALMON TROLLER “C - JOY”

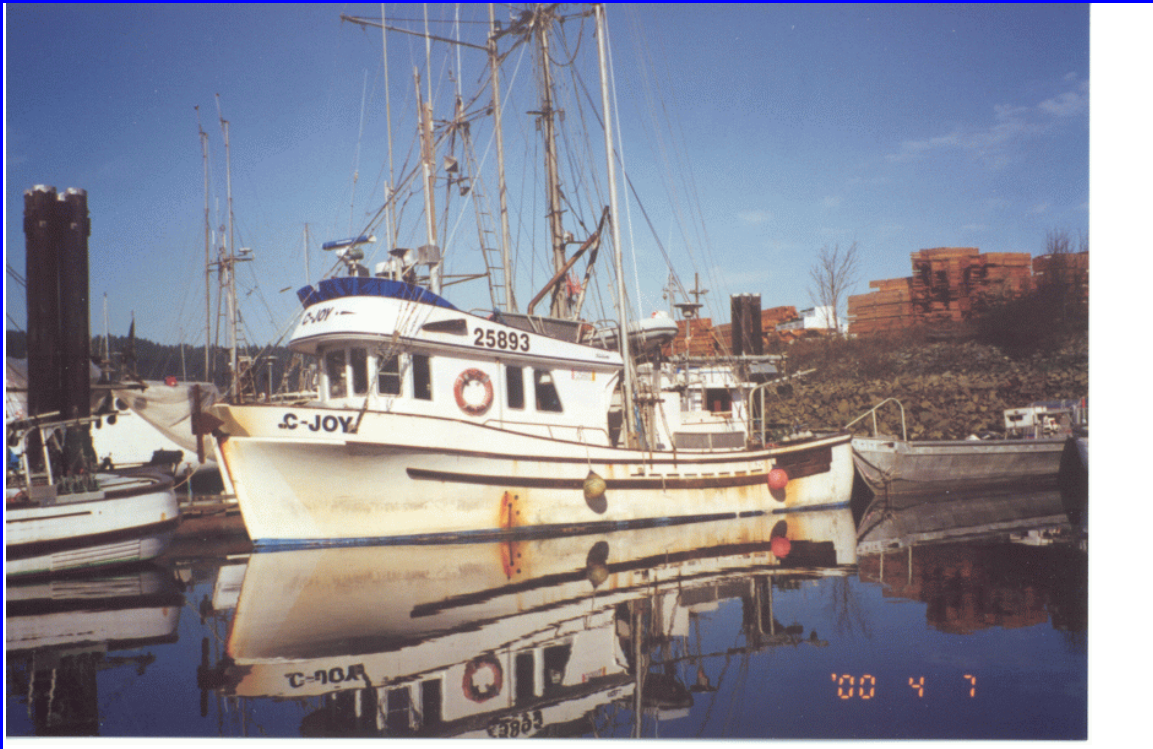
The "C- JOY" is a commercial salmon troller built in 1978 of moulded fibreglass construction. Below decks forward is crew accommodation. Aft it is the machinery space, aft of which (and separated from it by a watertight transverse bulkhead) is a refrigerated fish hold, at the after end of which is another watertight transverse bulkhead. Aft of this bulkhead is a lazarette terminating in a transom stern (see Photo 1).

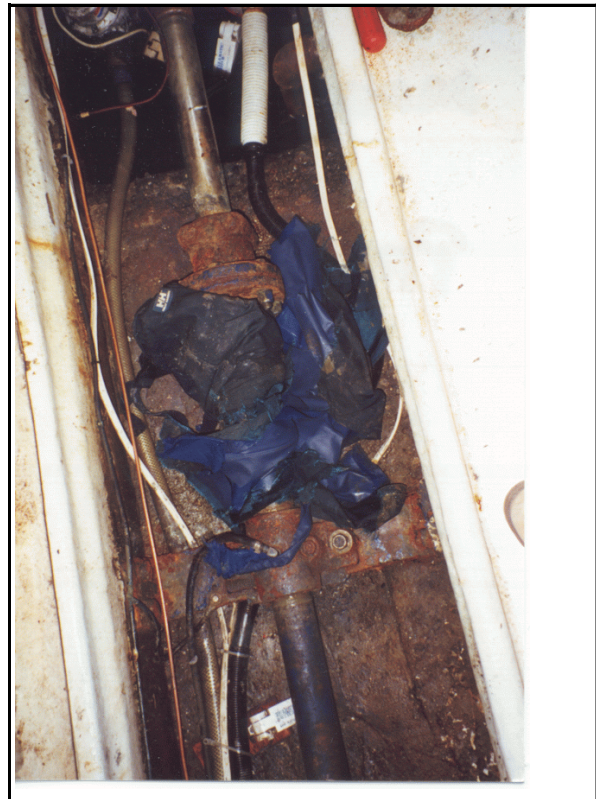
As the owner/operator reached the platform at the base of the ladder, he lost his footing. His legs went forward from underneath him and the left cuff of his weather protective trousers became entangled in the bolts of the rotating shaft coupling (see Photo 4). The operator's left leg was drawn progressively into the 150 mm void between a shaft coupling and the interior port side of the shaft well.

1. The owner/operator was working alone in a confined space where the guard on turning machinery had been removed.
2. The removal of the shaft well cover to work on the stern gland also exposed the rotating shaft coupling which caught and trapped the hem of the owner/operator's rain pants.
3. The severity of the owner/operator's injuries was due to his inability to stop the rotating propeller shaft and to the tear-resistant fabric of the rain pants worn by him. The fabric did not tear when first caught and the owner/operator's leg was drawn into the rotating shaft coupling with it.
