MARINE INVESTIGATION REPORT

M00W0220

COLLISION

PASSENGER/VEHICLE FERRY *SPIRIT OF VANCOUVER ISLAND*

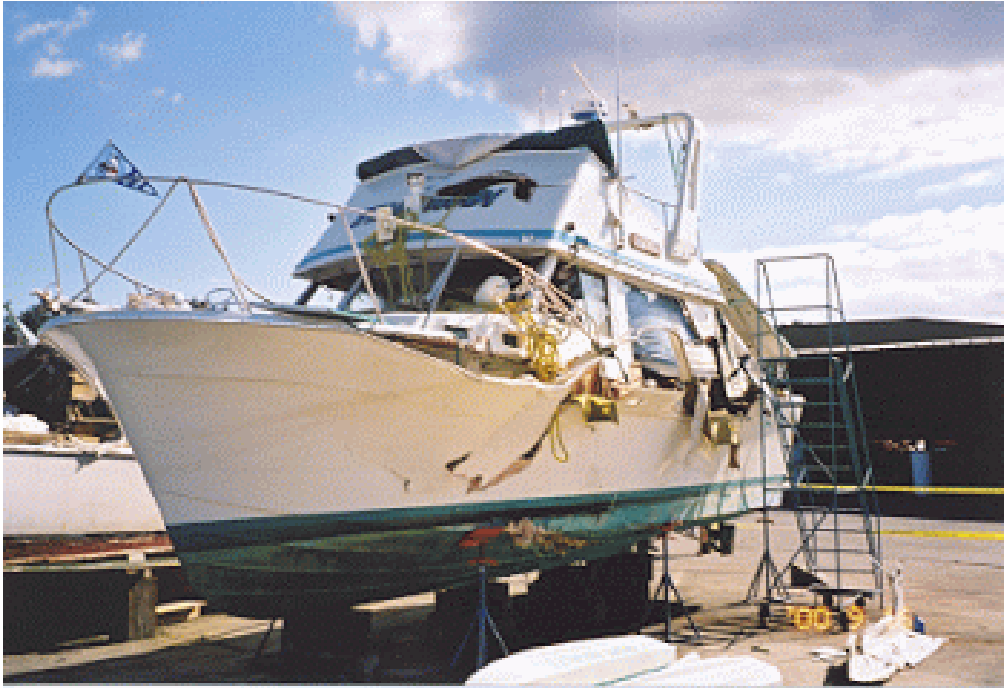
The *Spirit of Vancouver Island* sustained abrasions to the starboard corner of the main vehicle deck where it extends beyond the forward doors. An indentation 19 mm deep was observed in the 16 mm thick hull plating between frames 173 and 180 below the waterline.

The *Star Ruby* sustained major damage. The port side of the hull, forward of the beam and above the waterline, was significantly fractured and torn away, found hanging only from its forward edge. The port aft portion of the superstructure was torn away, leaving a gaping opening into the cabin. Below the waterline, between the port chine and the keel, the hull was gouged and torn open as a result of contact with a scupper pipe extending from the hull of the *Spirit of Vancouver Island* adjacent to the starboard anchor pocket. There was no discernable pollution.
