MARINE INVESTIGATION REPORT

M01W0006

CONTAINER SHIP *ALLIGATOR VICTORY*
DELTAPORT, VANCOUVER, BRITISH COLUMBIA
09 JANUARY 2001

Report Number M01W0006

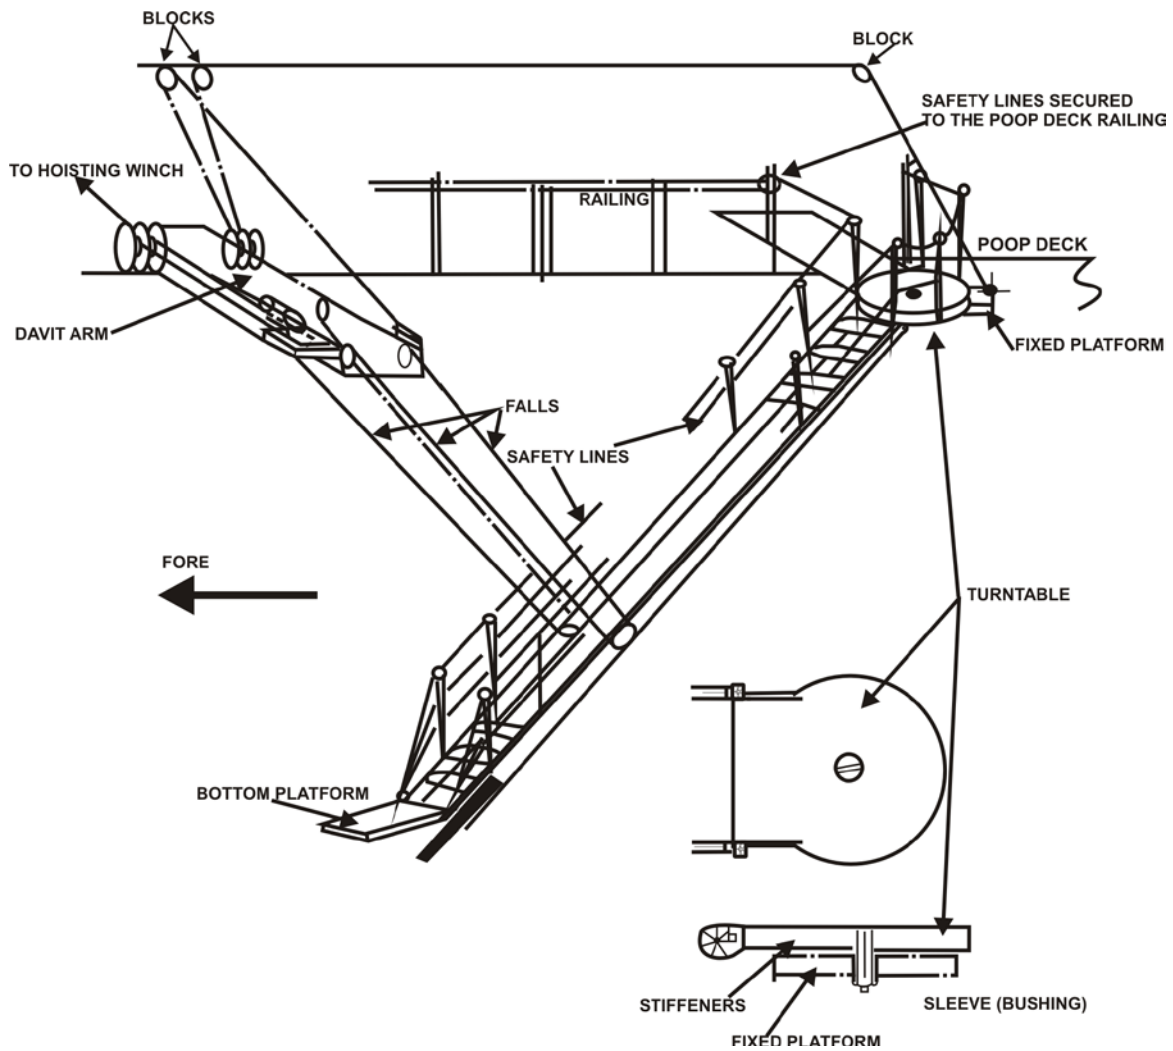
The accommodation ladder is stored on the ship and is considered an attachment. It provides access to the ship and enables its personnel, stevedores, and officials to embark and disembark. The accommodation ladder was rigged as shown in Figure 1.

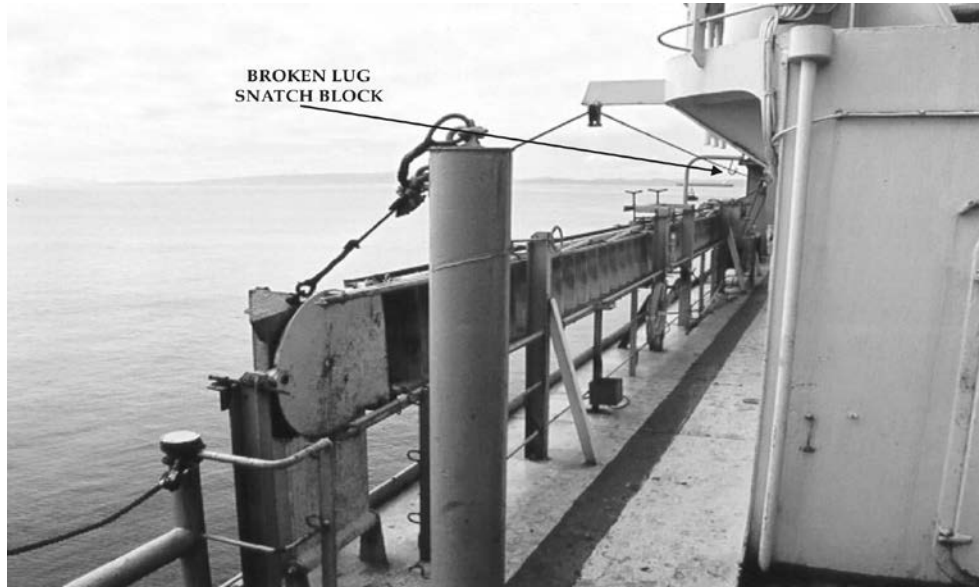
entire ladder and the turntable sideways. The complete assembly now pivots about the hinge between the turntable and the deck, until the assembly becomes vertical and lies on its side. The assembly can now be secured for an ocean passage. The ladder's and the turntable's stowed position is vertical, inboard of the ship side but outboard of the railings (Figure 2).

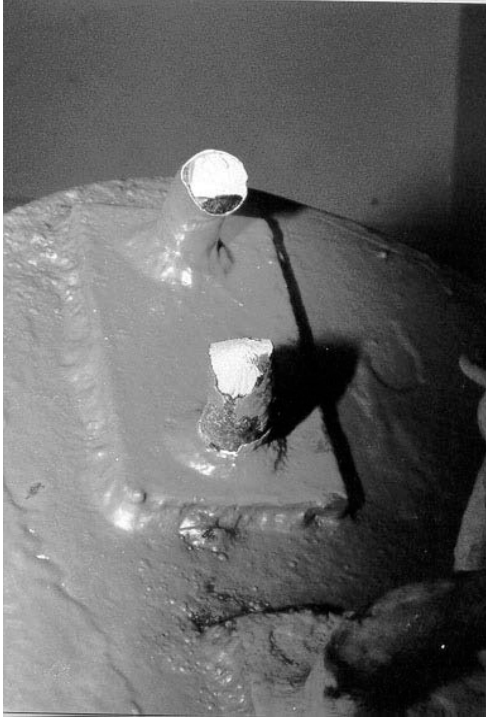
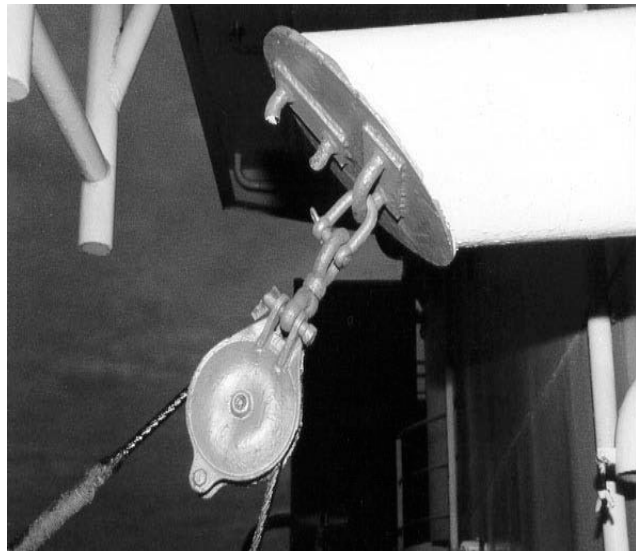
Inspection of the broken pad eye revealed two pre-existing cracks that had formed some time ago. The cracks were on the inside curvature of the pad eye and had escaped detection during preventive maintenance. The pad eye was subjected to repeated, nonuniform loading and unloading as the gangway was lowered and raised. Initially, the cracks were two points of stress concentration that slowly became enlarged, one of which had

extended to almost 25% of the cross-sectional area of the pad eye. The failure occurred as a result of tensile overload when the remaining intact area was insufficient to carry the load imposed on it.

- b) All pad eyes in way of the accommodation ladders were renewed, and guide blocks and shackles were serviced/replaced as required.
 - c) Both accommodation ladders were operationally tested, to the satisfaction of the attending Class NK surveyor.
