MARINE INVESTIGATION REPORT

M02W0049

CAPSIZING AND LOSS OF LIFE

SMALL OPEN BOAT *DEEP WATER*

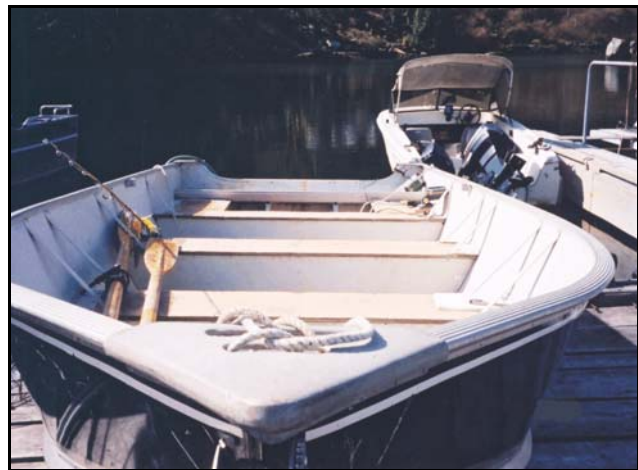
Photo 1. Open boat *Deep Water*

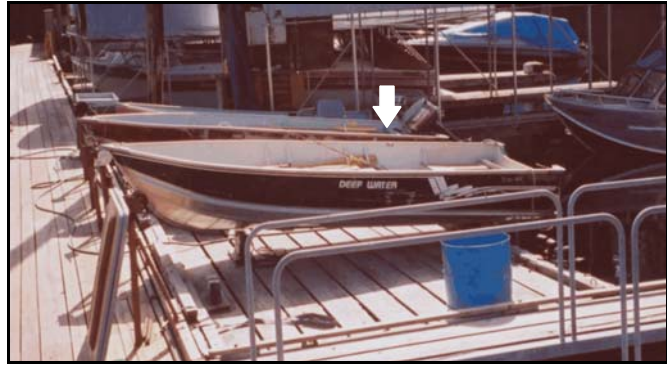
Photo 2. The *Deep Water* at marina moorings

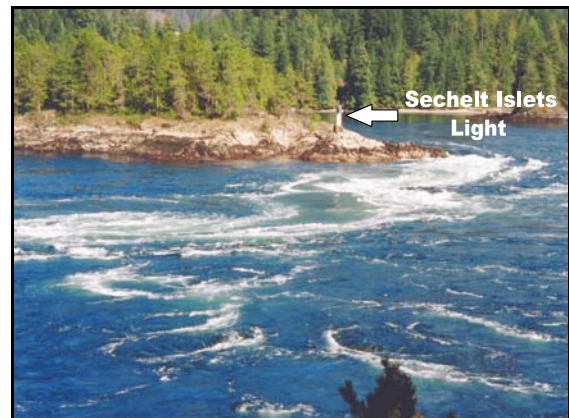
Photo 3. View of Sechelt Rapids

The strongest ebb stream occurs just west of Sechelt Islets light, with a strong cross-channel set toward the WNW. A large backeddy occurs to the north of the light, and whirlpools form close to the light.

It is hazardous for any vessel to attempt to navigate Sechelt Rapids except at or near slack water.⁴

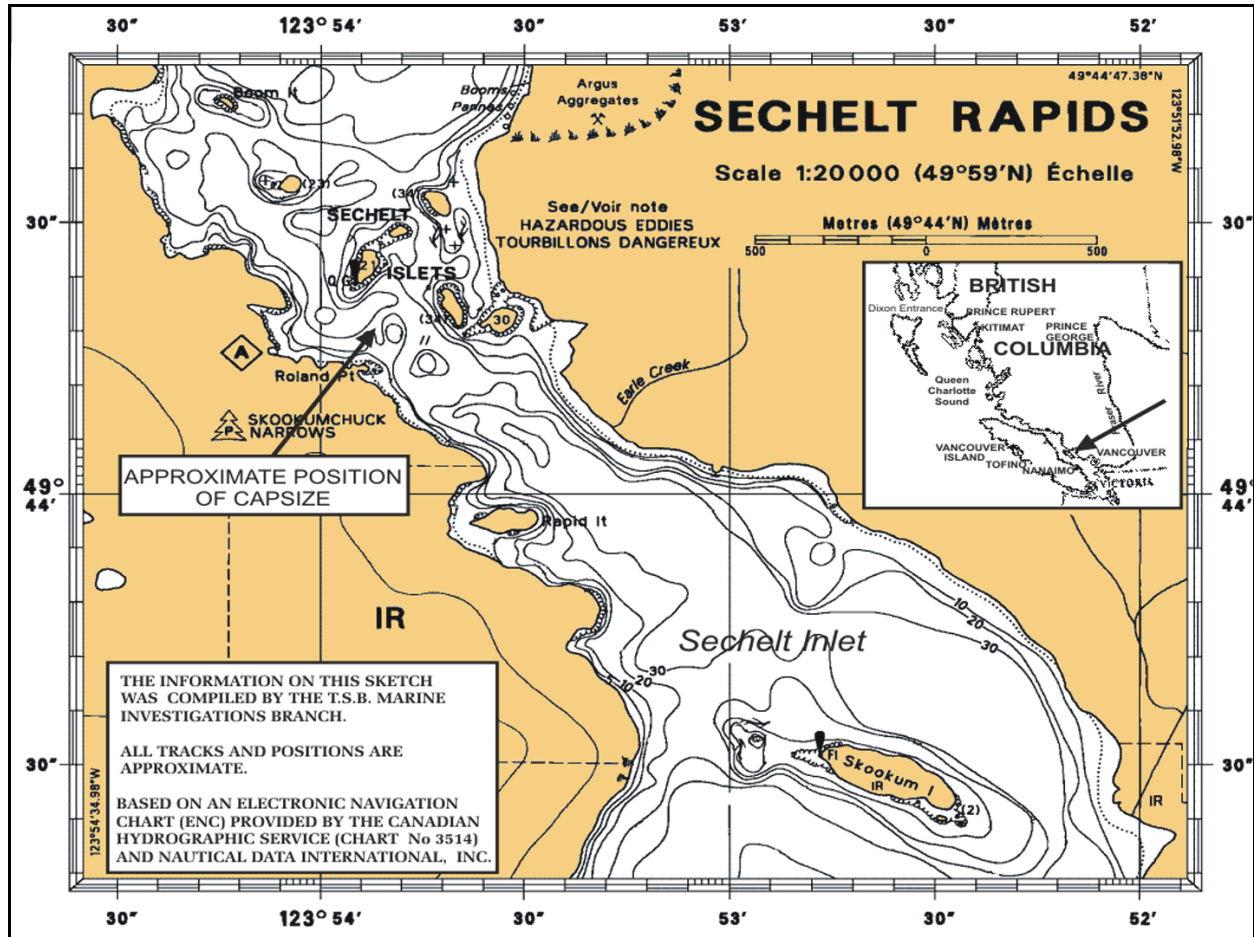
Appendix A – Sketch of Occurrence Area

The boat capsized to starboard while in the turbulent waters of a backeddy. Of the five persons aboard the boat, all but one were wearing PFDs. Two persons clung to the boat's overturned hull and were rescued later. Two swam to shore near Roland Point. All four survivors were taken to St. Mary's Hospital in nearby Sechelt, B.C., where they were treated for mild hypothermia. The fifth person had no PFD and was last observed clinging to an empty plastic cooler while being swept away by the fast flowing water. His body was recovered two months later in Sechelt Inlet. (See Appendix A – Sketch of Occurrence Area.)
