**MARINE INVESTIGATION REPORT**  
**M04N0086**

**CAPSIZING AND LOSS OF LIFE**

**SMALL FISHING VESSEL *RYAN'S COMMANDER***  
**5 NAUTICAL MILES EAST OF CAPE BONAVISTA,**  
**NEWFOUNDLAND AND LABRADOR**  
**19 SEPTEMBER 2004**

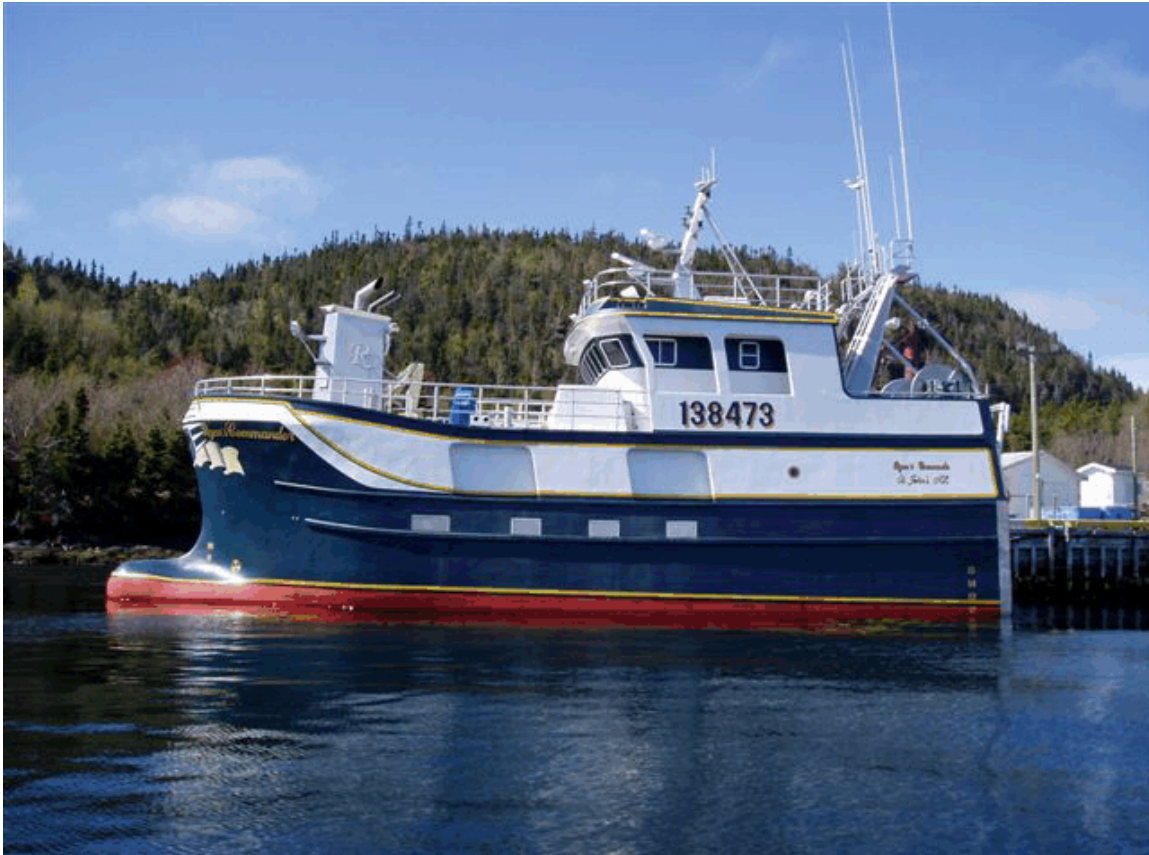
**Photo 1.** The small fishing vessel *Ryan's Commander*

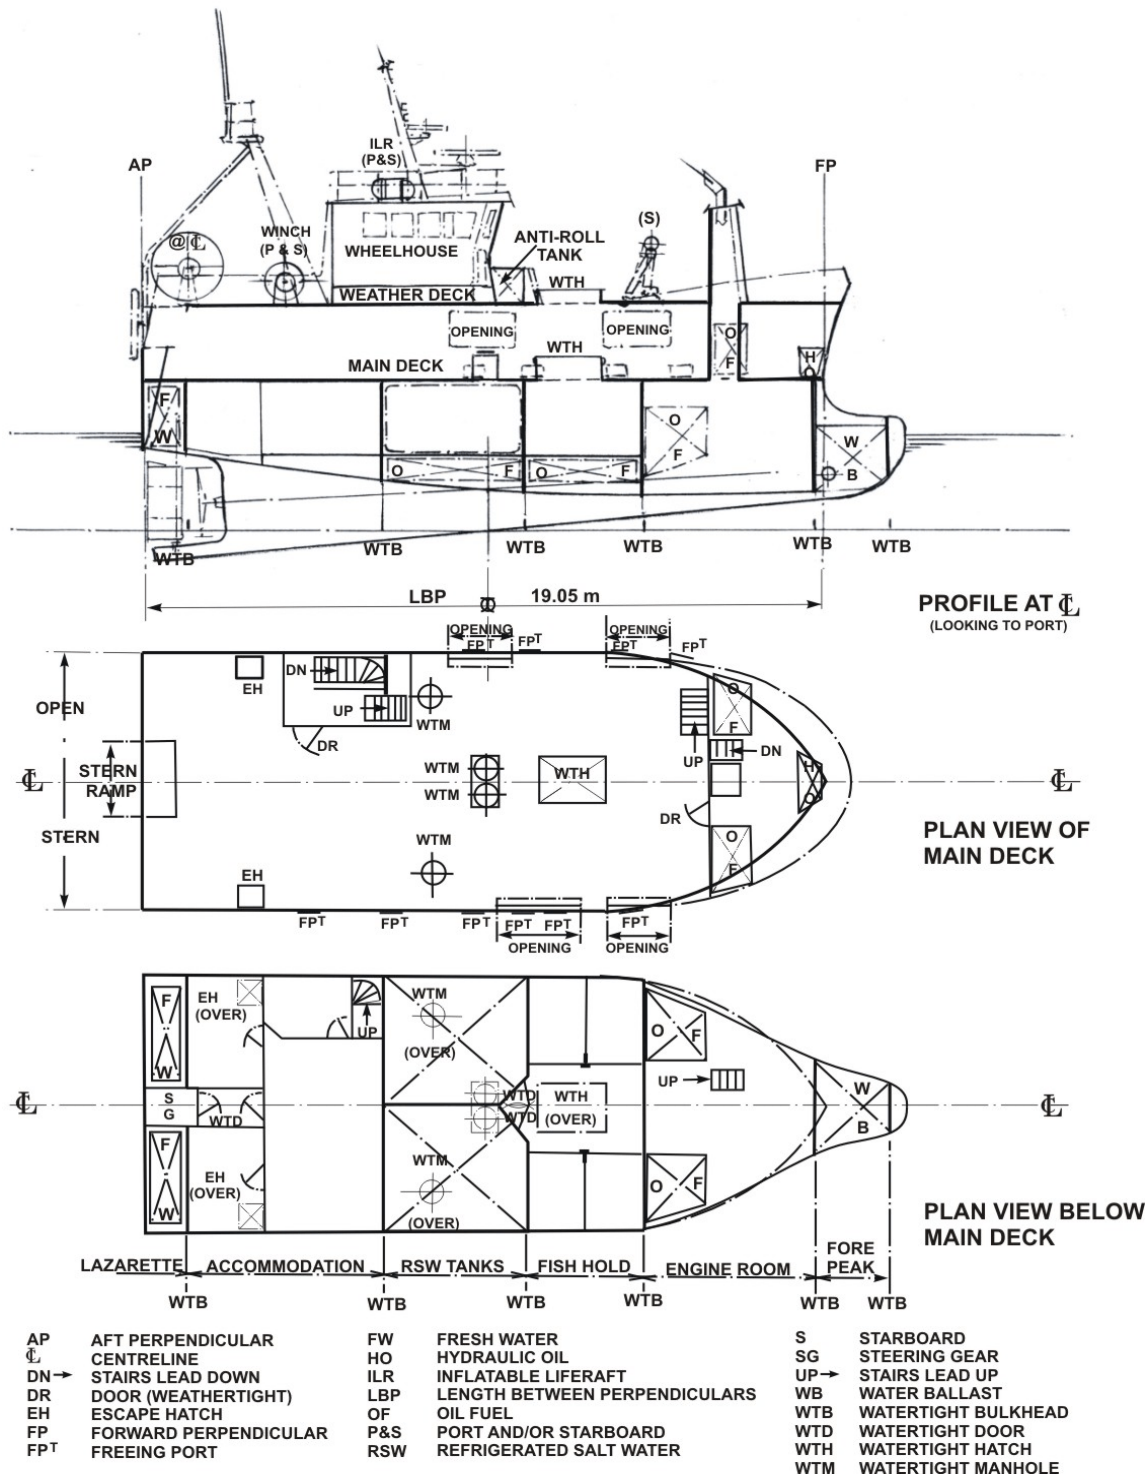
# Appendix A – General Arrangement Plan of the Ryan’s Commander

On 15 January 2004, the general arrangement for the *Ryan's Commander*, as submitted, was approved subject to notations in red by the TC technical office in St. John's. Approved copies of this plan were sent to the NA, TC Headquarters in Ottawa, Ontario (for retention purposes only), and the TC district office in Lewisporte, Newfoundland and Labrador, with a copy retained by the St. John's office. This plan with covering letter was then forwarded by the NA to the builder. The ART plan had not been returned by TC to the NA at the time of the occurrence. The diagram below represents relationships (contractual and otherwise) between the owners, builder, NA and TC.

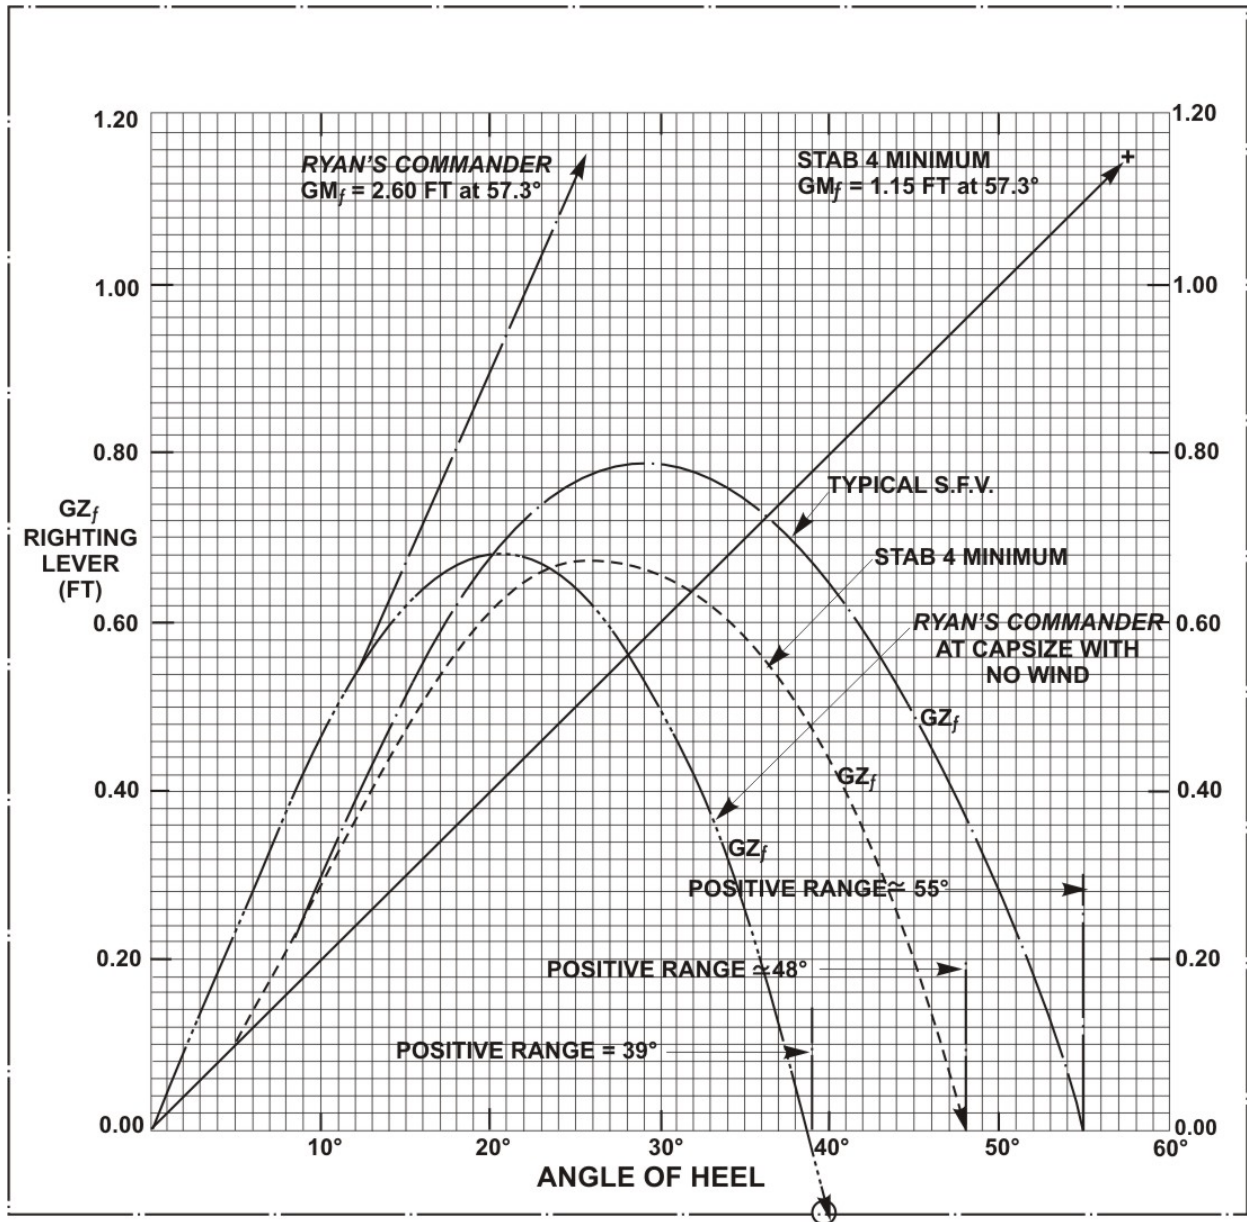
*Appendix C – Comparison of GZ Curves for the Ryan's Commander, STAB 4, and a Typical Small Fishing Vessel*

The results for the loading condition at the time of capsizing (with water ballast, the ART in use, and no wind) show that the vessel did not meet most STAB 4 criteria. Its stability beyond 30° is about 34 per cent of the criteria, and the maximum GZ occurs at 20° rather than the minimum 25° recommended in STAB 4. Furthermore, the vessel's range of positive stability is limited to a maximum of 39° while the STAB 4 typical range is about 48°, and angle ranges greater than 50 to 55° are generally to be expected for typical SFVs of this size (see Appendix C).

During the voyage, the lightly loaded vessel's range of positive transverse stability was below the minimum criterion of STAB 4 and what is generally expected for typical SFVs of this size (see Appendix C). The steady wind-induced heel of 7° to port, together with its range of positive transverse stability to not more than 35°, further reduced the vessel's power of recovery on that side. The situation was further compounded by the dynamic effects of beam and quartering seas, which caused significant fluctuations in trim and stability characteristics.

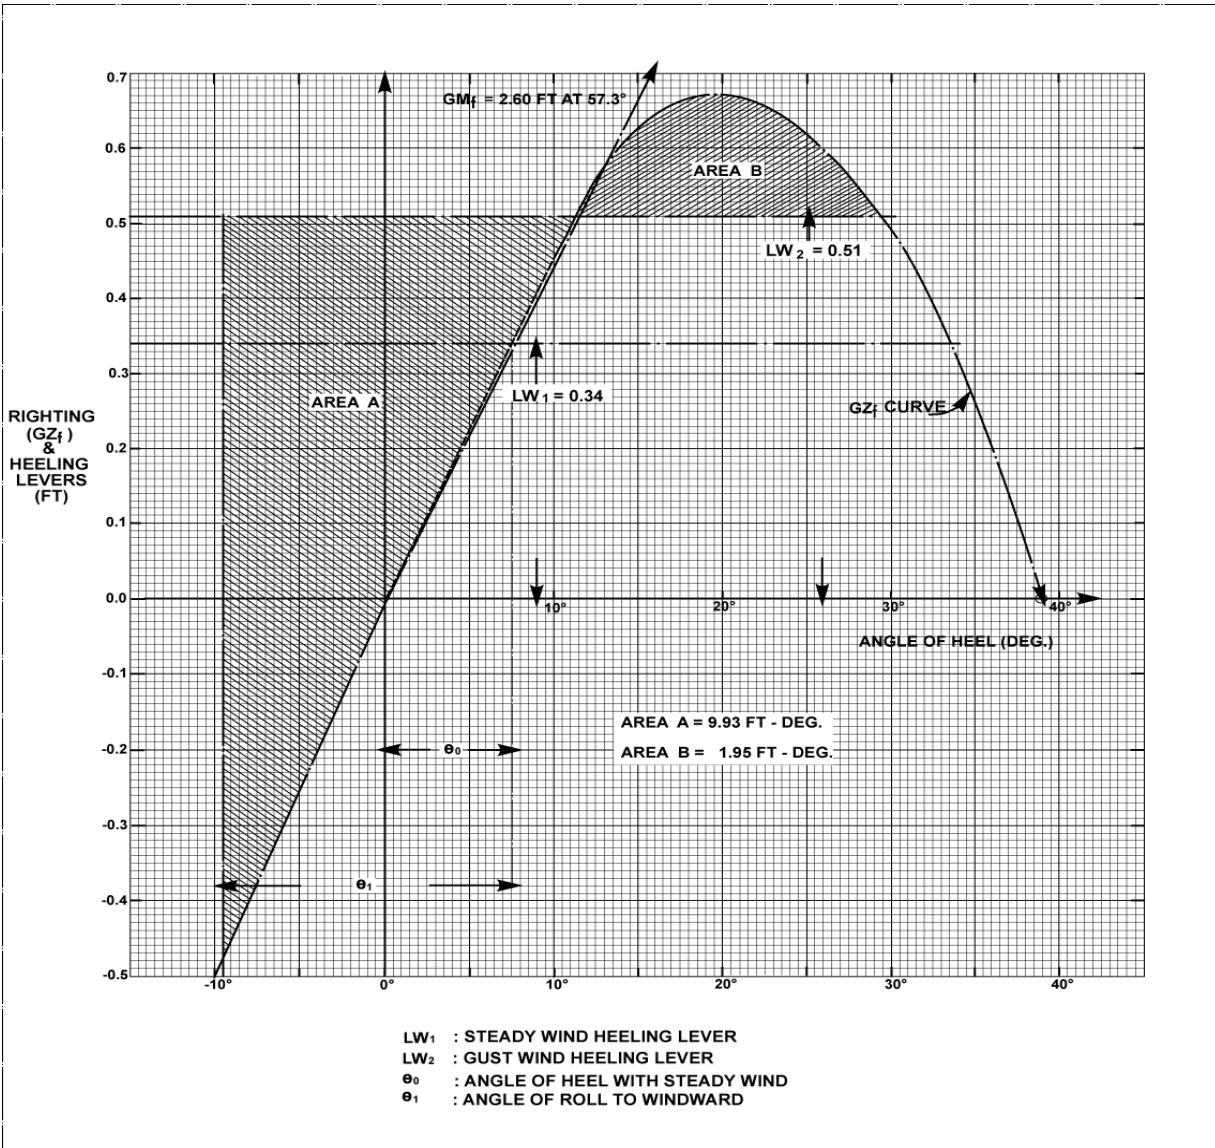
## Appendix D – Comparison of the GZ Curve for the Ryan’s Commander with the Weather Criteria

The results for the loading condition at the time of capsizing were compared with the weather criteria of the proposed TC document Stability Standard - Small Fishing Vessels under 24 m<sup>11</sup> and the International Maritime Organization (IMO) *Code on Intact Stability*. They show that the transverse stability and windage of the *Ryan's Commander* were such that the action of a beam wind would cause a steady heel of about 7° and that the range of positive statical stability would be limited to about 34° (see Appendix D). These figures are consistent with the vessel's heeled condition and the slow recovery characteristics the crew observed shortly before the capsizing. The results also show that the severe wind and rolling criteria of the standard mentioned above would be partly met. The angle of heel under action of steady wind (7°) would not exceed the minimum criteria of 16°, but the residual area B above the gust wind heeling lever ( $LW_2$ ) and below the GZ curve would be equivalent to only 20 per cent of area A, while the set criterion is at least 100 per cent (see Appendix D).
