MARINE INVESTIGATION REPORT

M05M0052

RO-RO PASSENGER FERRY *CONFEDERATION*
WOOD ISLANDS, PRINCE EDWARD ISLAND

27 JUNE 2005

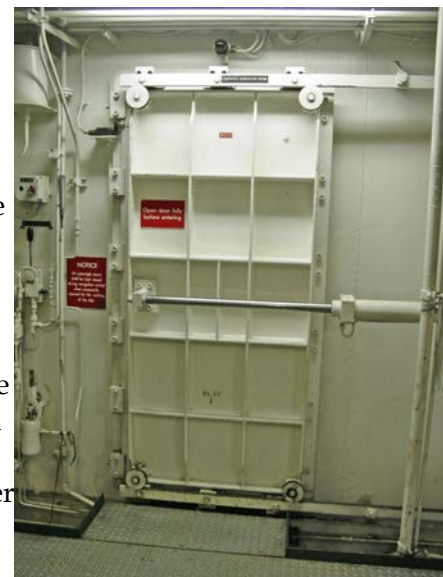
from the central location on the bridge whenever the vessel is at sea. This policy is addressed in the vessel's training manual as well as on signage posted at each of the three watertight doors. Additionally, warning signs are posted at each watertight door, instructing "Open door fully before entering."

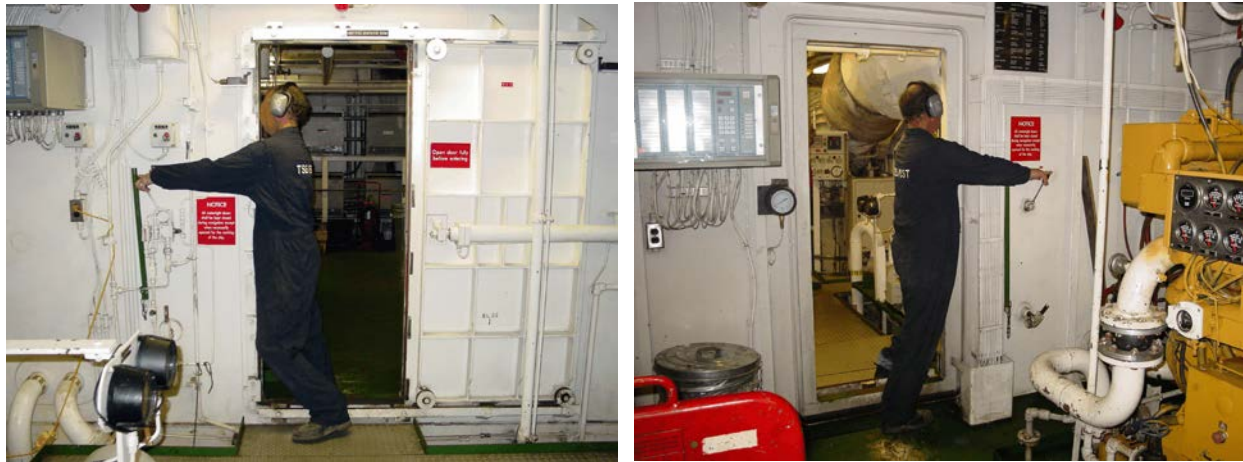
Post-occurrence trials on the *Confederation* showed that for all three sliding watertight door installations, it was very difficult to hold both operating levers at the same time. In the case of the horizontal sliding watertight door, the axis of rotation for the operating lever was approximately 51 cm from the edge of the door, and it had a 13 cm throw. This required the operator of the door to have a reach of approximately 64 cm (see photo 3).

The control levers for the horizontal sliding door have been modified to reduce the distance that the operator must reach. The operator can now, on both sides of the door, comfortably hold the levers in the open position while passing through the opening. Also, the door now slides in the same direction that the lever handle is moved.

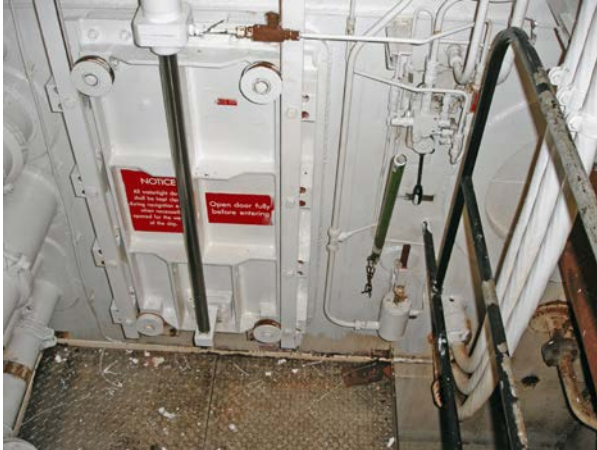
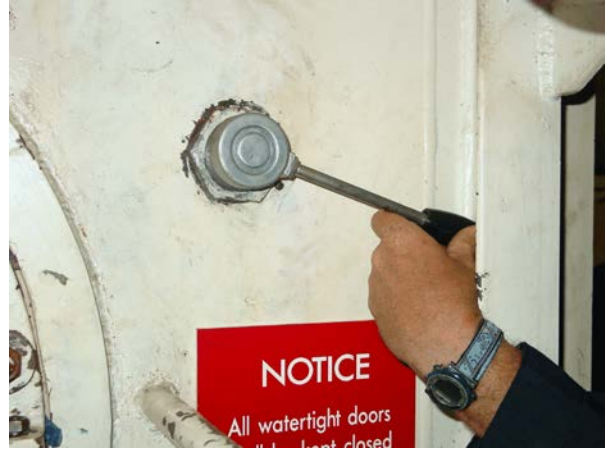
In the case of the two vertical sliding watertight doors, the axis of rotation for the operating levers was 37 cm and was, therefore, closer to the edge of the door. However, access to the operating levers on one side of both doors was restricted by an angle frame (see photo 6). Additionally, the lever operation of the two doors was not consistent. In one case, the door was opened by pushing the lever, while in the second case the lever was pulled.

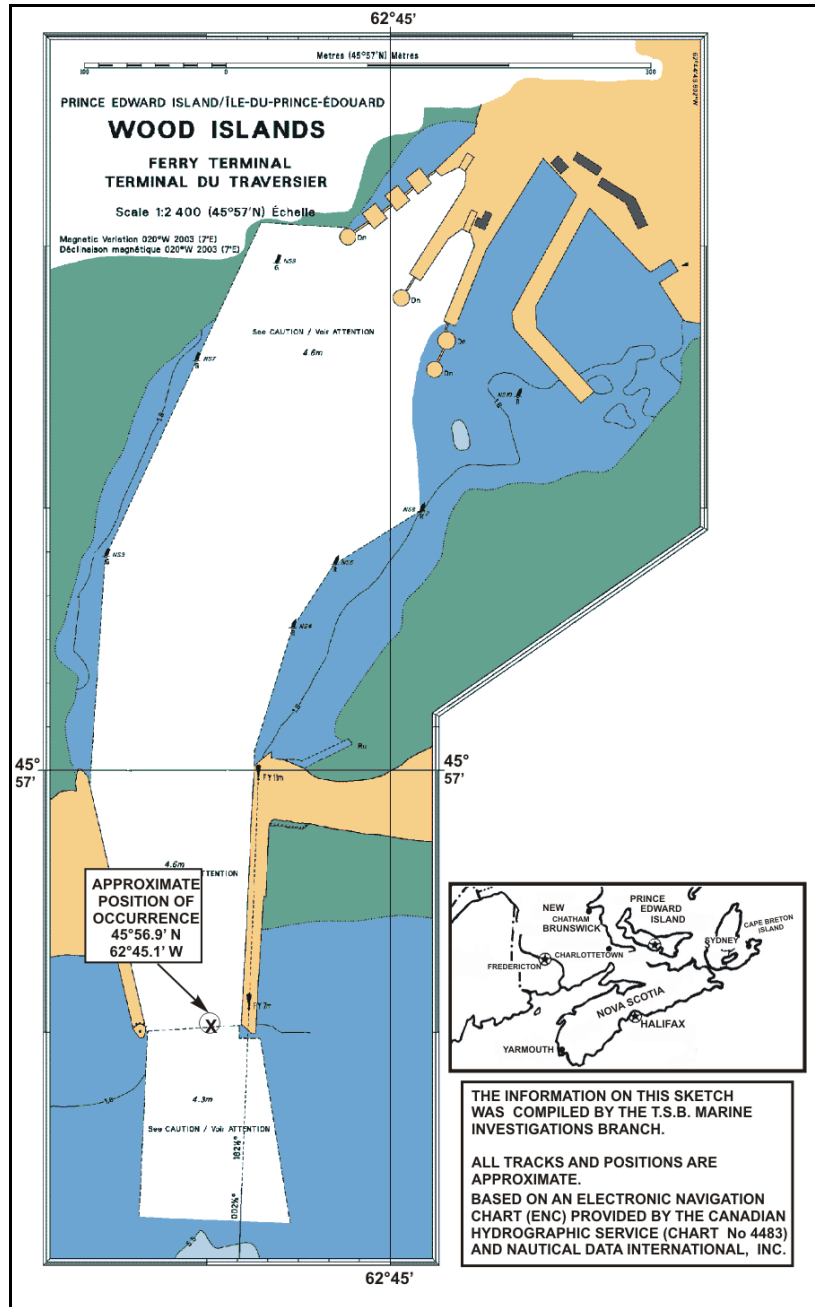
Appendix A – Sketch of the Occurrence Area

At approximately 1727, the crew member was noticed caught in a horizontal sliding watertight door by his co-worker. The co-worker immediately opened the door, freeing the unconscious crew member. He carefully lowered him to the deck and made him comfortable. Shortly afterwards, the crew member regained consciousness. The vessel continued on to the Wood Islands ferry terminal, arriving five minutes later, where the crew member was treated and transported to hospital by ambulance.
