MARINE INVESTIGATION REPORT M06L0045

EXPLOSION

**GENERAL CARGO VESSEL *NILS B*
GRANDE-ANSE TERMINAL,
PORT SAGUENAY, QUEBEC
22 APRIL 2006**

Report Number M06L0045

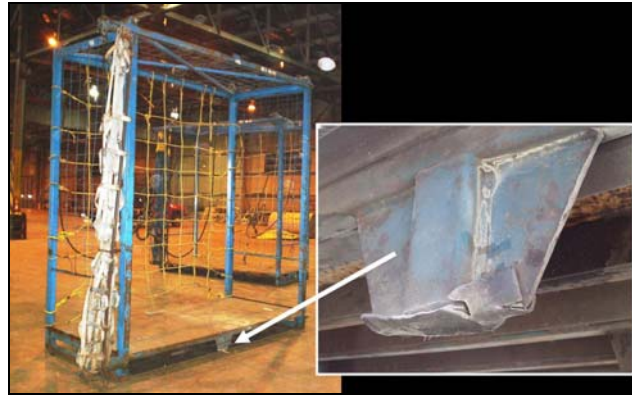
The blast displaced the cage approximately 30 cm upward and deformed one of the support feet (see Photo 3). In addition to the loud noise, shockwave, and smoke, there was a fireball nearly 1 m in diameter. A small fire on the deck was rapidly extinguished by a stevedore using a fire extinguisher.

Photo 3. Metal cage with support feet deformed by the explosion

1. A combination of inadequate packaging and poor loading and unloading practices resulted in explosive material being spilled and left on deck.
2. Because there was no source of friction or heat in the immediate vicinity, it is likely that the detonation occurred when the metal cage made contact with the explosive material on the tank top.

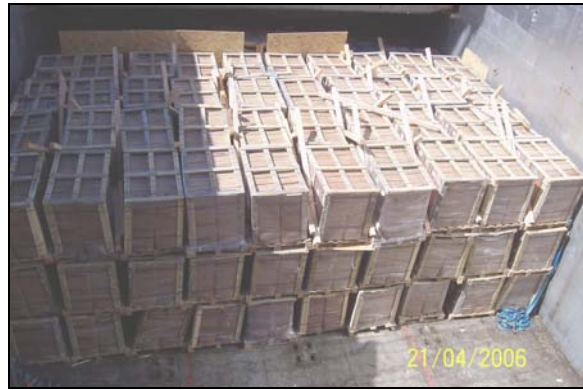
The cargo in the lower hold, from Germany, was loaded in three tiers and reached a height of approximately 3.5 m.¹⁶ There were indications that the cargo had shifted in the lower hold (see Photo 6). Also, the wood planking on some pallets was rotten, and some pallets had missing or damaged flooring. The top of the pallets and the top tank were covered with sawdust and detritus, making it difficult to detect any spilled material. Some packaging was found perforated with cargo spilled on the deck, while other packaging was deformed (see Photo 7 and Photo 8).

Photo 6. Cargo loaded in Germany

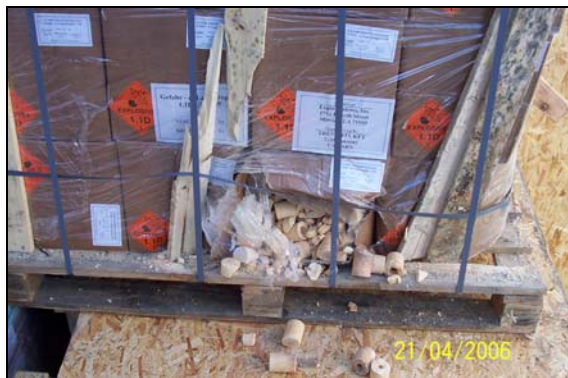
Photo 7. Damaged packaging from Germany

Packaging that is used to transport dangerous goods should be able to withstand the shocks of normal loading activity, and should bear markings proving that it was tested accordingly.³² The decision to choose one type of packaging over another is the shippers' and is mainly guided by the intended use, by receiver requirements, and by economics. However, the condition of some cardboard boxes indicates that the packaging was unable to withstand the rigours of shipping and handling en route³³ and did not meet IMDG requirements.

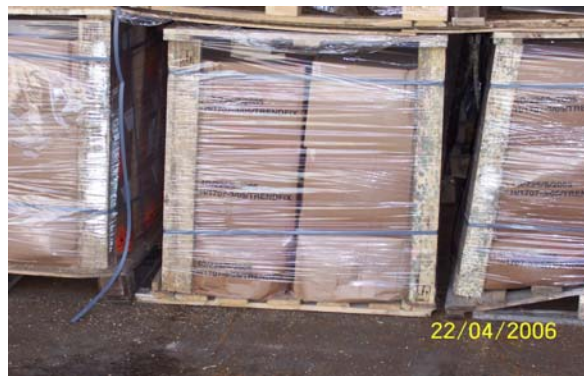
Photo 8. Broken and/or rotten pallets

Furthermore, there are no standards for the pallets used for dangerous goods, even though palletizing of cargo is a common practice with the potential to affect operations. Inadequate pallets, for example pallets with sharp edges or missing or damaged flooring, can compromise the safe carriage of goods. In this occurrence, it resulted in cargo being dropped on the wharf and, as some pallets had missing flooring, the use of unsafe practices to remove them from the hold; i.e., to lift the pallets that were sitting on the tank top, the steel forklift prongs had to be slid under the pallets while scraping the steel deck.
