MARINE INVESTIGATION REPORT

M07C0034

ENGINE ROOM FIRE

SAIL TRAINING VESSEL *FAIR JEANNE*
OFF AMHERST ISLAND, LAKE ONTARIO, ONTARIO
13 JULY 2007

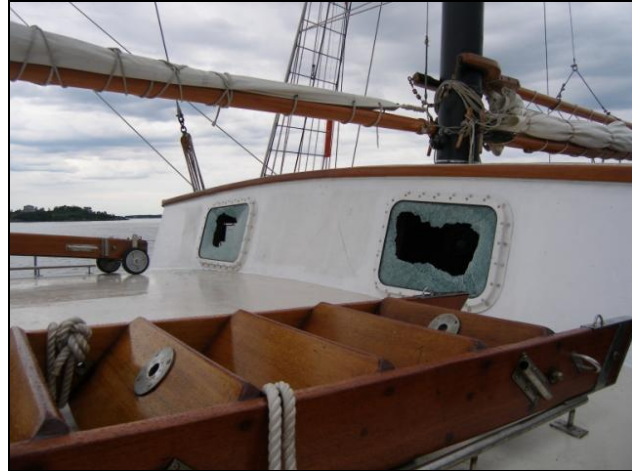
Photo 2. Front windows of the deckhouse broken by firefighters (to ventilate the accommodation area)

Several deckhouse windows were broken for ventilation and the accommodation had extensive smoke and water damage.

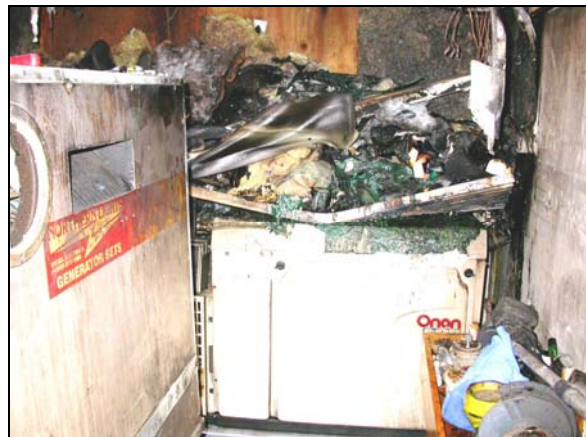
Photo 3. Collapsed shelf in engine room where flammable goods were stored

The vessel's engine room had extensive heat, smoke, and water damage. An inspection of an engine room shelf that had collapsed revealed damage patterns indicative of localized hot spots ⁴ (see Photo 3) and the remains of burned/melted plastic containers were found on the shelf. It was discovered afterwards that flammable goods had likely been stored openly on a shelf in the engine room, thus contributing to the fire.

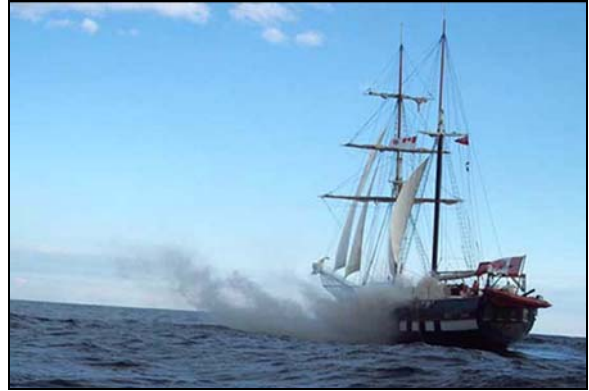
By about 1830, eight vessels were on scene, including the fire boat *Last Chance*, from Clayton, New York, U.S.A., as well as a helicopter and a Hercules SAR aircraft from Trenton, Ontario. As firefighters from the *Last Chance* approached the *Fair Jeanne*, they noted grey smoke billowing from the vessel (see Photo 4).

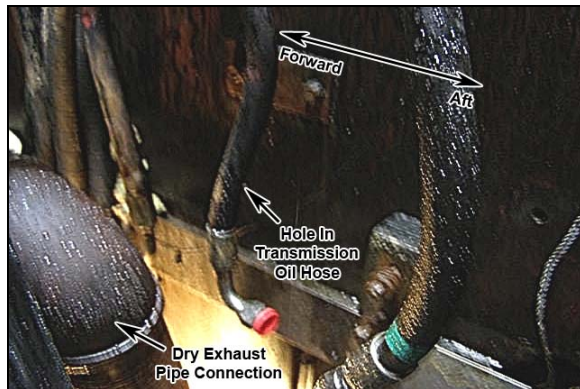
Post-occurrence testing revealed that, when the engine was running, transmission oil sprayed from a leak in the transmission hose onto the hot section of the dry-exhaust pipe. Further investigation found that the hose had a small slit, which likely pre-dated the fire. In addition, when the engine was shut down, the transmission oil level was checked and the sump was almost empty.

Photo 6. Starboard wall showing the transmission oil hose placed where it had been mounted. A small hole was found in the hose, facing down and aft, toward the dry exhaust section

During the occurrence, a large amount of flame was originally observed aft on the starboard side of the engine room. Analysis indicates that the seat of the fire was also in this area, at the base of the dry section of the engine exhaust pipe, near the bilge. The hydraulic filter was located above this section of pipe – which was wrapped with a thin layer of insulating material – and the leaking transmission oil hose was located nearby.

During a post-occurrence refit in August 2007, hydraulic lines and associated equipment were relocated and the dry exhaust pipe was redesigned in a P-trap shape. Thicker insulation was also applied in way of the lower part of the exhaust. Additional work included:

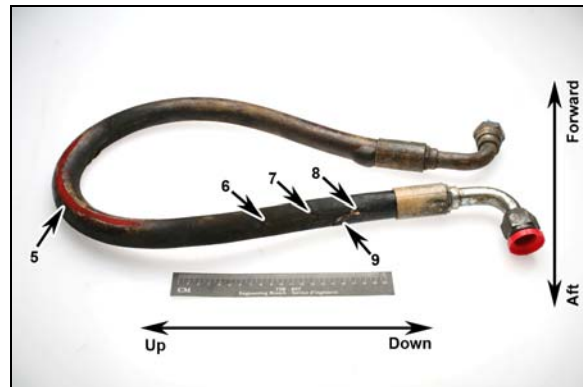
The investigation revealed that the hose was worn and may have been part of the original equipment installed on board in 1981. An examination of other hoses and lines in the engine room did not reveal any components that may have broken or failed prior to the fire.

Photo 7. Outboard face of the transmission oil hose showing the large wear mark (5), holes (6 to 8) and slit (9) in the outer cover

1. The fire likely started when the transmission hose failed, spraying oil onto the hot exhaust pipe.
2. The hose failed as a consequence of a small slit – most likely caused by old age – that developed in its side wall.
3. Lack of shielding allowed the fire to spread to flammable materials stored openly in the engine room.

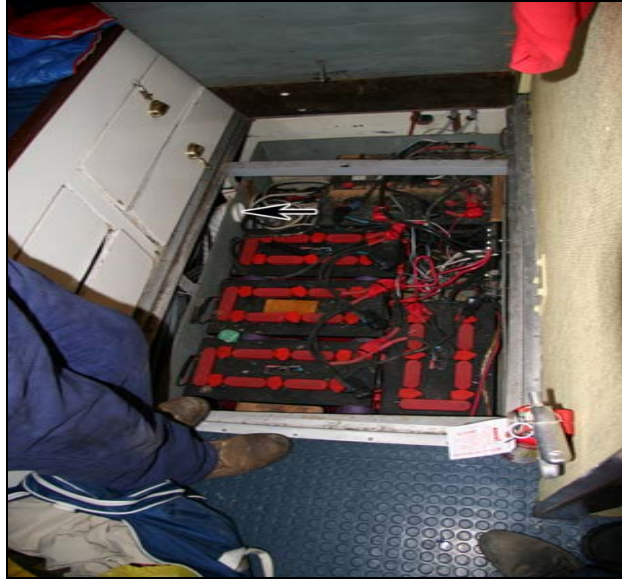
A post-occurrence inspection of the engine room's electrical wiring revealed that the compartment housing the main house-and-electronic battery bank was located within an accommodation space – on the lower deck in the after port side stateroom/cabin. Ventilation was intended to be provided by a plastic hose connected to the compartment (see arrow in Photo 8). This hose ran under the sole and up through a closet to a vent on the main deck. The vent, however, was found sealed and painted over.

Photo 8. Floor compartment housing the main house-and-electronic battery bank

- Relocation of the battery storage box to the engine room in accordance with a design submitted and approved by TC;
