**MARINE INVESTIGATION REPORT**  
**M09C0051**

**GROUNDING**

**BULK CARRIER *FEDERAL AGNO***  
**LAC SAINT-LOUIS, QUEBEC**  
**05 OCTOBER 2009**

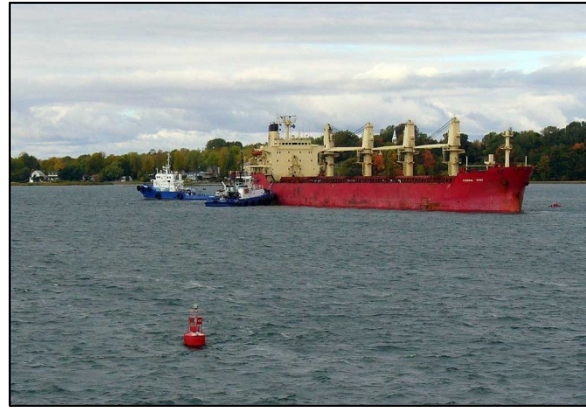
**Photo 1.** *Federal Agno* aground near buoy A52  
(photo credit [www.BoatNerd.com](http://www.BoatNerd.com))

The seabed consisted mainly of mud, clay, and some rock. The vessel grounded from approximately hold 2 to the aft section of hold 5 without a list. The draft after grounding was 8.10 m aft and 7.40 m forward. Neither the rudder nor propeller touched the seabed. On October 8, the vessel was refloated with the assistance of 3 tugs. An underwater inspection was subsequently carried out and found the following damage:

- Heavy scratching/grooving along flat bottom, with plating waved between frames 175 and 210
- Several hull indentations on the C strake, to a depth of 70 mm
- The bilge keel was bent downward between frames 115 and 121

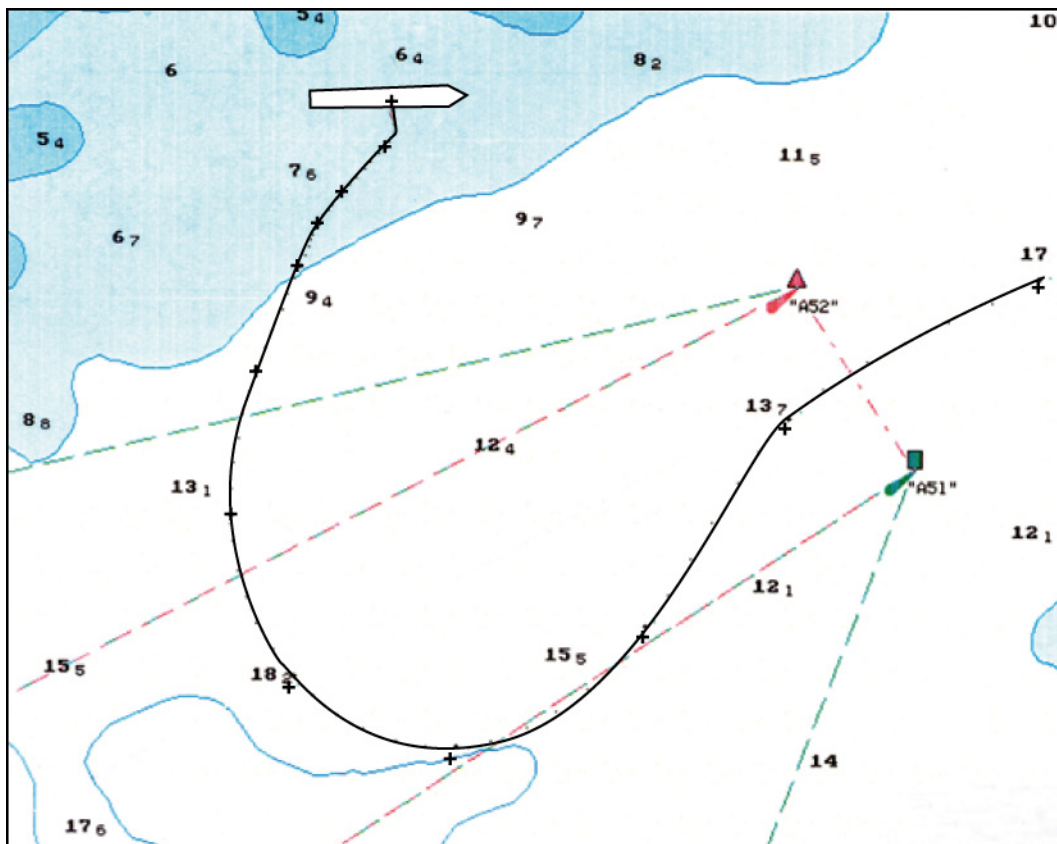
**Figure 1.** Track of the *Federal Agno* as shown on the vessel electronic chart system playback

The engine was run at full astern for approximately 3 minutes, but the turn rate could not be increased and the vessel exited the anchorage, running aground at approximately 1945, 4 cables northeast of buoy A52<sup>8</sup> before pivoting to a final heading of 088° G.

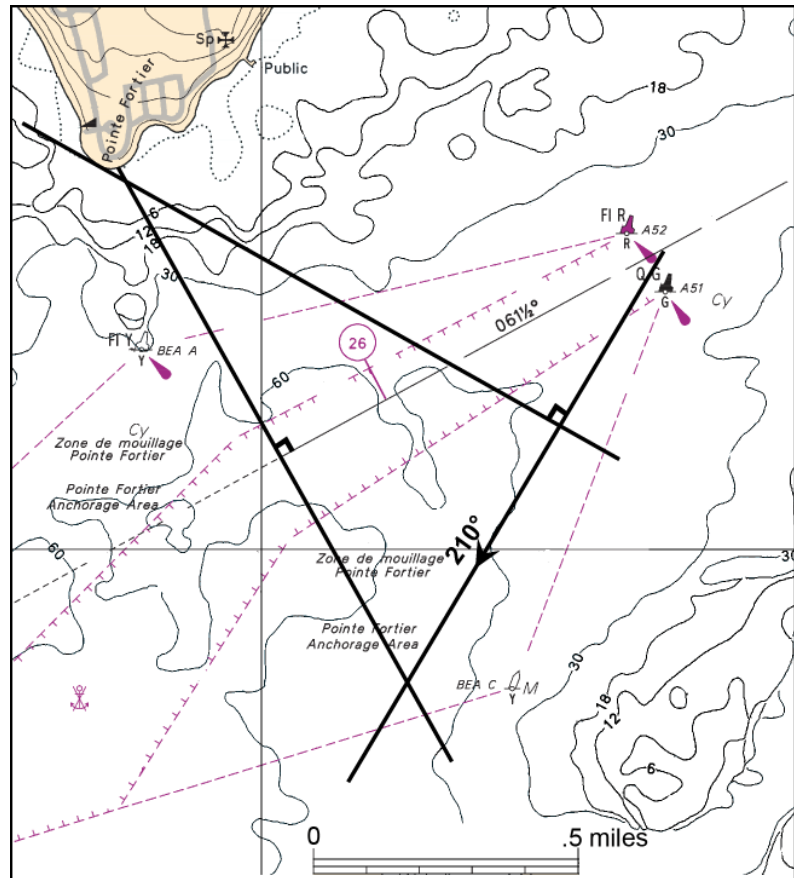
When transiting the anchorage toward Lower Beauharnois Lock, the pilot's practice was to track the vessel's progress using a beam bearing off Pointe Fortier. He identified this location by setting the radar's EBL at 90° to the vessel's course – usually 235° T down the centre of the channel. In this occurrence, however, the usual beam bearing was set relative to the intended port alteration to a course of 210°. This alteration from the normal course through the anchorage area meant that Pointe Fortier would bear abeam much earlier than usual (see Figure 2).

**Figure 2.** Two beam bearings off Pointe Fortier: one perpendicular to the course along the Melocheville range, and the other to heading 210°

The pilot was using the radar to help determine when to initiate the turn; however, his focus was on when the EBL would approach Pointe Fortier rather than the exact position of the vessel. Reliance on the EBL as set meant that the vessel's turn was initiated at an assumed position rather than a verified one. As a result, the vessel's turn was initiated too early, and the vessel subsequently did not have enough room to complete the manoeuvre as intended.
