**MARINE INVESTIGATION REPORT**  
**M12W0207**

**STRIKING OF TERMINAL**

**BULK CARRIER *CAPE APRICOT***  
**ROBERTS BANK, BRITISH COLUMBIA**  
**07 DECEMBER 2012**

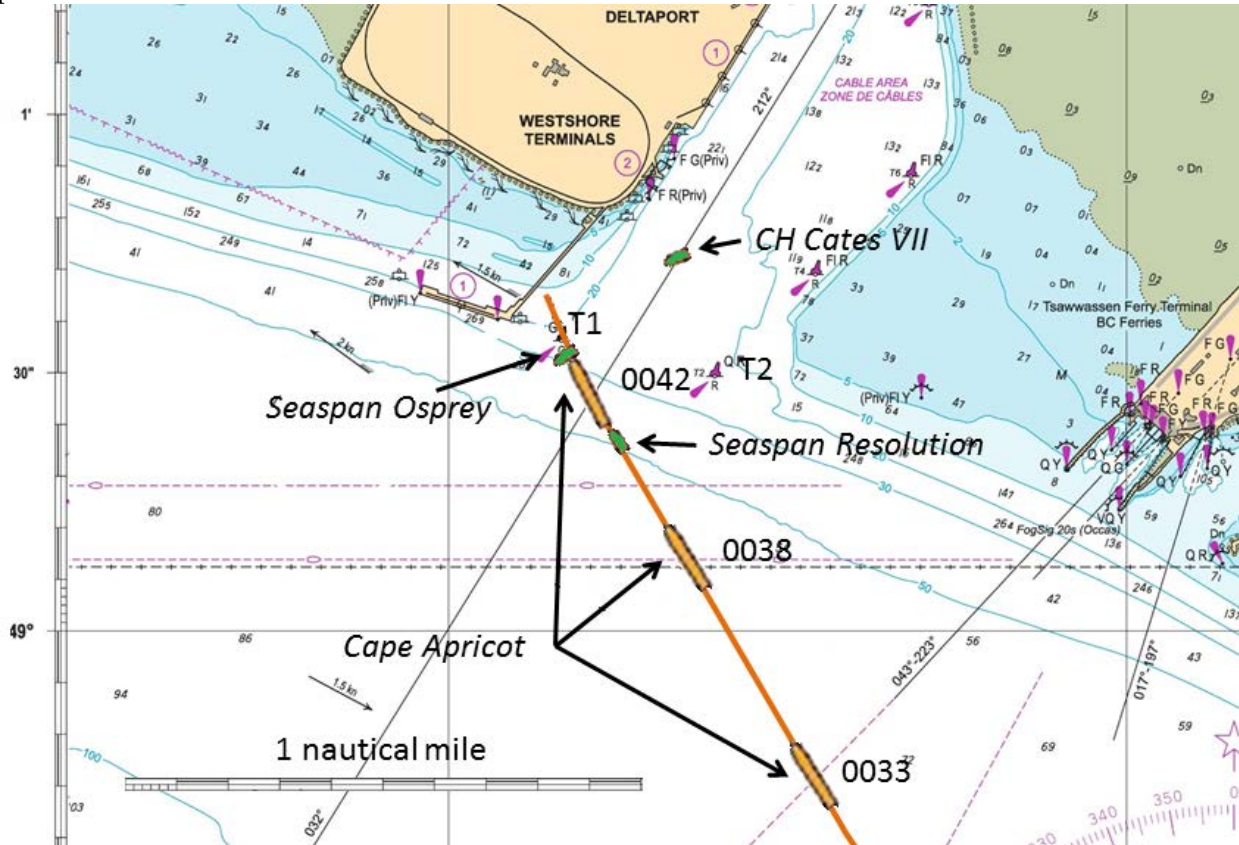
5.2 cables from the trestle (Figure 1) and the *Seaspan Resolution* was at the stern. At this time, the vessel's speed was 5.4 knots and the heading was 327°G. Approximately 1 to 3 minutes later, when the vessel was between 1.9 to 0.5 cables from the transit leading into the basin,<sup>9</sup> the pilot ordered the rudder hard to starboard, but the vessel's response was minimal. At the time of the order, the rudder was already hard to starboard. At 0040, the pilot made a call on his mobile phone.

Figure 1. *Cape Apricot's* progress towards berth 2, and tugs' positions at 0042

By 0042, the *Seaspan Resolution's* line was made fast on the *Cape Apricot's* stern and the pilot ordered the slack to be taken out of the line. The *C.H. Cates VII* was standing by. The *Seaspan Osprey* was alongside the port shoulder of the *Cape Apricot*, approximately 1 minute later, at which time it was requested to push easy<sup>10</sup> by the pilot. The bridge of the *Cape Apricot* then crossed the transit and the pilot ordered the *Seaspan Resolution* to pull half, straight astern.

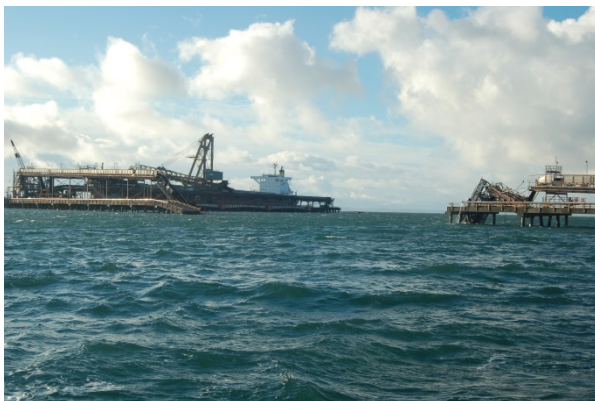
Damage to the terminal was extensive; approximately 128 m (6 pile sections) of the causeway to berth 1 collapsed into the water, and the damage to the coal conveyor system extended approximately 145 m (see Photo 3 and Photo 4). Furthermore, services to berth 1 (including electrical power and fresh water) were cut off at the time of the striking, rendering the berth temporarily inoperable. A quantity of coal, estimated at less than 30 tonnes, also entered the water.

**Photo 3.** Trestle seen from the basin looking towards berth 1

The berth was back in service 2 months later and repairs to the causeway were completed in late April 2013.

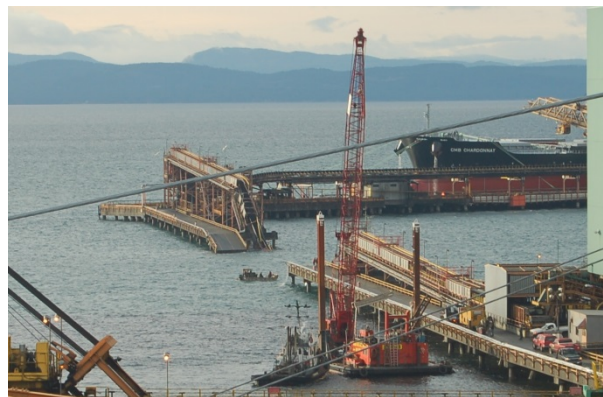
**Photo 4.** Trestle and conveyor belt seen from berth 2

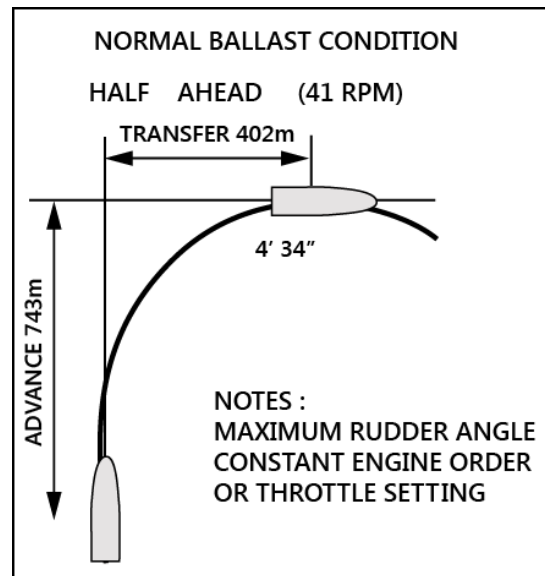
The vessel's manoeuvring information on the bridge indicated that, for a starboard turn made under normal ballast conditions with maximum rudder angle and the engine half ahead (41 revolutions per minute), the vessel's advance would be 743 m (or 4.0 cables) and the transfer would be 402 m at 90° heading change (Figure 2).

If the heading change was less than 90° or if the rudder angle or engine orders differed from the ones specified above, the transfer and advance distances would be affected. The diagram supplied with the *Cape Apricot* was not sufficiently detailed to measure these values. When compared to other bulk carriers of a similar size, for a heading change of 65°, the advance value would be between 80 to 92 percent of the 90° course change value.

Figure 2. *Cape Apricot* turning circle

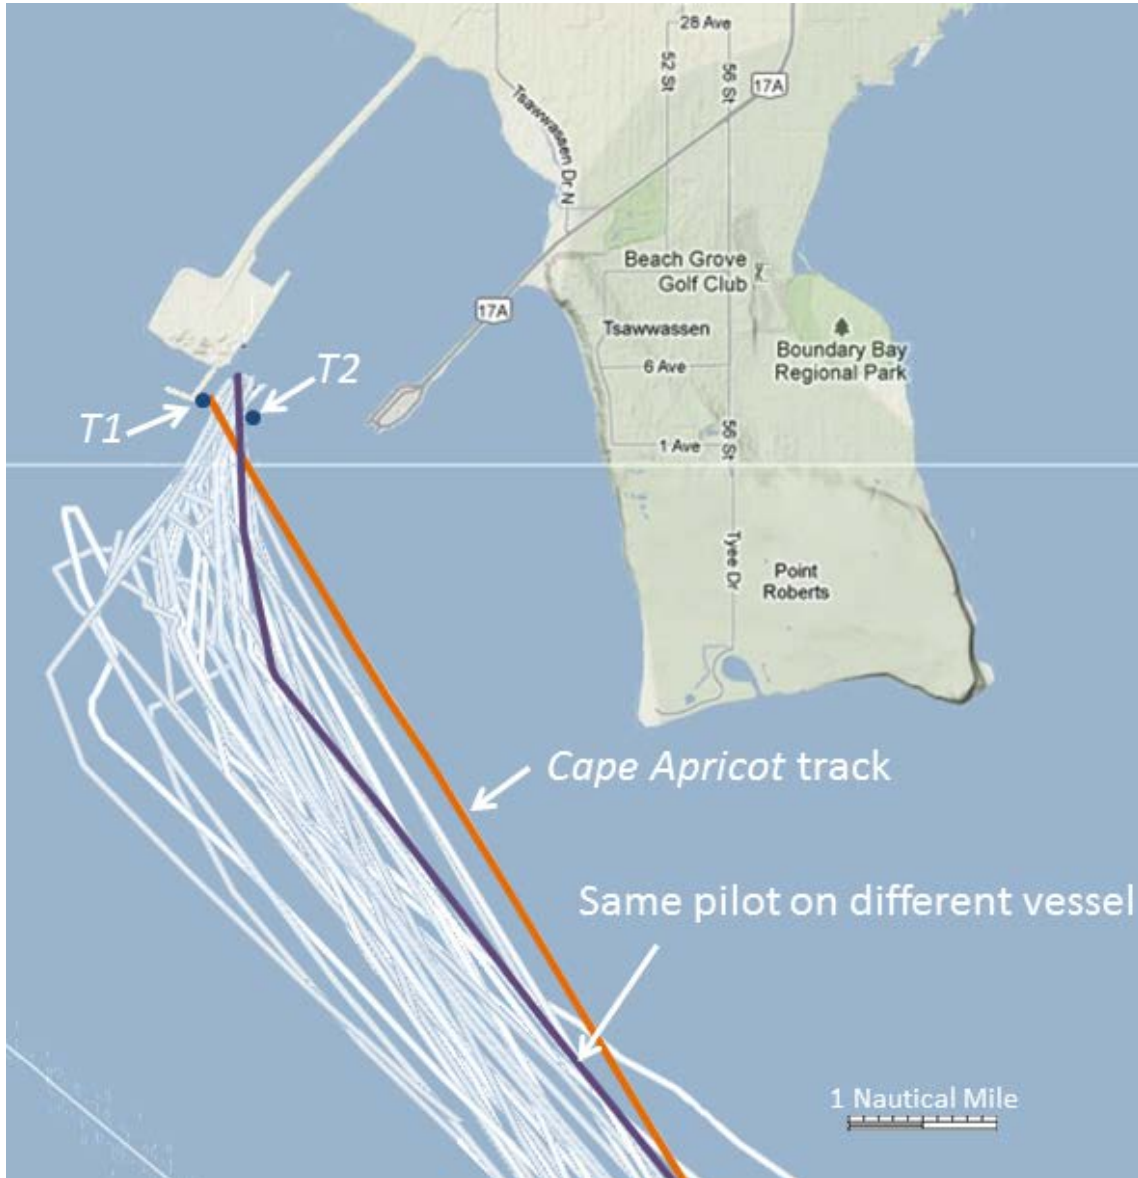
show the different approaches to berth 2 (see Figure 3). Of these 35 approaches, 6 were made in environmental conditions (wind and current) similar<sup>14</sup> to those experienced by the *Cape Apricot* around the time of the occurrence. The *Cape Apricot's* track was the closest track to Point Roberts, meaning that it required the largest change of course in order to enter the basin on the transit. The data included also 1 other approach made by the same pilot while on board a bulk carrier of the same type as the *Cape Apricot*.

**Figure 3.** Southerly approaches to Westshore Terminals berth 2 (original map and vessel track information from Shipfinder.co; compilation of vessel tracks by TSB)

Just before midnight on 06 December 2012, as the *Cape Apricot* was proceeding towards Roberts Bank, the pilot ordered a direct course towards the entrance of the basin. The 327° True (T) approach necessitated a course alteration of about 65° to starboard for the turn into the basin using the transit. This course of approach was more direct than other approaches<sup>27</sup> made by vessels docking at berth 2 that same year. The other courses, which were less direct, required a smaller course alteration to enter the basin.
