MARINE INVESTIGATION REPORT
M14P0121

SINKING AND LOSS OF LIFE
SMALL FISHING VESSEL *FIVE STAR*
JOHNSTONE STRAIT, BRITISH COLUMBIA
12 JUNE 2014

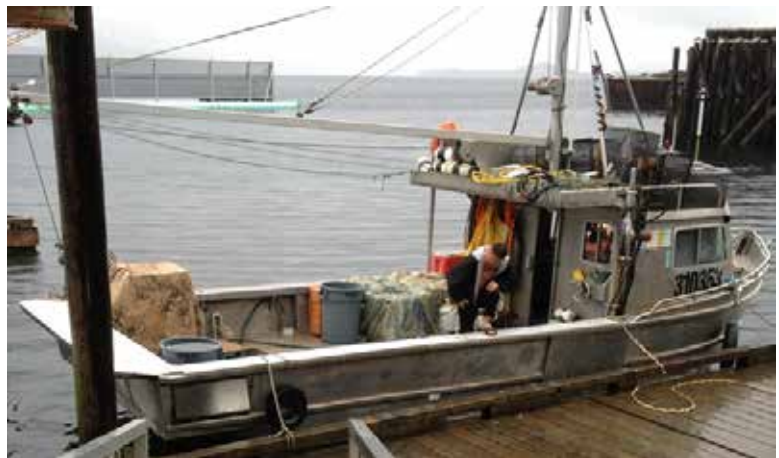
Photo 1. *Five Star*

The *Five Star* was a single-decked crab fishing vessel with a planing hull form constructed of aluminium (Photo 1). The hull was 8.69 metres long.² A 1.5-metre stern extension and overhang above the waterline had been added at the time of the vessel's construction.

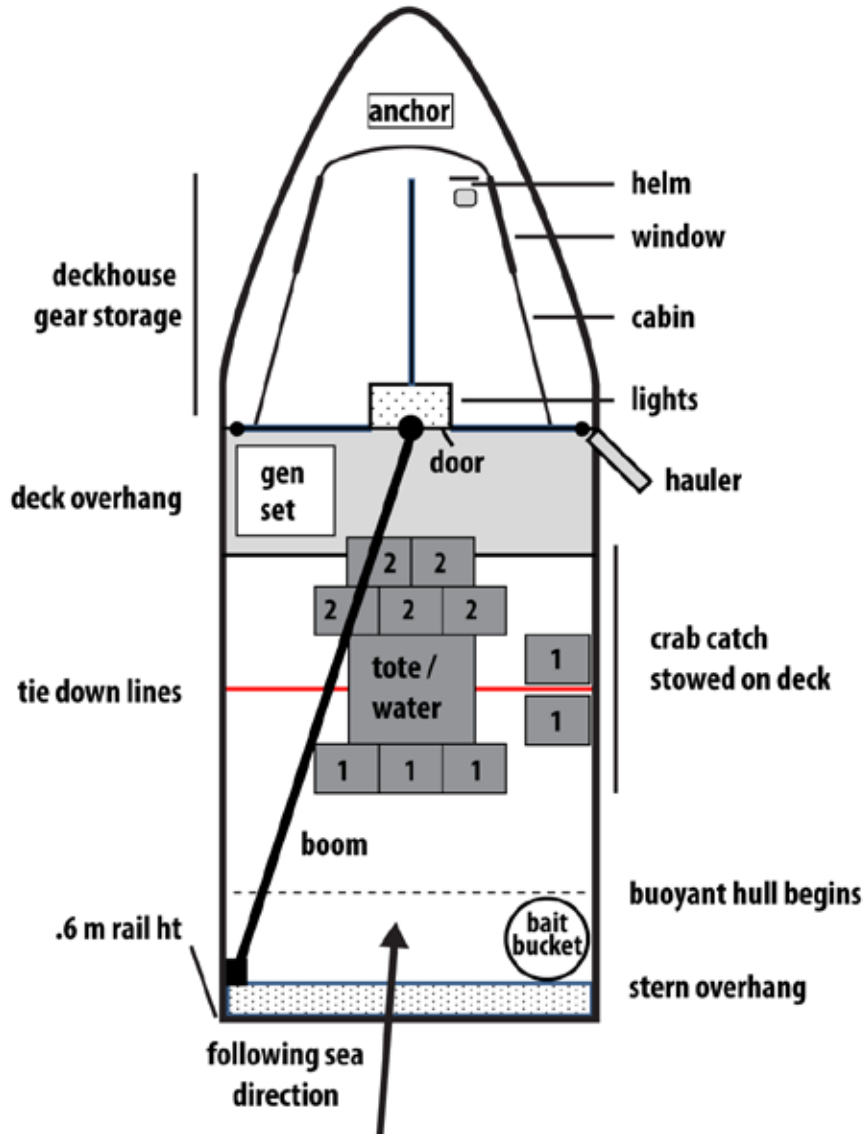
Appendix A – Five Star deck arrangement

While the vessel was underway, the crew member transferred crabs from 7 of the holding cages into a large empty tote⁸ that was positioned on the centreline of the working deck. The crew member then secured the tote in place using 2 lines,⁹ 1 that extended from the bottom of the tote to the port bulwark and 1 that extended from the bottom of the tote to the starboard bulwark. After the crew member had secured the tote, the master checked and retightened the lines. The crew member then organized the remaining 15 holding cages so that 10 were placed between the tote and cabin; these cages were stacked 2 high. Three other holding cages were placed aft of the tote on the rubber mat covering the hatch covers. As the vessel had a slight port list, 2 holding cages were placed against the bulwark on the starboard side (Appendix A and Appendix B). None of the holding cages were secured to the vessel.
