**MARINE INVESTIGATION REPORT
M15A0045**

PERSON OVERBOARD AND SUBSEQUENT LOSS OF LIFE

**SMALL FISHING VESSEL *FOUR LADIES* 2003
15 NAUTICAL MILES SOUTH OF CAPE SABLE ISLAND,
NOVA SCOTIA
09 MARCH 2015**

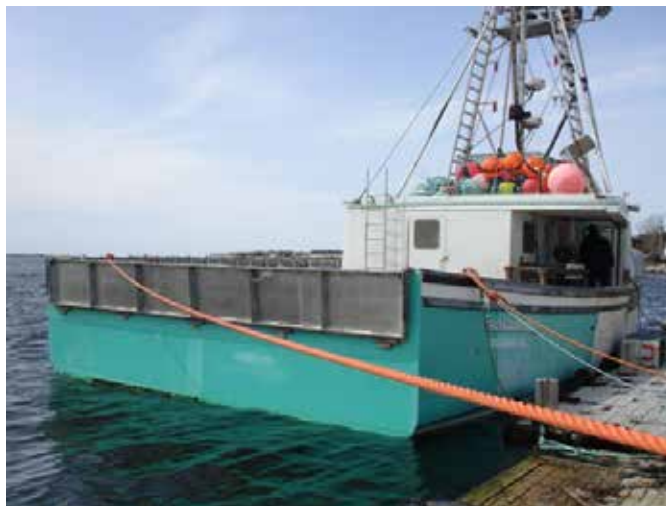
Photo 2. Hinged gate in the upright position

At the stern, a 61 cm hinged gate forms the transom when in the upright position (Photo 2) and extends the working deck when lowered. A cargo boom with a small winch is mounted atop the wheelhouse. The vessel is used primarily for trapping lobster and catching swordfish and is fitted with a trap hauler on the starboard side of the working deck.

The weather had deteriorated as the crew was working, so they departed the area for shallower water, leaving the hinged gate at the stern in the lowered position, as was the common practice for the vessel when lobster fishing.

As the master on the *Four Ladies 2003* was making a turn prior to setting traps, a wave struck the port side of the vessel and knocked an anchor and 1 trap over the open stern. While all 3 crew members were attempting to retrieve the anchor and trap, another wave struck the vessel and knocked some unsecured traps onto the main deck, which in turn knocked the master overboard.

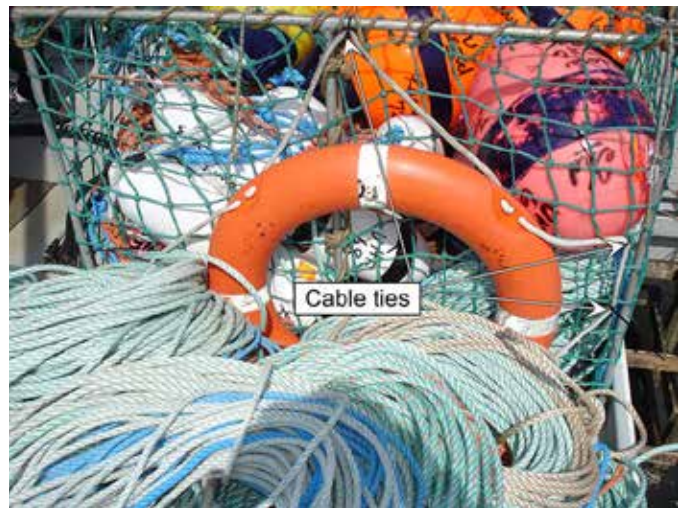
Photo 3. Locations of cable ties

The life rings were located on top of the wheelhouse and their grab lines had been secured to a mesh container using cable ties (Photo 3).

Another aspect that must be considered is the stowage of emergency equipment to ensure ease of access. On the *Four Ladies 2003*, the life rings were not stowed in a location that was readily accessible from the working deck and were lashed with cable ties, making them difficult and time consuming to deploy in the event that they were required.

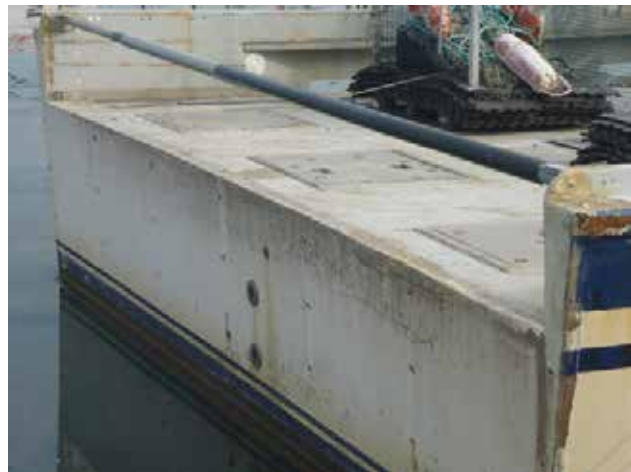
Photo 4. Aluminum stern pole as seen on some lobster vessels

While the majority of fishermen on these types of vessels leave the stern open while fishing lobster, some will place a chain or aluminum pole across the opening to act as a guardrail (Photo 4). Poles can be adjustable and can be placed in numerous orientations across the deck so that the crew members are never nearer the open stern than they have to be. Additionally, crew members can place the pole between themselves and the open stern when preparing traps for setting, which maintains a physical barrier.

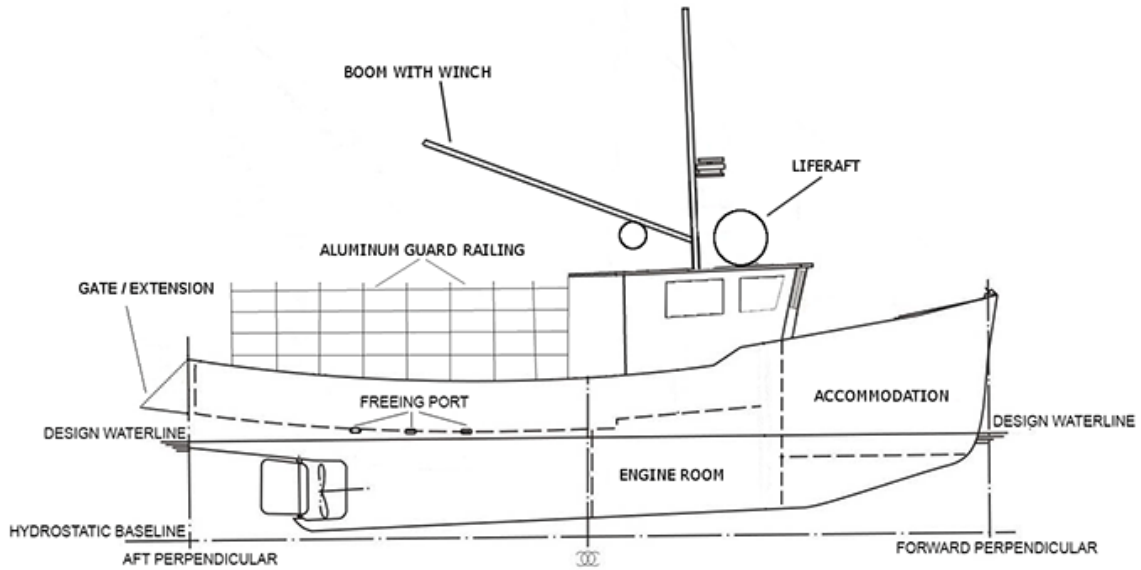
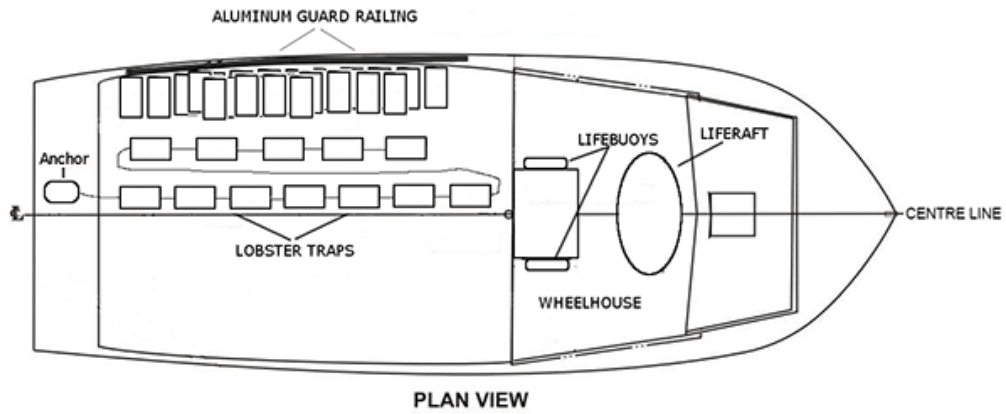
Appendix A – Four Ladies 2003 profile and deck arrangement

Prior to the occurrence, there was an aluminum guardrail bolted to the gunwale on the port side; the guardrail extended upwards from the gunwale by about 1.5 m and extended from the cabin to the stern. The guardrail provided a measure of support when stacking the lobster traps on deck. The guardrail was torn off the vessel during the occurrence.

- The traps on the first string were stowed along the port side at deck level,
- The traps on the second string were stacked on top of them in a row of 8 and then a row of 4, and
- The traps on the third string were stowed in a row of 7, located amidships, with 5 traps placed along the port side of the row (Appendix A).
