**MARINE INVESTIGATION REPORT**  
**M15P0037**

**SINKING**

**TUG SYRINGA**  
**OFF SEHEL T, BRITISH COLUMBIA**  
**18 MARCH 2015**

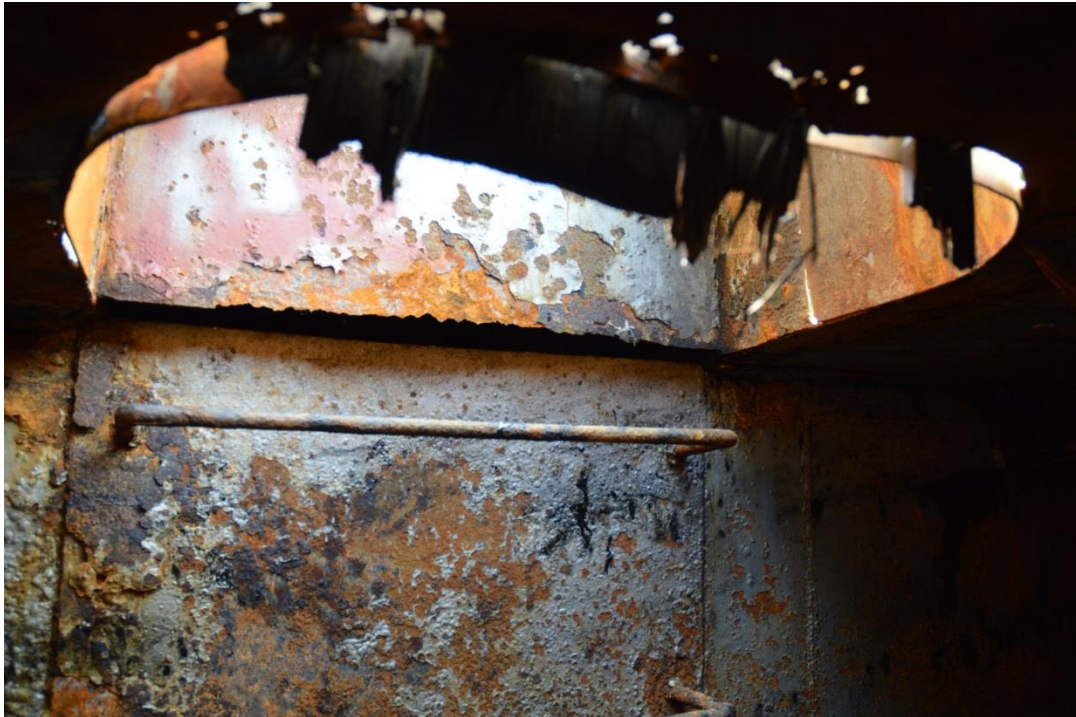
## *Appendix B – Incision in bulkhead*

- The original steel wheelhouse was replaced with a smaller aluminum wheelhouse in 2006.
- A new diesel engine was installed around 1998.
- Sponsons<sup>11</sup> were installed on the port and starboard sides of the hull.
- An incision (approximately 270 mm by 100 mm) was made in the watertight bulkhead between the lazarette and the machinery spaces at main deck level for ventilation purposes<sup>12</sup> (Appendix B).
- The starboard-side engine room vent, which is located in the winch well, was cropped at deck level<sup>13</sup> to accommodate a working platform. The platform was installed on the vent opening without a sealing arrangement (Appendix C).

- the incision in the watertight bulkhead had not been repaired nor protected to prevent water from moving between hull compartments;
- the high-level bilge alarms were disconnected.

Location of incision in bulkhead

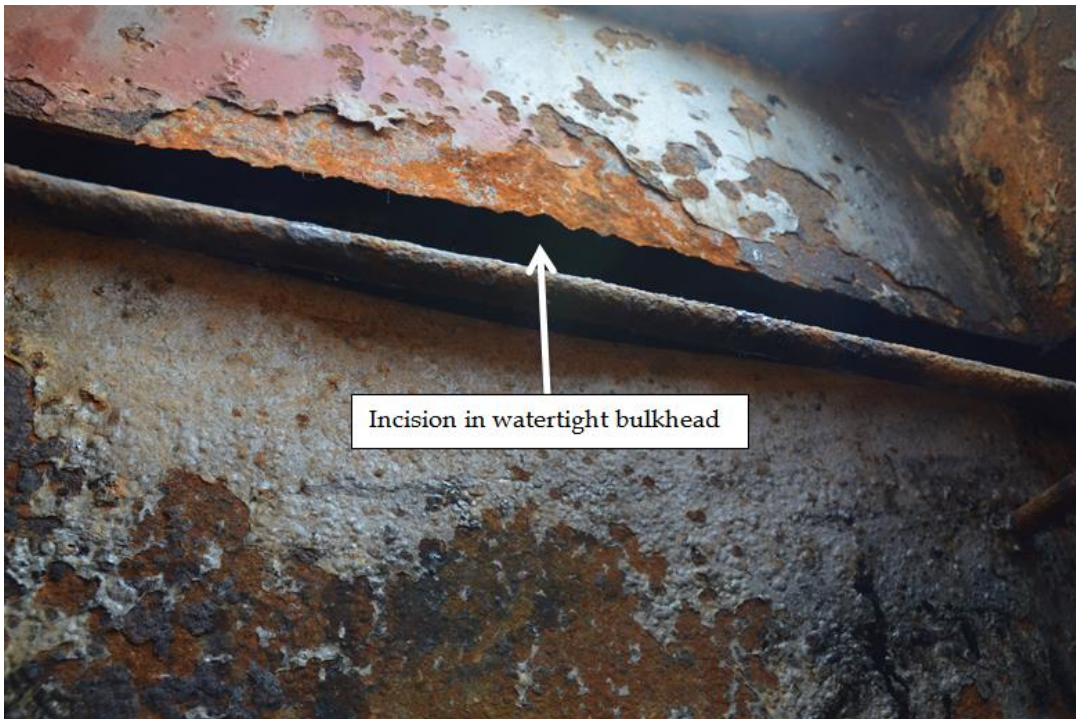
Close-up of incision in bulkhead

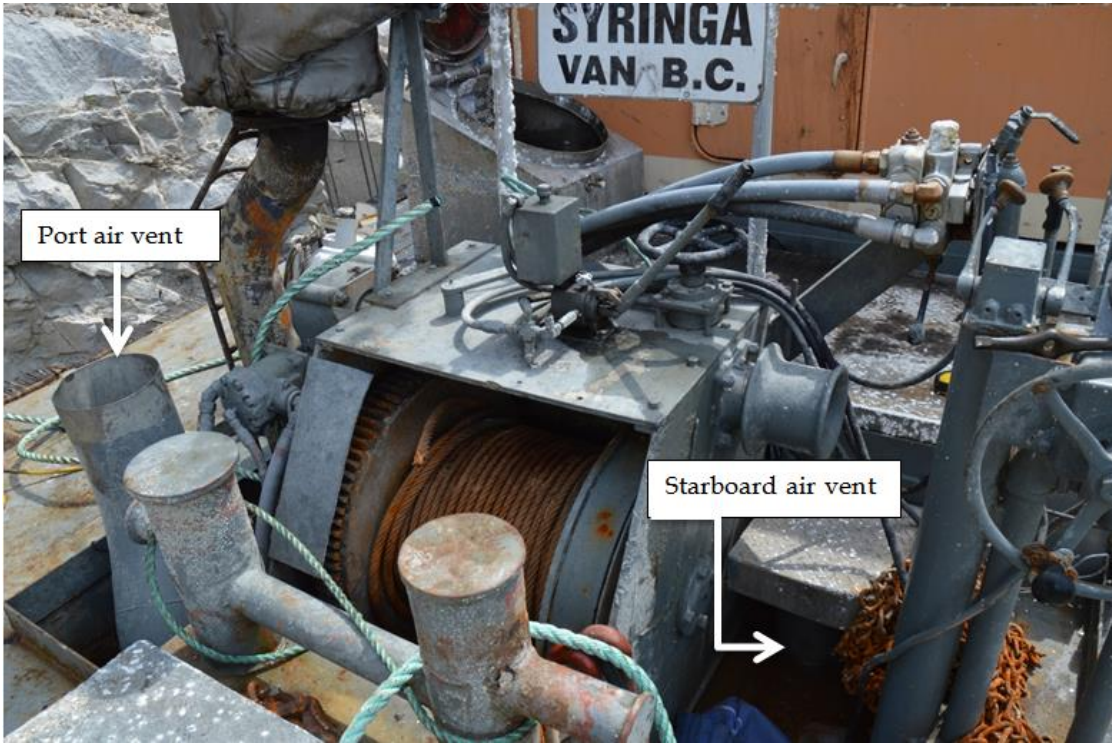
*Appendix C – Cropped starboard-side engine room air vent*

- the gap in the main deck plating in way of the lazarette coaming was temporarily repaired with materials that were not sufficient to withstand the conditions of the voyage;
- neither the cropped starboard-side air vent nor the cable glands in the winch well were protected against water ingress;

Location of port and starboard air vents within the towing winch well

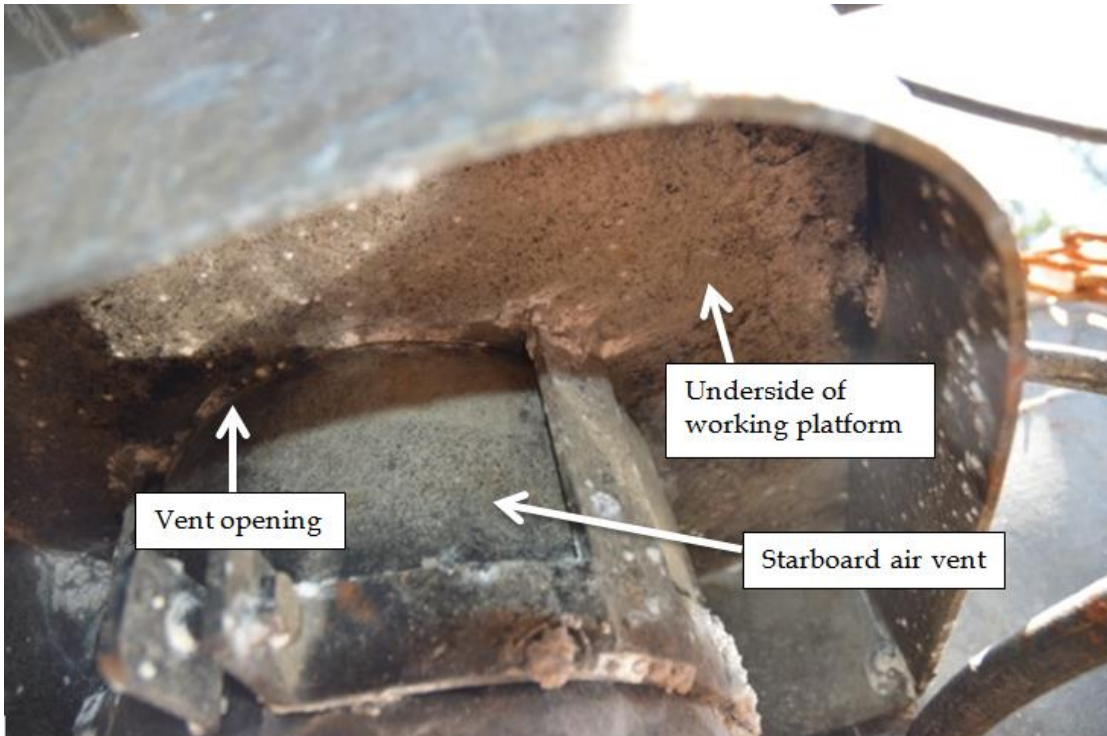
Close-up of starboard air vent from underside of working platform

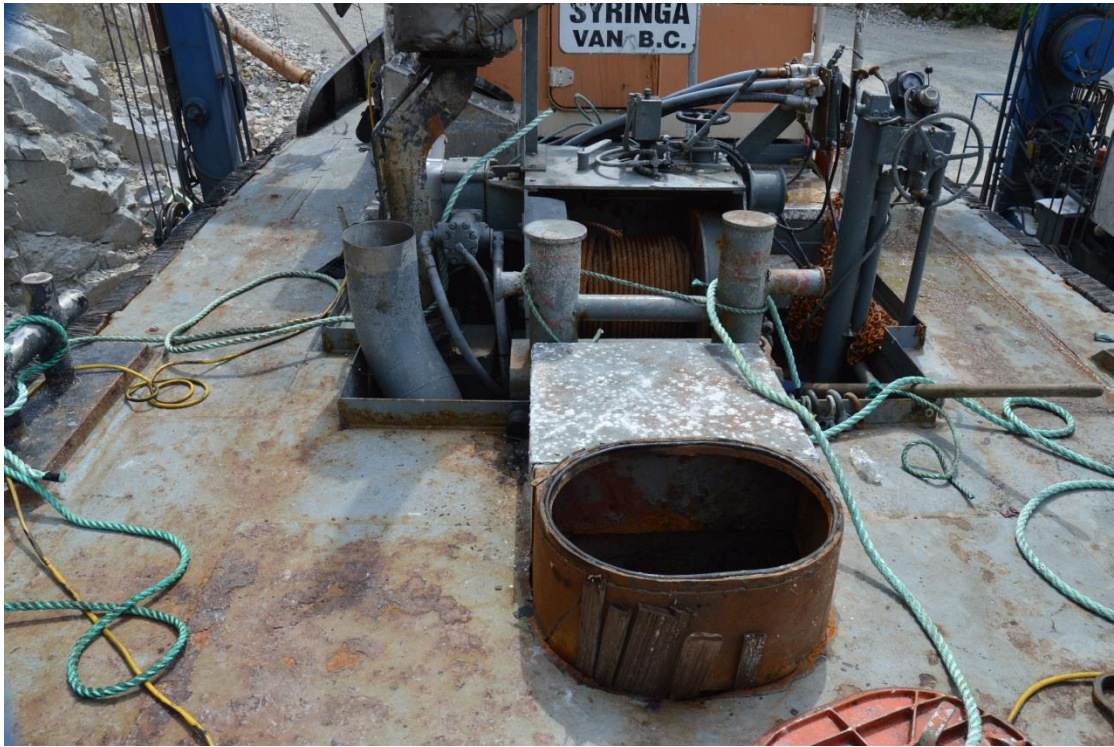
## *Appendix D – Gap in deck plating*

On the evening prior to the *Syringa's* scheduled departure, the master observed a gap in the deck plating that had resulted from the repairs, which had not been completed. The gap was approximately 2.5 cm wide by 60 cm long in way of the lazarette coaming. The master temporarily patched this gap with cedar wedges and waterproof sealant. On the morning of 17 March, the tug took on approximately 3000 litres of fuel and 1890 litres of water and, at approximately 1200,<sup>4</sup> departed Saltery Bay with the barge *Matcon 1* in tow. Manned by the master and a deckhand, the tug and barge arrived at Blackberry Point, British Columbia (Appendix A) at approximately 1600 and tied up to pilings for the night.

The *Syringa* departed Saltery Bay, British Columbia, with a gap in the deck plating as a result of repairs that were not completed. The master had temporarily filled the gap using cedar wedges and sealant prior to departure.

Gap in deck plating in way of the lazarette coaming

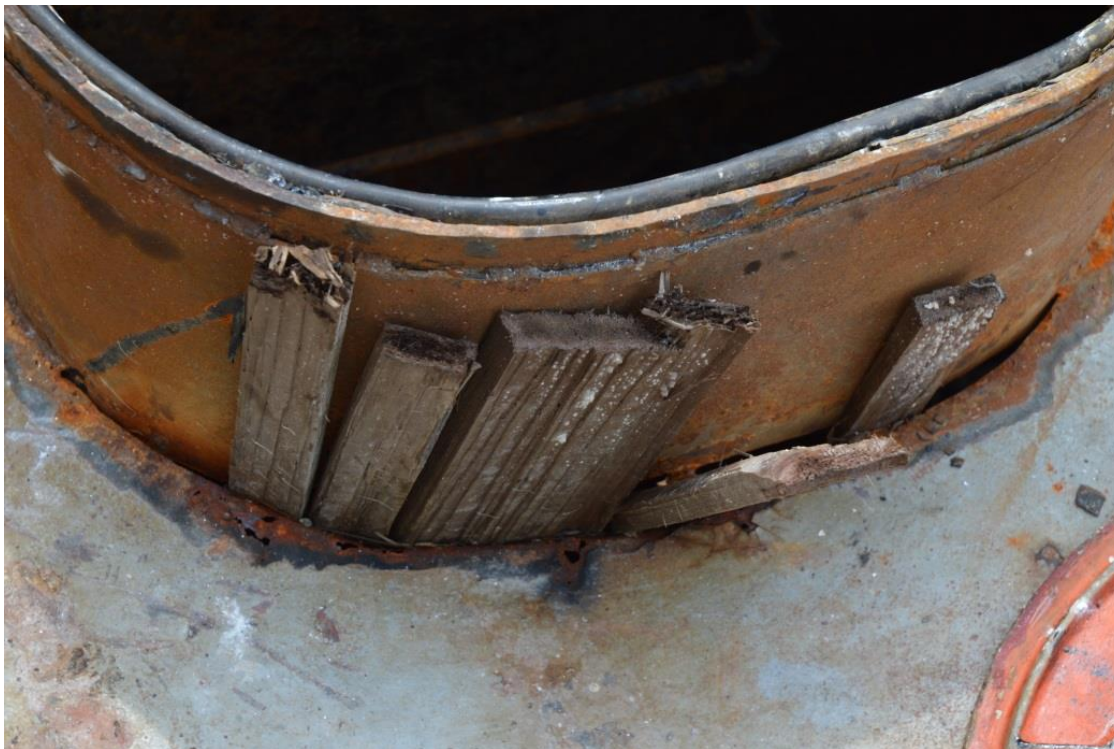
Close-up of incomplete repairs
