MARINE INVESTIGATION REPORT M16A0115

Deck crane failure and fatality

Unregistered aquaculture vessel

Milligan's Wharf, Prince Edward Island

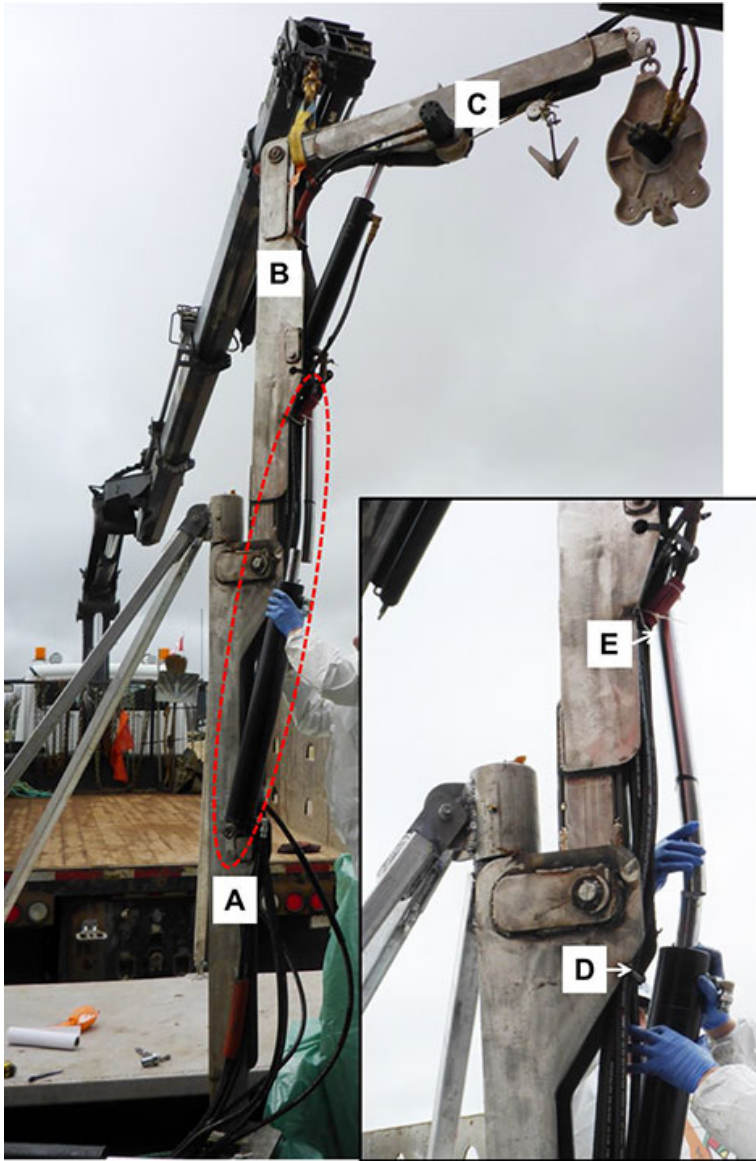
Figure 6. Crane and broken hydraulic cylinder shown in situ

There was no damage to the vessel. The on-board crane's lower hydraulic cylinder (Figure 6) failed when the extended piston rod fractured.

Further measuring and testing determined that when the boom of the crane was at its maximum height, the piston rod was prevented from fully extending because the fully extended rod was approximately 1 inch longer than the space available within the confines of the crane body: the mechanical stop within the piston did not limit the rod's extension to the available space. Additionally, the 2 tie rods (D and E in Figure 6) restricted the path that the hydraulic cylinder and rod could travel when the boom was being raised or lowered, resulting in side loading of a sufficient extent to cause the permanent bending of the piston rod into a half-moon shape. These 3 factors resulted in an overstress of the piston rod, causing it to buckle and eventually fracture.

The fractured hydraulic cylinder piston rod had scoring and discoloration that indicated the rod had experienced bending on previous lifts when the crane boom was fully raised. Operation of the hydraulic cylinder with a bent piston rod resulted in damage to the piston rod's chrome plate and to the rod bearing.⁶ Over time, surface cracks formed in the piston rod's chrome plate, some of which extended into the induction-hardened layer underneath. Loading analysis indicates that the bending stress applied to the bent piston rod is close to

the material's ultimate tensile strength.⁷ Eventually, the combined effect of the applied bending stress and stress concentration from the previously formed surface cracks exceeded the fracture strength of the piston rod, and it broke in brittle bending overload.

The failure was caused by a design flaw in the construction of the crane itself: the attachment points for the hydraulic cylinder within the crane were not far enough apart to allow for the full extension of the piston rod when the crane was fully elevated. Also, the piston rod was subject to side loading due to contact with the hose guards. As a result, the piston rod was forced to bend. After it had bent on several occasions, the material was no longer able to sustain the bending stress, and the rod fractured fully at the time of the occurrence.

5. As the piston rod was not able to fully extend without making contact with the hose guards, it was subject to side loading from that contact and was forced to bend. After bending on several occasions, the material was no longer able to sustain the bending stress and the rod fractured.

- designed using an engineered design;
- inspected and maintained on a regular basis to verify they are in safe working order; and
- positioned and designed so as to minimize overhead hazards for workers.⁴¹
