MARINE INVESTIGATION REPORT

M16P0241

Fire and abandonment

Tug Ken Mackenzie

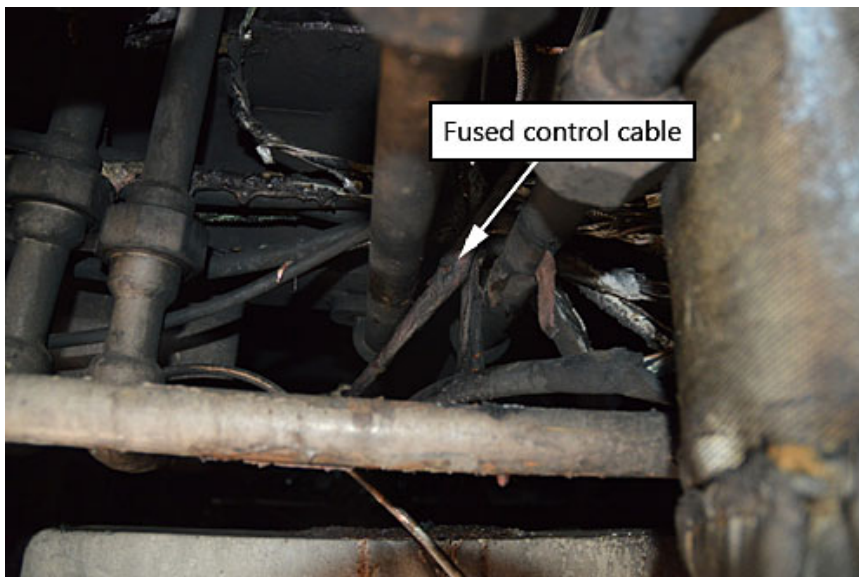
There was significant burning and charring of materials in the engine room, particularly around the generator. The heat from the fire melted and/or burned numerous components directly above the generator, and distorted some deck plating. The cable jacket and conduit liner of the control cables that operated the fuel shut-offs for the aft tanks were fused, rendering the cables inoperable (Figure 2). Both the cable jacket and the conduit liner were polyethylene-based.

Figure 2. Fused control cables

- The emergency shut-off valves for the aft fuel tank could not be operated remotely from the main deck. In this occurrence, heat from the fire in the engine room affected the cable jacket and conduit liner, causing the cable to seize within the conduit.

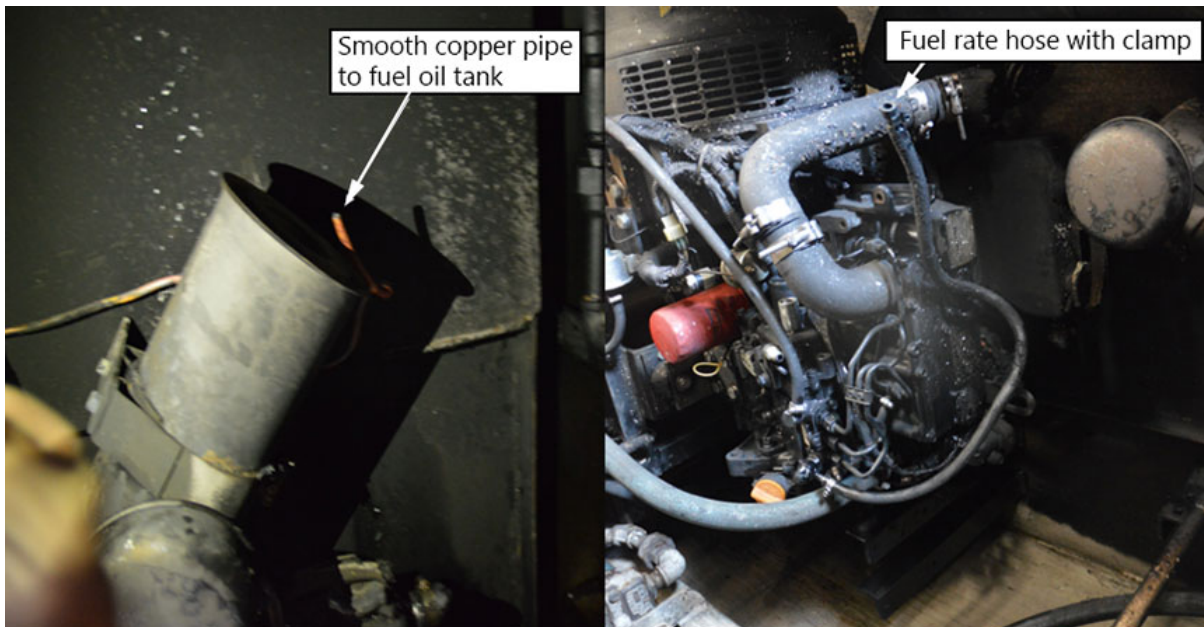
- The fuel return line from the generator to the manifold was a combination of a 6 mm rubber fuel hose and an 8 mm copper tube. The rubber hose and the copper tube were connected by a single hose clamp. The end of the copper tube was smooth and without serrations or a bead at the end (Figure 3).

Figure 3. Return fuel arrangement on the *Ken Mackenzie's* generator

1. Although a diesel smell, indicative of fuel leaking, had been detected in the engine room, the crew was unable to identify the source of the smell and continued to operate the vessel.
2. The copper tube installed in 2009 was smooth and did not have serrations or a bead at the end. A single hose clamp held the tube and the flexible fuel hose together.
3. The connection between the flexible fuel hose and copper tubing, which returned diesel fuel from the generator to the fuel tank, separated, resulting in diesel fuel spraying onto components of the generator.
4. The fuel on the generator components ignited, causing a fire.

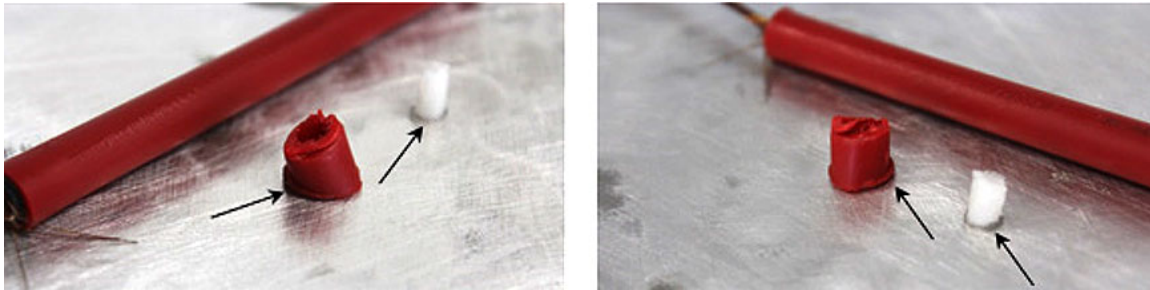
Figure 4. Polythene fragments starting to melt at the surface of the plate (indicated by arrows) at 113 °C

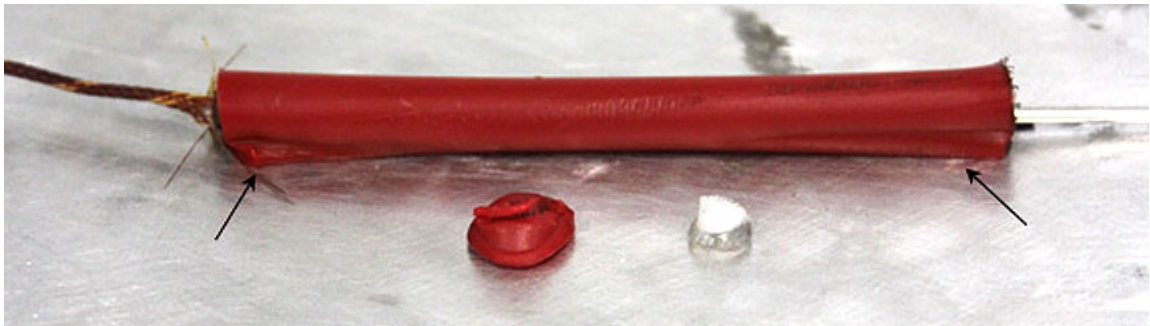
Figure 5. Fragments continuing to melt, and cable jacket starting to melt at 124 °C
