# Marine Transportation Safety Investigation Report M19C0387

## BOTTOM CONTACT

Bulk carrier *Kaministiquia*  
Kahnawake, Quebec  
27 November 2019

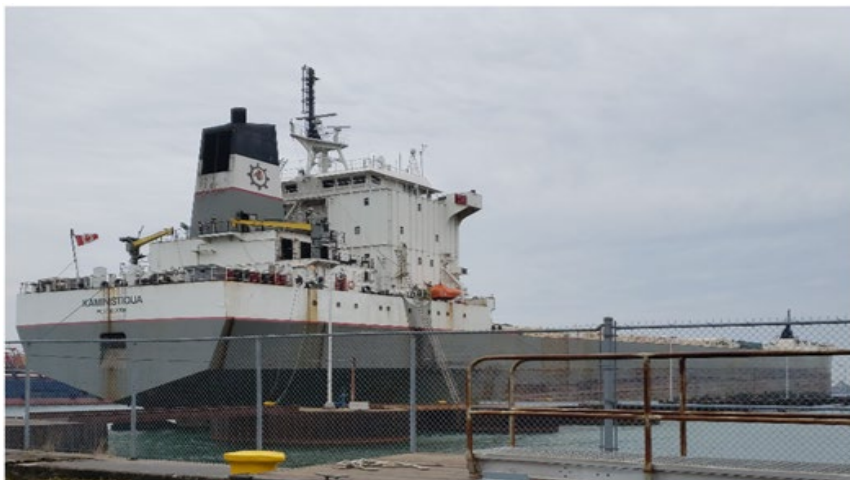
Figure 1. The bulk carrier *Kaministiquia* on the day of the occurrence, secured alongside the north wall of lock No. 4 in Beauharnois, Quebec (Source: TSB)

The following day, 28 November 2019, the vessel's classification society reported that the *Kaministiquia* had sustained damage to its No. 6 starboard side hopper and double-bottom ballast tank. Temporary repairs were carried out before the vessel resumed its normal operations.

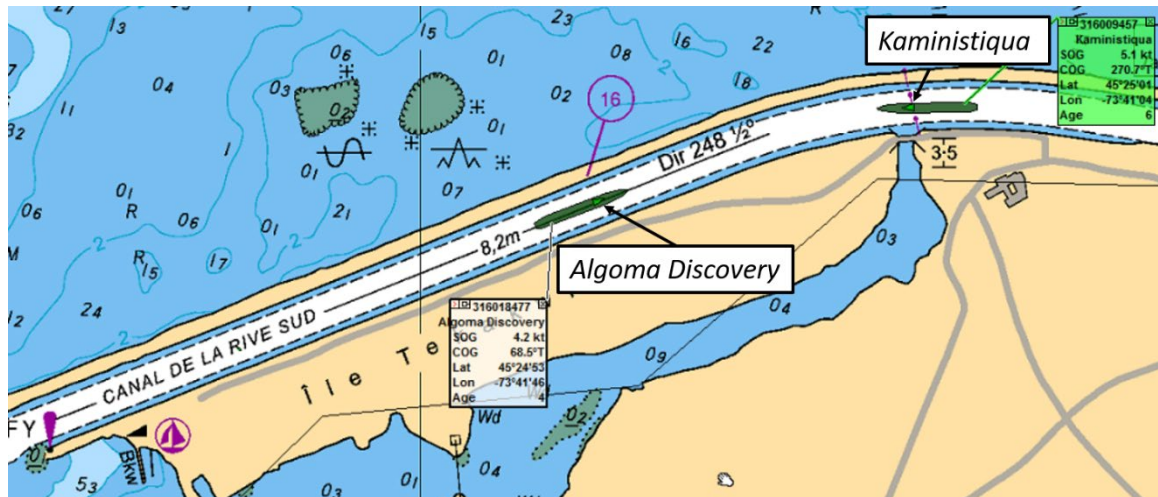
At 0646:23, as the *Kaministiquia* was altering its course away from the centre of the canal, the *Algoma Discovery* was approaching the curve at a speed of 4.9 knots. The *Algoma Discovery* was positioned close to the centre line of the canal, and the vessels were approximately 0.4 NM apart (Figure 4). The master of the *Algoma Discovery* made a VHF call to the *Kaministiquia*, requesting that it give the *Algoma Discovery* more room. The *Kaministiquia* did not acknowledge the *Algoma Discovery's* call.

Figure 4. Electronic chart capture depicting the vessels' positions before their meeting. Vessels are not to scale. (Source: St. Lawrence Seaway Management Corporation, with TSB annotations)

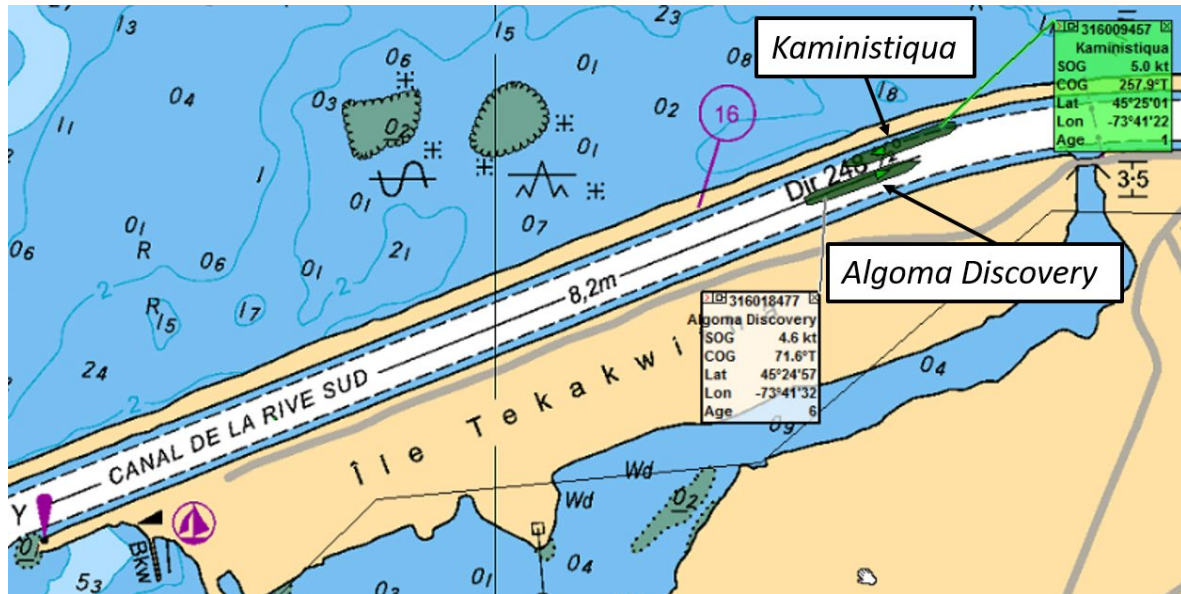
At 0648:50, the 2 vessels were abeam each other (Figure 5). The *Kaministiquia* was slowly changing course to port, toward the centre of the canal. The *Algoma Discovery* was still positioned close to the canal's centre line, just before the curve, and maintaining its course. While manoeuvring, the *Kaministiquia's* starboard quarter came within approximately 7 m of the north bank of the canal<sup>4</sup> and the vessel made bottom contact. Seconds later, the vessels passed each other and continued their intended voyages.

Figure 5. Electronic chart capture depicting the positioning of the vessels during their meeting. Vessels are not to scale. (Source: St. Lawrence Seaway Management Corporation, with TSB annotations.)
