MARINE TRANSPORTATION SAFETY INVESTIGATION REPORT M20A0434

SINKING WITH LOSS OF LIFE

Fishing vessel *Chief William Saulis*
12 nautical miles NNE of Digby, Nova Scotia
15 December 2020

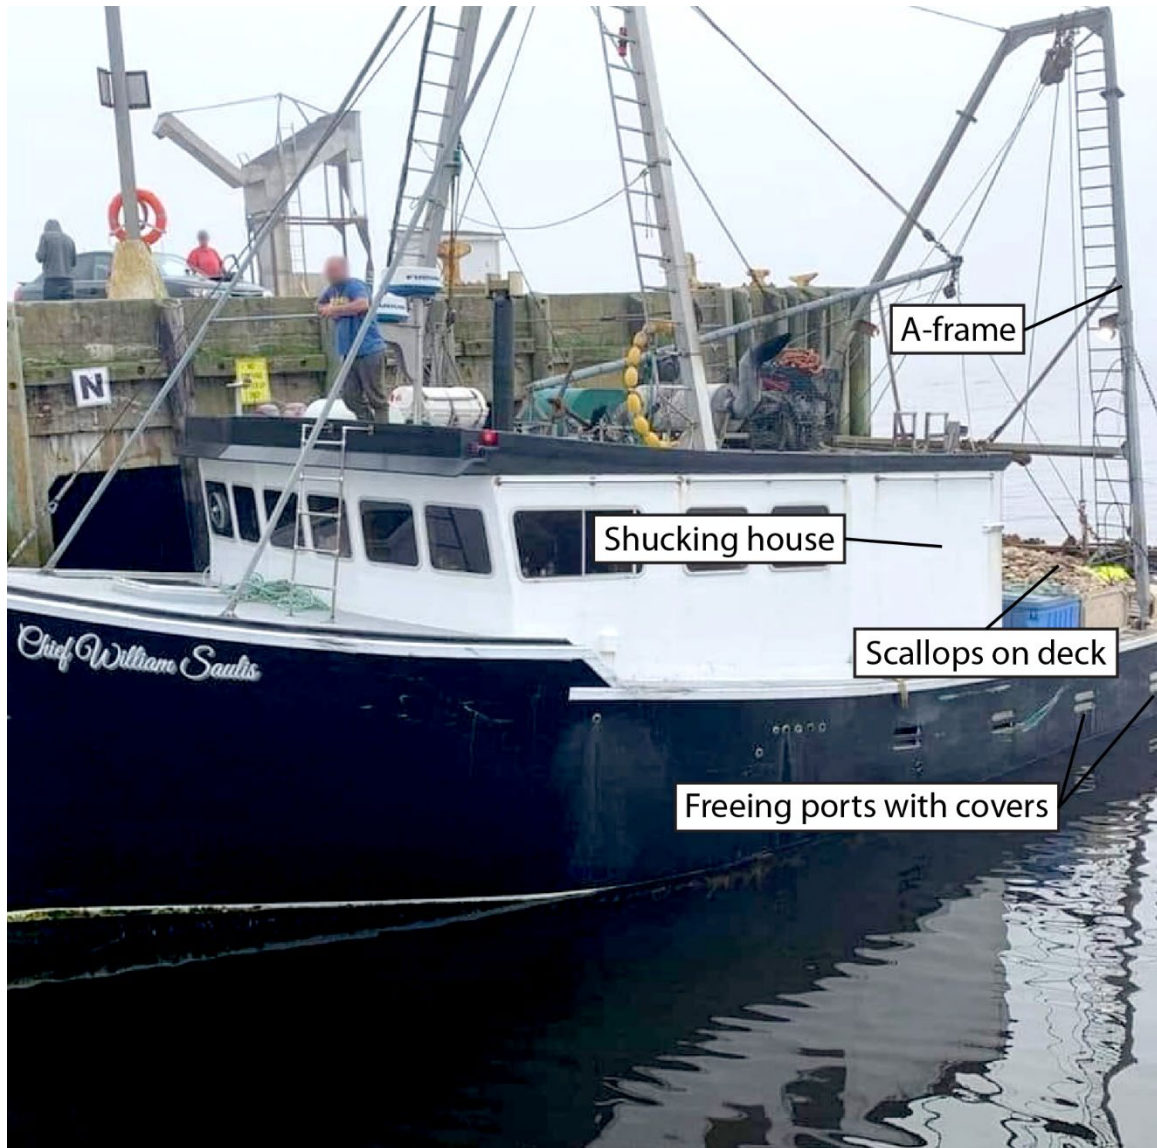
Figure 1: The fishing vessel *Chief William Saulis*, showing the A-frame for the scallop drag, the freeing ports and covers, and a shucking house (Source: Third party, with TSB annotations)

unshucked scallop can measure 7.5 cm to 15 cm long. When loose on deck they can pile against freeing ports, reducing the ports' ability to shed water. The total weight of scallops on board was approximately 4300 kg.

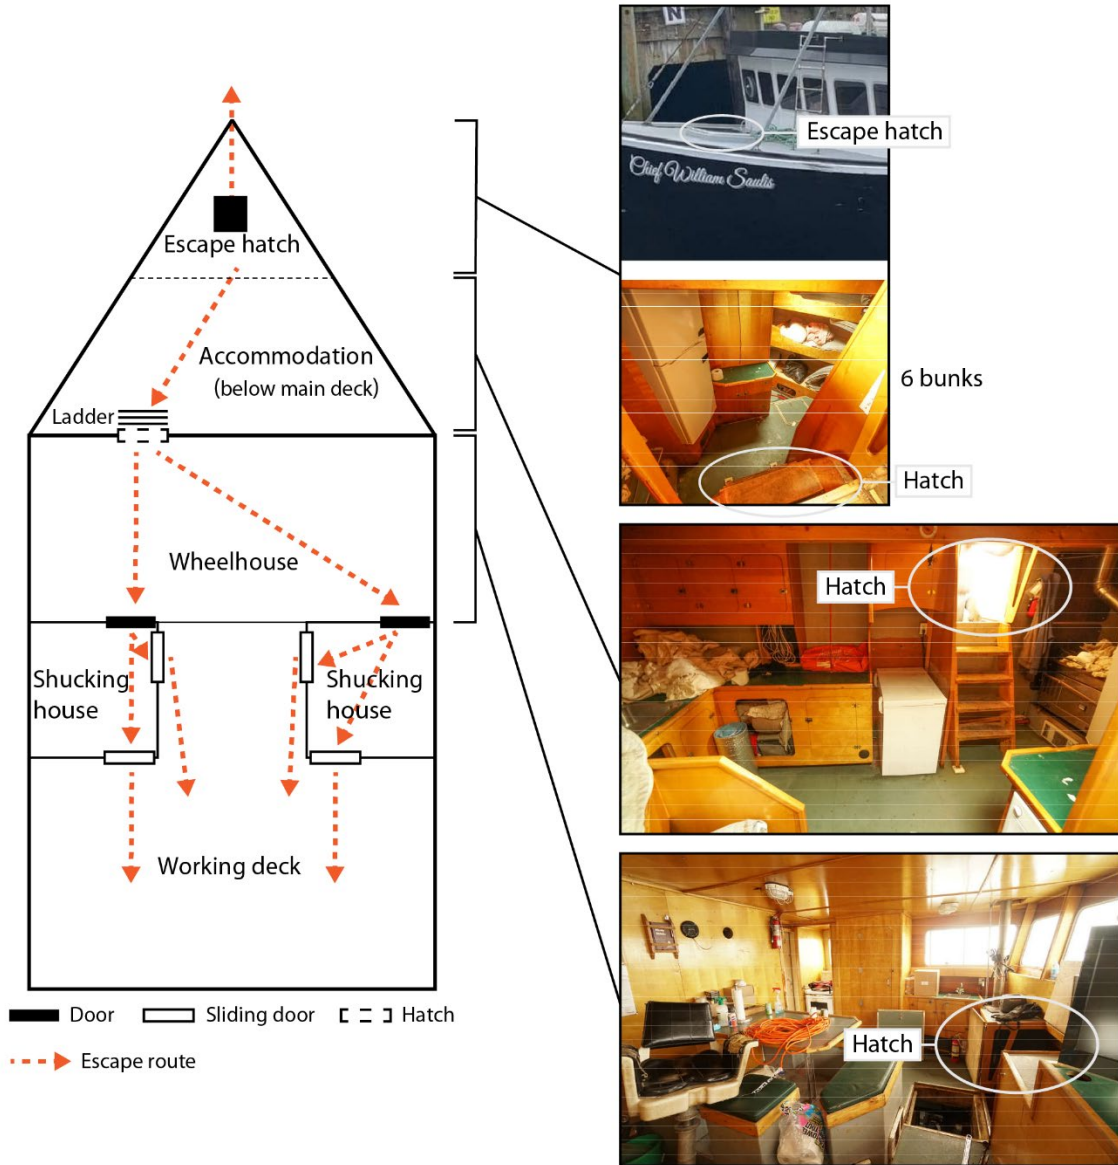
Figure 2. Diagram of the vessel and inset photos illustrating the main emergency escape route from the accommodation space to the deck, which required moving through the wheelhouse and a shucking house. The routes from the wheelhouse to the deck required moving through a shucking house. (Source of diagram: TSB, based on survey report by Jameson Theriault Marine Surveys. Source of escape hatch inset photo: Third party, with TSB annotations. Source of other inset photos: Jameson Theriault Marine Surveys, with TSB annotations)

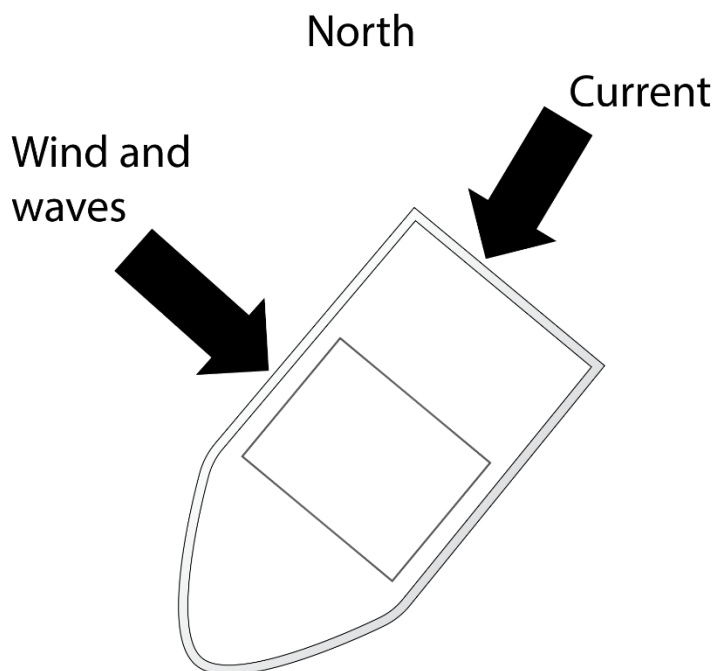
The Western Bay of Fundy wave buoy, 31.7 NM away from where the EPIRB activated, recorded a wind direction of 305°, wind speeds of 25.1 knots gusting to 31.1 knots, and peak wave heights of 2.66 m. Given the wind and current directions at the time of the occurrence, the vessel was travelling in a beam sea (Figure 4). The waves in the area of the occurrence were reported to be much higher than the forecast.

Figure 4: Diagram illustrating the effect of wind, waves, and current on the Chief William Saulis travelling in a beam sea (Source: TSB)

Vessels travelling in a beam sea encounter waves at approximately 90° relative to their heading. These conditions create large roll angles and increase the amount of water shipped on deck, increasing the risk of the vessel capsizing.

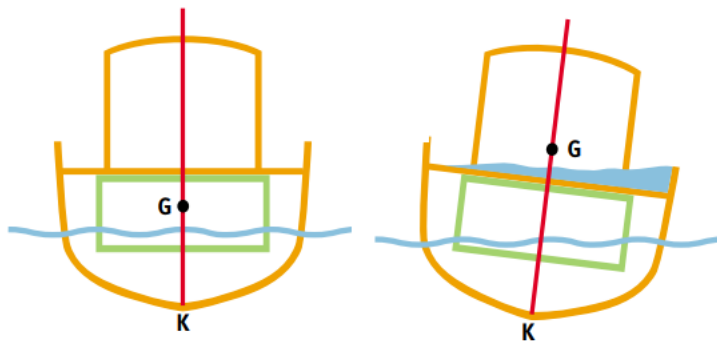
When cargo, gear, and water in tanks or on deck are able to move freely with the motion of the vessel they shift the centre of gravity, where their weight is acting, and so change the stability of the vessel (Figure 5). This effect, called the free surface effect, results from the changes in the centre of gravity as the materials move. The severity of a free surface effect increases with the weight of the material and the distance moved. The free surface effect becomes particularly severe when the materials, such as water trapped on deck, are able to shift along the entire width of the vessel.

Figure 5. Diagram illustrating the free surface effect on a vessel. When water or other materials, like scallops on deck, are able to move with the motion of the vessel, the vessel's centre of gravity (G) changes, and this affects the stability of the vessel (Source: Fish Safe BC, Fishing Vessel Stability: Make It Your Business: The Stability Handbook, Effect of Free Surface on Deck, p. 34)
