# MARINE TRANSPORTATION SAFETY INVESTIGATION REPORT M20C0188

## **COLLISION**

General cargo vessels *Florence Spirit* and *Alanis*  
Welland Canal, Ontario  
11 July 2020

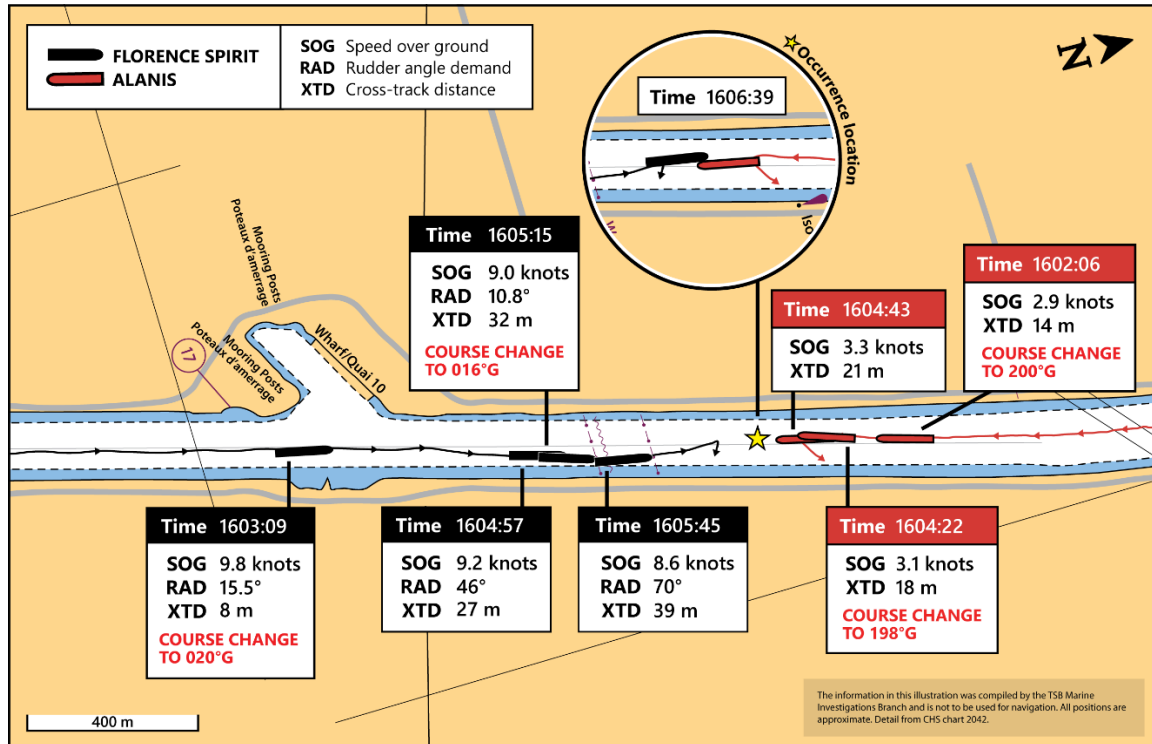
Figure 6. Diagram showing the tracks of the Florence Spirit and the Alanis leading up to the collision (Source: TSB)

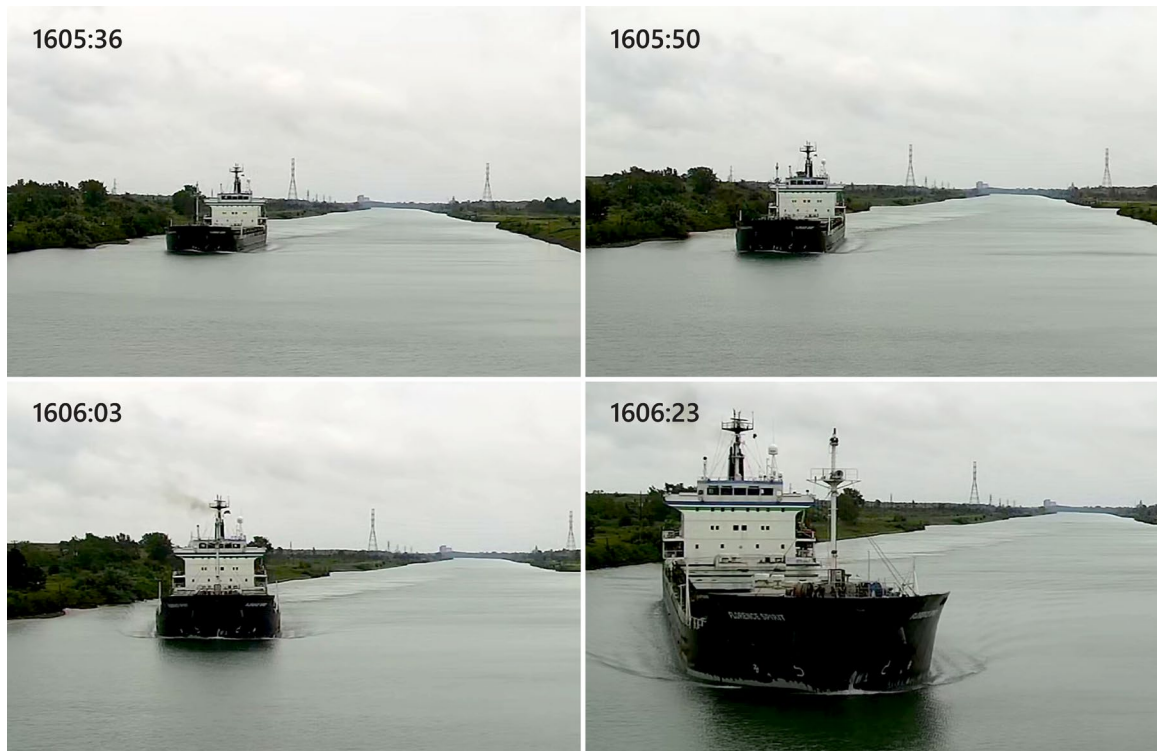
A few seconds later, the piloting master on the *Florence Spirit* cautioned the wheelsman about the potential for bank suction. Seconds later, the *Florence Spirit* started to sheer to port (Figure 7).

Figure 7. Four images taken prior to the collision, showing the *Florence Spirit* sheering to port over a period of 47 seconds, as seen from the *Alanis* (Source: ALANIS / Rambow Bereederungs GmbH & Co. KG)

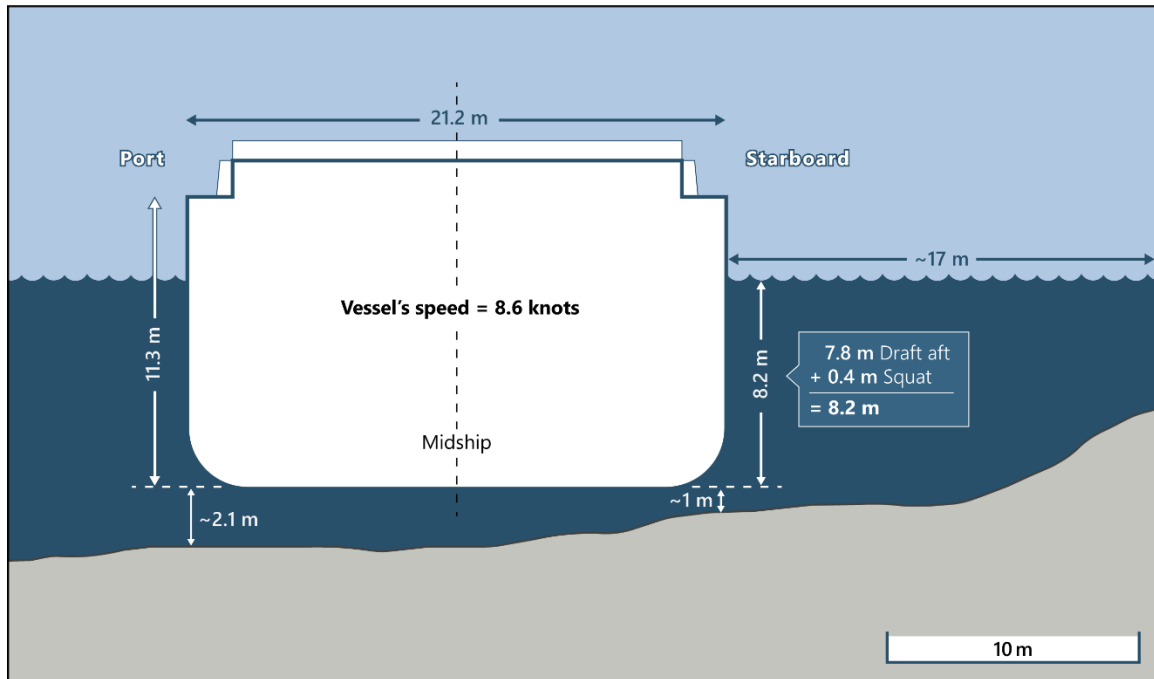
Once the *Florence Spirit* began to sheer, the piloting master ordered the wheelsman to steer hard to starboard. The wheelsman applied the rudder to 70° in response. The master of the *Florence Spirit* then set the propeller's pitch to 91% ahead, increasing the vessel's speed, in an attempt to regain control of the vessel. At 1605:45, the *Florence Spirit* was continuing to sheer to port at a rate of turn of 26° per minute. The distance between the 2 vessels was 0.29 NM. While sheering, the *Florence Spirit* reached a maximum XTD of 39 m at 8.6 knots (Figure 8).

Figure 8. Drawing of the *Florence Spirit* when it reached the navigable limit of the canal (Source: TSB)

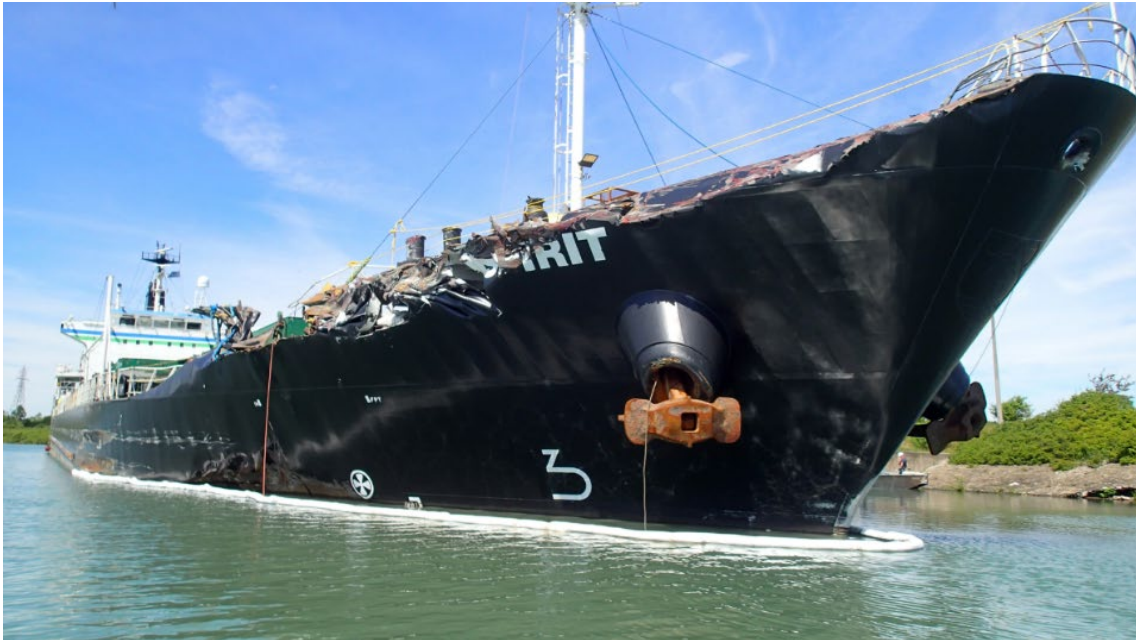
The *Florence Spirit* sustained damage to the forward starboard section of its hull (Figure 9). The forecastle, starboard shell plating, and associated internal structure were deformed and cracked. The hull was punctured, and a ballast water tank and a cargo hold were breached and partially flooded. The forward bulwarks, railings, vents, and pipework were also damaged.

Figure 9. Damage to the forward starboard section of the *Florence Spirit*'s hull (Source: TSB)

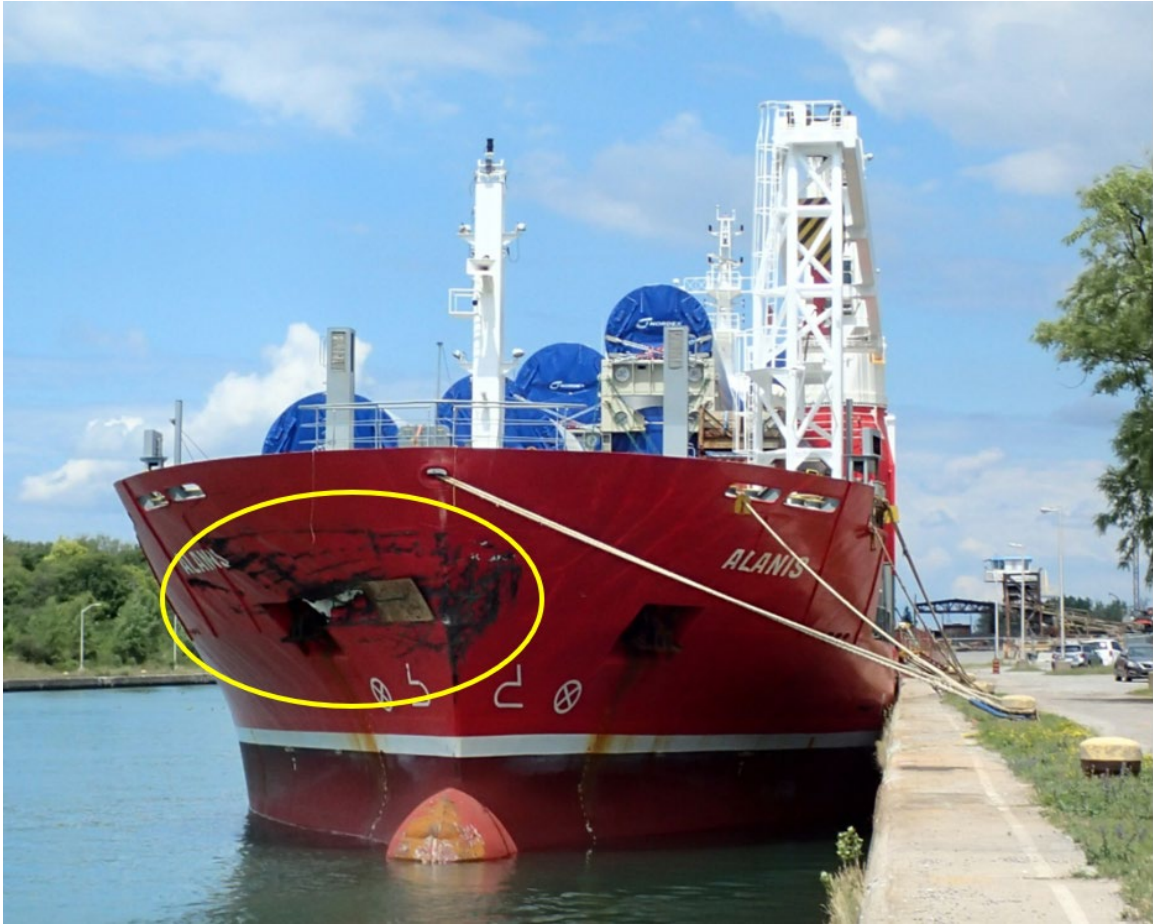
The *Alanis* sustained damage to the forward starboard section of its hull (Figure 10). There were multiple perforations and deformation of the shell plating. The starboard anchor flukes were also bent.

Figure 10. Damage to the forward starboard section of the Alanis's hull (circled) (Source: TSB)

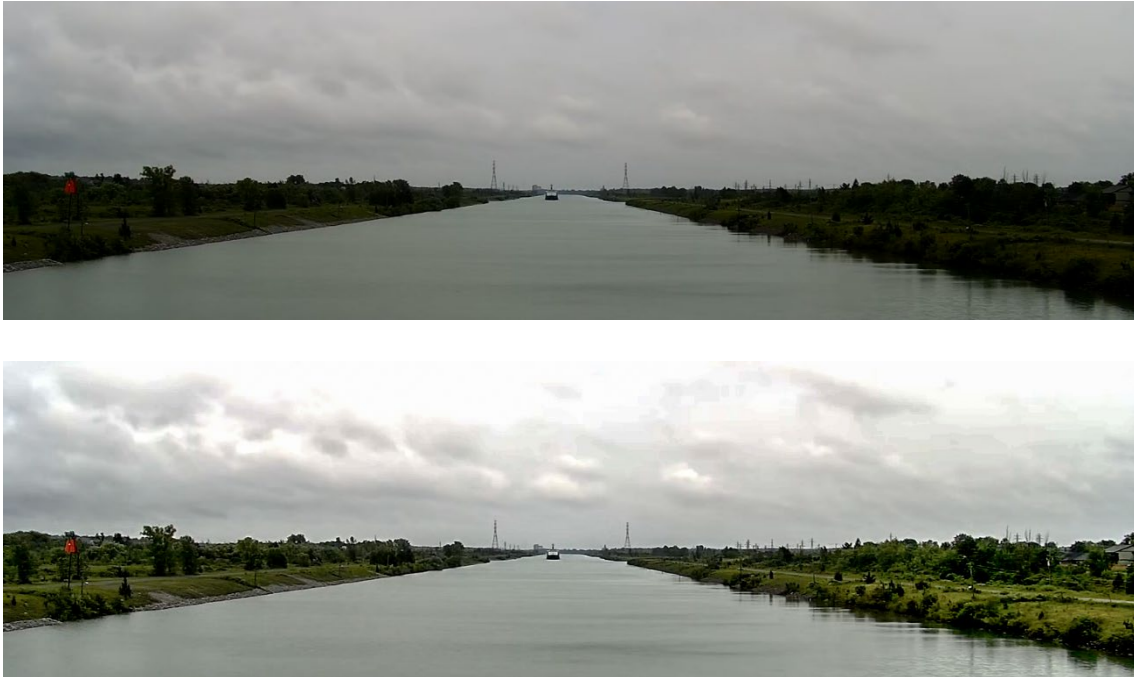
Another factor that can degrade a viewer's ability to discern a vessel's aspect is flat light conditions (Figure 12). These low-contrast conditions can cause the vessel to blend in with its surroundings, making it harder to see. They can also make it hard to determine how far away a vessel is and how quickly it is coming toward the viewer.

Figure 12. The top image shows the Florence Spirit at 0.8 nautical miles from the Alanis in flat light conditions. The bottom image shows the same view modified by the TSB to demonstrate higher contrast conditions. (Source of both images: ALANIS / Rambow Bereederungs GmbH & Co. KG, with TSB modifications).

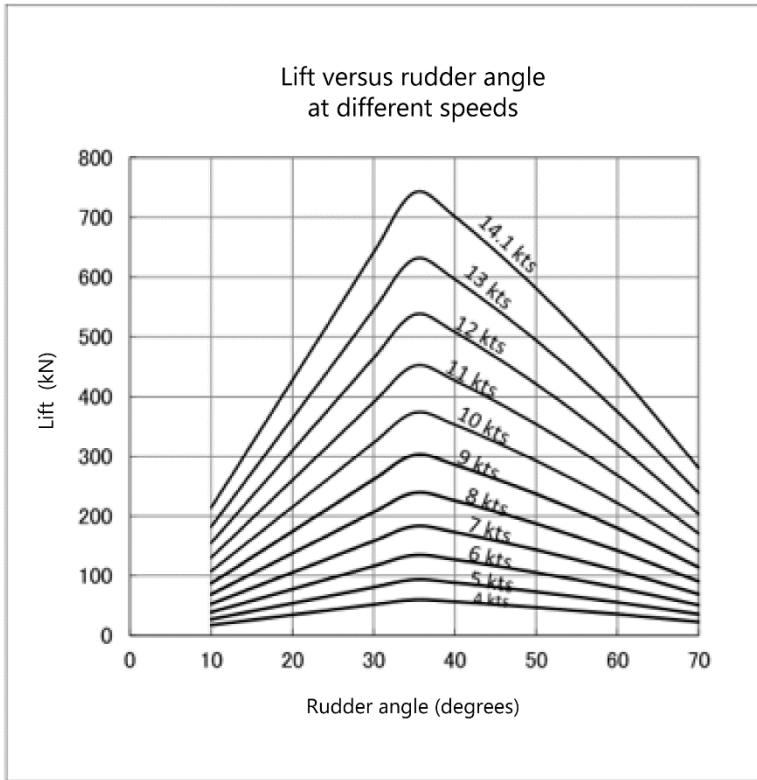
Figure 13. Lift force in relation to rudder angle at different speeds  
(Source: Japan Hamworthy & Co. Ltd.)

The *Florence Spirit* was constructed to Bureau Veritas's rules, which recommended that steering systems such as the one on the *Florence Spirit* include a limit system to prevent the use of the rudder at angles above 35° when the vessel is at full speed. Bureau Veritas's rules also required a notice to be posted at all steering wheel stations indicating that rudder angles of more than 35° are to be used only at very reduced speed.<sup>58</sup> The investigation determined that the steering stand on the *Florence Spirit* did not contain such a notice, and the steering gear had no limit system. At the time of the occurrence, the *Florence Spirit* was classified under Lloyd's Register, which does not have rules about operational limits or notices for steering systems of this type.

The fact that the lift force generated by the rudder at full speed reached its maximum at 35° and declined at greater angles was not indicated in the steering gear manual, the rudder arrangement plan, or the manoeuvring characteristics of the *Florence Spirit*, and both McKeil Marine and the bridge team were unaware of this information. It was common practice for the bridge team to apply rudder angles above 35° while the vessel was proceeding at speeds above 4 knots, and rudder angles of up to 70° were applied just prior to the occurrence when the *Florence Spirit* was proceeding at speeds in the range of 8 to 9 knots.
