MARINE TRANSPORTATION SAFETY INVESTIGATION REPORT M20P0230

BATTERY EXPLOSION

*Tug *Risco Warrior**
Bute Inlet, British Columbia
07 August 2020

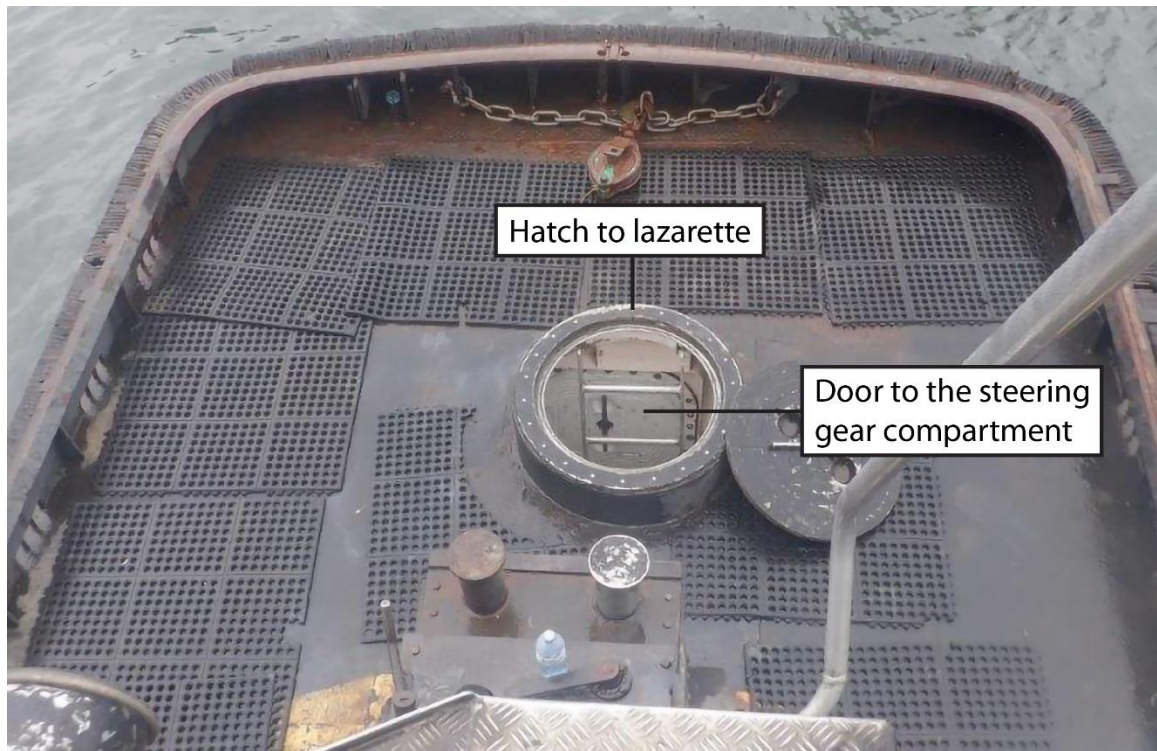
Figure 3. Aft deck hatch to enter the battery compartment, showing the door to the steering gear compartment (Source: Accurate Appraisals & Marine Surveys Ltd., with TSB annotations)

Internally, the lazarette is separated into 2 unventilated compartments, forward and aft, by a watertight bulkhead. The forward section of the lazarette (known on board as the battery compartment) contains 2 fuel tanks (port and starboard). The 32-volt direct current (VDC) battery bank, comprising four 8-VDC batteries, is located between the fuel tanks (Figure 4). A fresh water tank and the steering gear are located in the aft compartment of the lazarette. An opening in the bulkhead leading to the steering gear space is closed with a dogged steel watertight door (Figure 3).

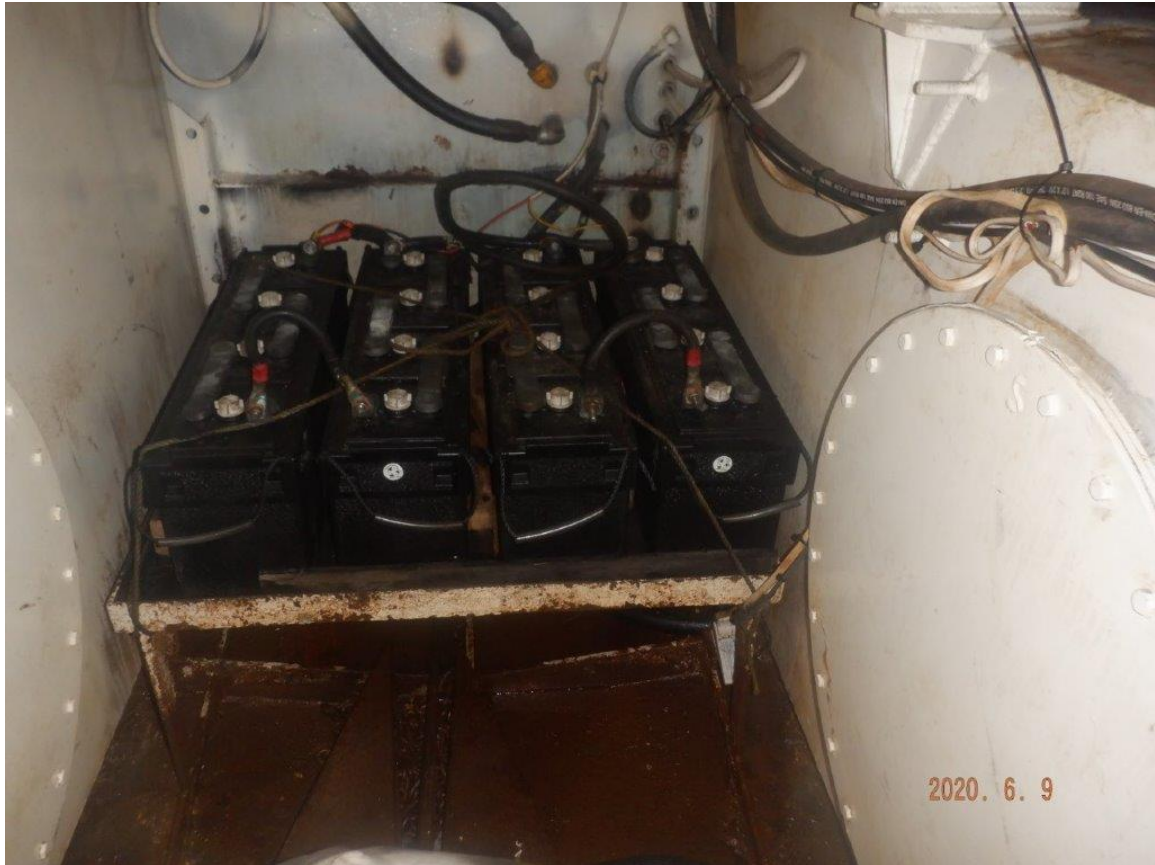
Figure 4. A photo taken 2 months before the occurrence shows the battery bank of four 8-VDC batteries located in the forward part of the lazarette in between 2 fuel tanks (Source: Accurate Appraisals & Marine Surveys Ltd.)

In June 2020, an independent survey of the *Risco Warrior* was carried out for Glory Days Towing Ltd. to ascertain the vessel's condition and to make an appraisal for insurance purposes. The survey identified a number of areas with deficiencies. Those related to the electrical system were the following (Figure 4):

- Protective covers were missing from the starting and ship power batteries.
- Ship power batteries were not secured.
- Protection against chafing for wires and cables was missing.
- The electrical system was not properly sized in relation to the rated overcurrent circuit protection.
- Waterproofing was recommended for all electrical wiring connections that may be exposed to moisture.
- The alternating current (AC) shore power input connector needed to be replaced with a proper plug.

The June 2020 report on the independent survey of the *Risco Warrior*, which was conducted to ascertain its condition and make an appraisal of the vessel, indicated that the batteries (Figure 4) were kept without protective covers and were not secured, which did not meet the standards defined in TP 127 *Ships Electrical Standards*. Also, wires and cables were not waterproofed or protected against chafing. The company did not attempt to rectify any of those issues prior to the occurrence. Any damaged wiring, such as the bilge pump wiring or grounding wires, could have generated a spark inside the battery compartment.

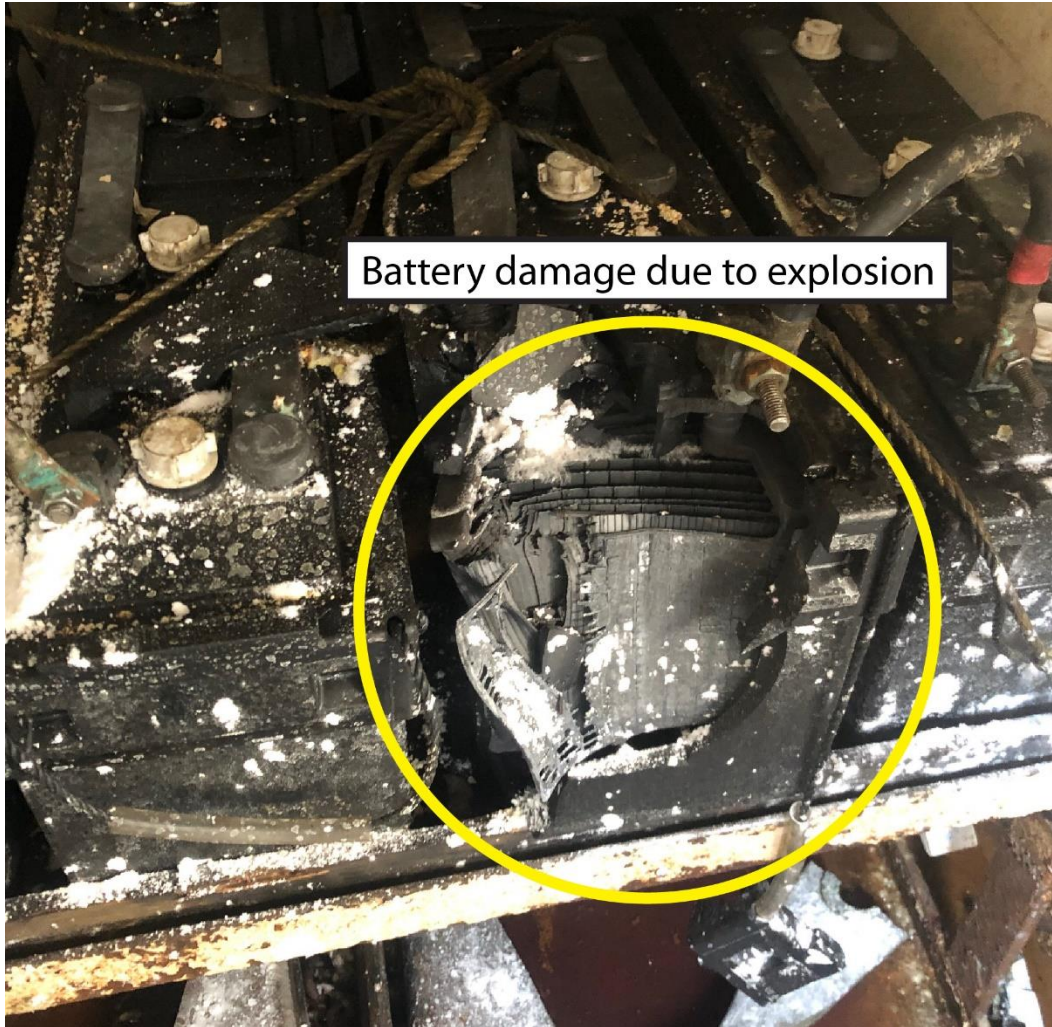
An explosion had occurred inside the second battery from the starboard side of the 32-VDC battery bank, and the battery was damaged as a result (Figure 6). The steel structural frames and bulkhead adjacent to the battery bank in the battery compartment were bent (Figure 7).

Figure 6. The second battery from the starboard side, showing damage to the battery (circled), and baking soda, which was sprayed after the explosion (Source: Glory Days Towing Ltd., with TSB annotations)

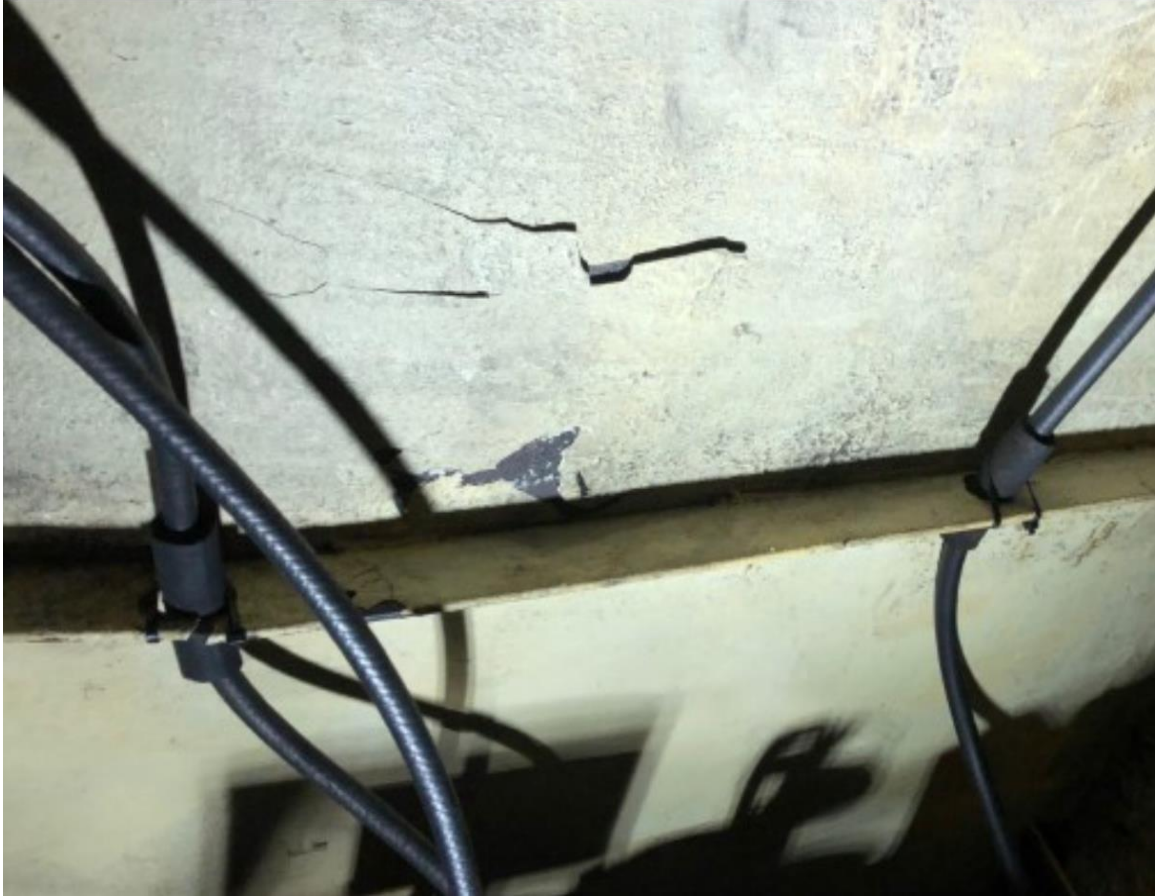
Figure 7. Damage to the structural frame and bulkhead that separated the battery compartment from the engine room (Source: Glory Days Towing Ltd.)

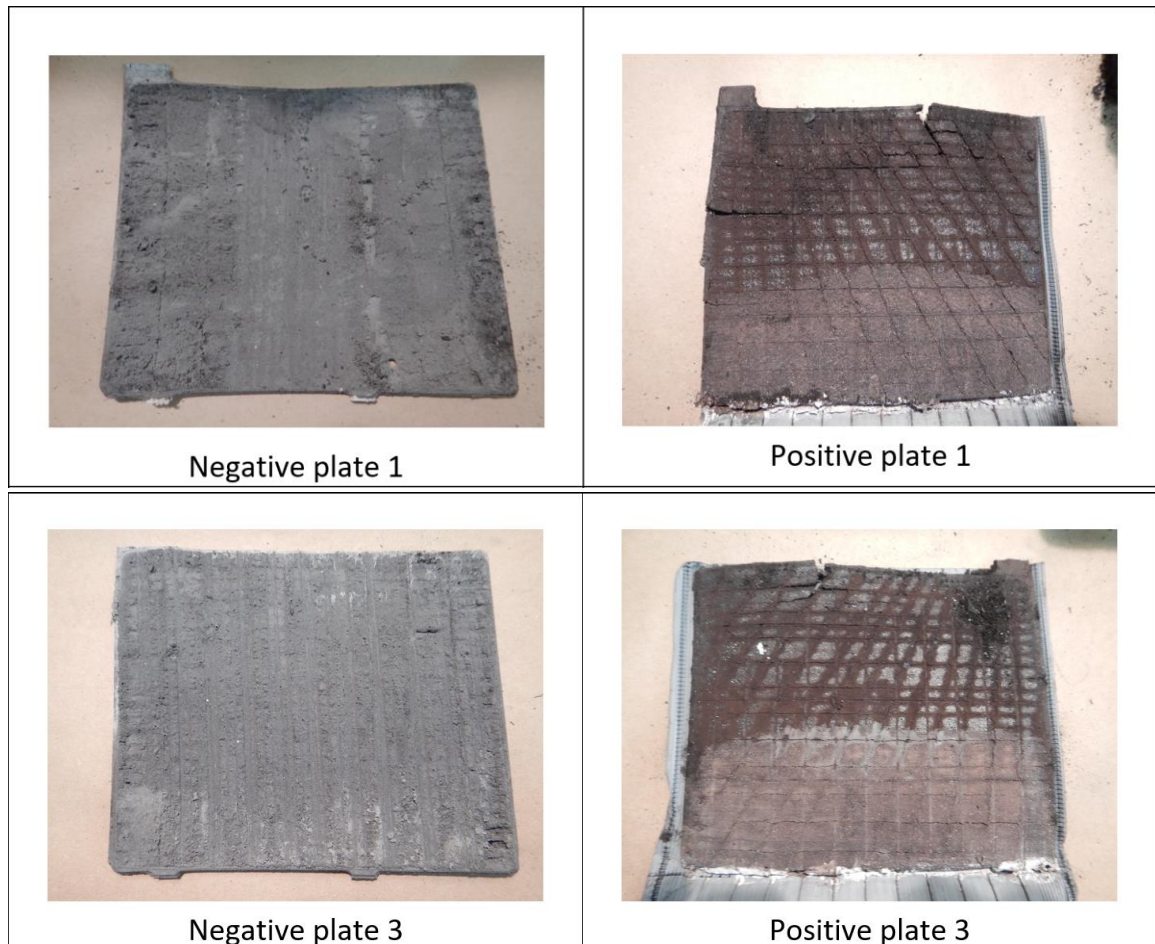
- Every cell of the 1st battery from the starboard side showed lead sulphate buildup on top of the visible negative plates. Buildup in cells 2 and 4 was more pronounced.
- Every cell of the 3rd battery from the starboard side showed lead sulphate buildup on top of the visible negative plates. Buildup in cell 3 was more pronounced.
- Every cell of the 4th battery from the starboard side showed lead sulphate buildup on top of the visible negative plates. Cell 2 showed a cracked positive plate and cell 3 showed a more pronounced buildup of lead sulphate.
- Lead sulphate buildup and crystallization were seen in cell 3 of the damaged battery (Figure 10).

Figure 10. Photos of the negative and positive plates from the damaged battery cell 3, showing lead sulphate buildup and crystallization (Source: TSB)

The batteries were connected to a charger that had no overcharge circuitry protection system. Therefore, it could be surmised, from the lead sulphate buildup on the negative plates of these batteries, that constant charging had depleted the water, resulting in low electrolyte levels and electrolyte degradation and raising the temperature, which caused cracking of the positive plates of cell 3 of the damaged battery.

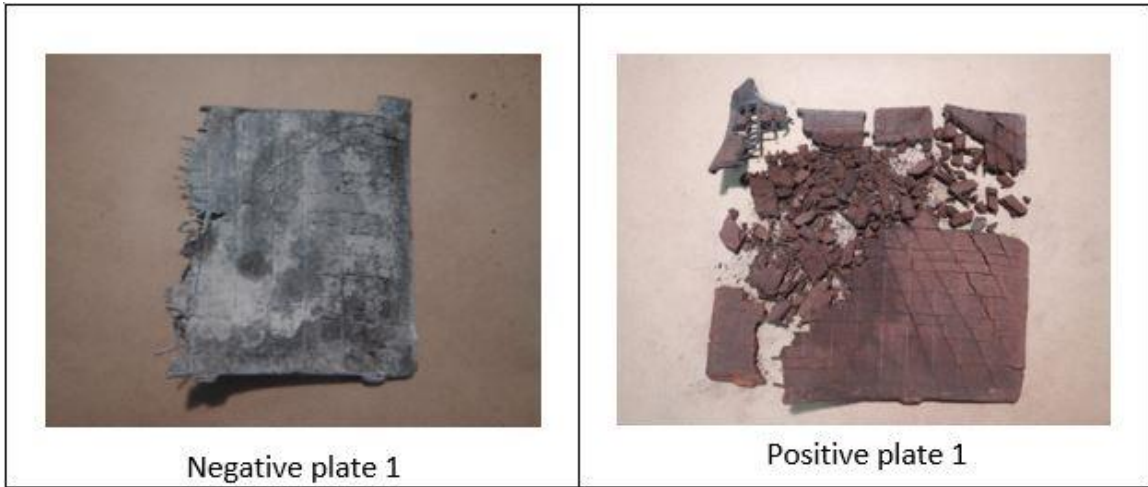
- The negative plates of cell 4 in the damaged battery showed signs of lead sulphate buildup, stratification,²² and deterioration of plate material. The 1st positive plate had disintegrated (Figure 11).
- The water filler cap on cell 4 of the damaged battery was missing. The investigation could not determine whether the filler cap was missing before the explosion or due to the explosion.
- All of the mechanical pressure-relief valves for the filler cap on the 3 undamaged batteries were found to be functional.

Figure 11. Photos of the negative and positive plates from the damaged battery cell 4 (Source: TSB)

Low water levels caused stratification of the plates, cracks and disintegration of the positive plates, as well as lead sulphate buildup on the plates, which increased the internal resistivity of the damaged battery. In addition, the 3 negative plates of cell 4 of this battery showed reduced surface material and sulphation, which also indicates overheating of the plates caused by overcharging and low electrolyte levels.

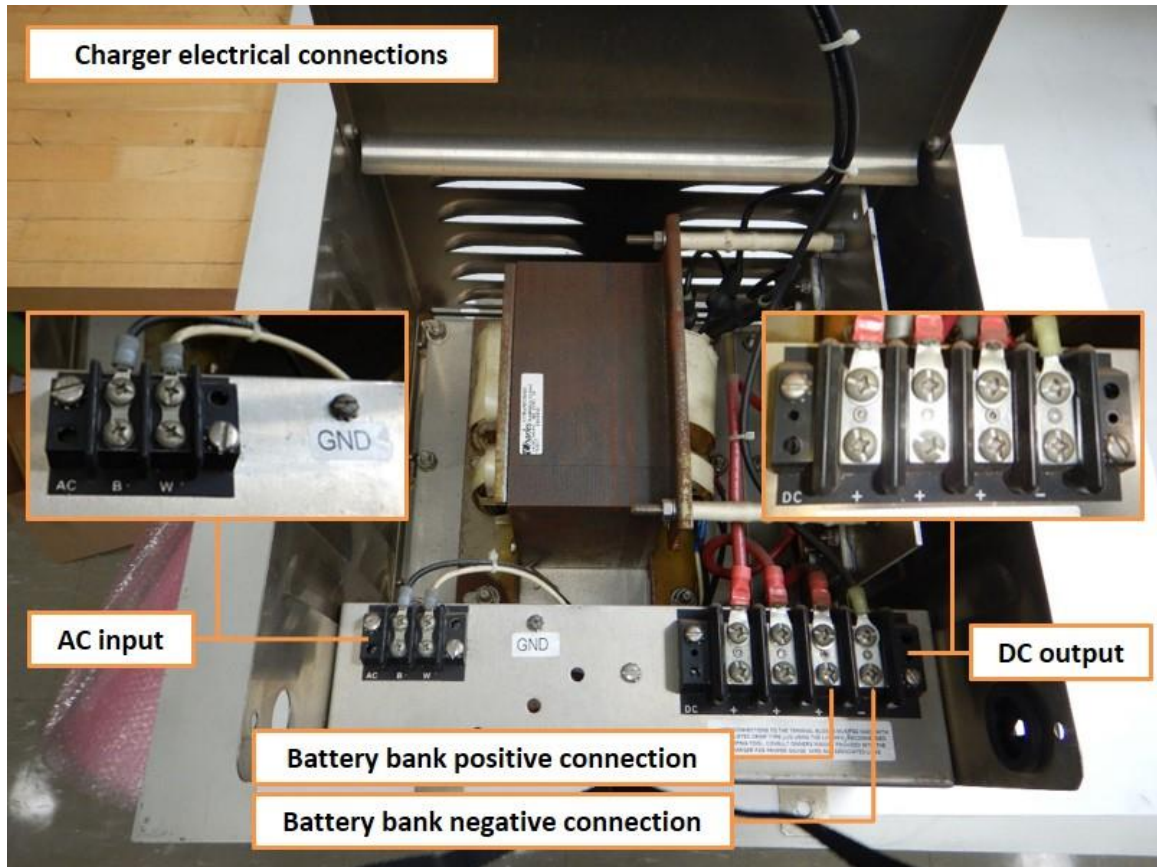
The vessel's 32-VDC battery charger had been discontinued by the manufacturer. The charger had 3 separate outputs that could charge 3 battery banks simultaneously. At the time of the occurrence, only one output of the charger was used to charge the 32-VDC battery bank. Upon visual inspection by the TSB Engineering Laboratory, the charger's internal circuitry appeared to be clean, with no signs of overheating (Figure 12).

Figure 12. 32-VDC charger internal connections (Source: TSB)
