# MARINE TRANSPORTATION SAFETY INVESTIGATION REPORT M21A0065

## **CAPSIZING WITH LOSS OF LIFE**

Fishing vessel *Tyhawk*

03 April 2021

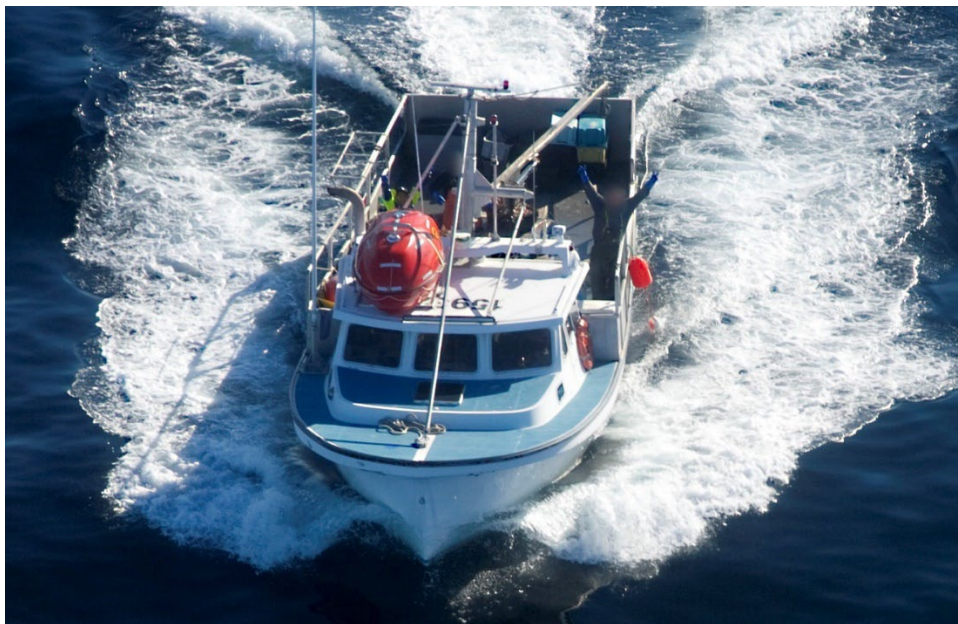
The *Tyhawk* had a removable aluminum deck for use in the snow crab fishery. On the centreline, immediately aft of the wheelhouse and before the removable deck, were a mast and a boom used for retrieving crab traps.

Figure 1. The fishing vessel *Tyhawk*, with a removable deck in place. Note that the rigid 4-person life raft on top of the wheelhouse was not in place on the day of the occurrence. (Source: Fisheries and Oceans Canada)

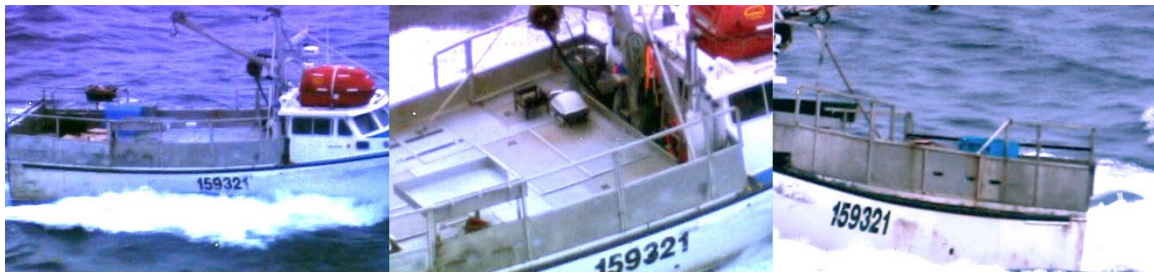
The *Tyhawk* had been modified by the addition of a removable deck. The investigation determined that the *Tyhawk's* stability was compromised in part by the addition of the removable deck, which had not been evaluated for its impact on the vessel's stability. In 2013, Transport Canada (TC) inspected the vessel, issued a deficiency because of the removable deck, and required a stability assessment. The master completed a stability questionnaire in May 2015 and identified the existence of a removable deck, but he did not recognize the deck as a modification that would require a stability assessment. The stability assessment required by TC was not completed, and TC's subsequent inspection documentation did not reference the removable deck.

In 2002, when the *Tyhawk* began participating in the snow crab fishery, a removable deck (Figure 2) and a boom were installed. The removable deck provided space to stow live snow crab on the entire aft (main) deck, while leaving space to stow traps on top of the removable deck. The removable deck weighed approximately 900 kg.

Figure 2. Three photos showing how the removable deck bulwarks sit on the top of the main deck bulwarks (left photo), the gap between the removable deck and the wheelhouse (centre photo), and the stern view of the removable deck (right photo) (Source: Fisheries and Oceans Canada video)

The removable deck was installed in 1 piece over the main deck and bolted to the top of the bulwarks, leaving the area between the main deck and the removable deck unobstructed. The connection between the top of the bulwarks and the removable deck was not watertight. The surface height was about 1.4 m over the main deck (about 0.45 m over the upper edge of the bulwarks). Access to the top of the removable deck was via a set of stairs from the wheelhouse. Access to the space under the removable deck was from the forward end (near the wheelhouse door) or through one of 3 hatches located on top of the removable deck. When the removable deck was in place, the engine compartment was still accessible via the main deck hatch. The removable deck had bulwarks with freeing ports on both sides.

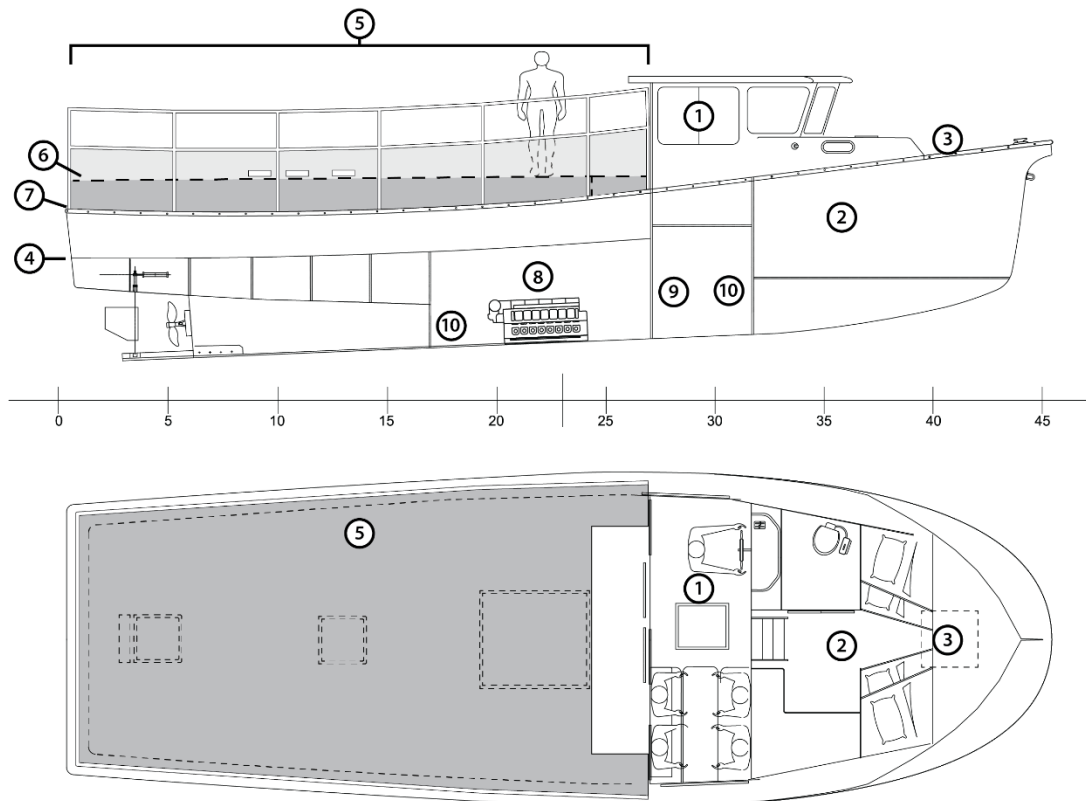
Figure 3. Profile and plan diagrams of the *Tyhawk*, showing the wheelhouse (1), the accommodation space (2), the emergency escape hatch (3), the main deck (4), the removable deck structure (5), the walking surface of the removable deck (6), the upper edge of the original bulwarks (7), the engine compartment (8), the high-level bilge sensor (9), and bilge pump locations (10) (Source: TSB, based on drawings from Guimond Boats Ltd.)

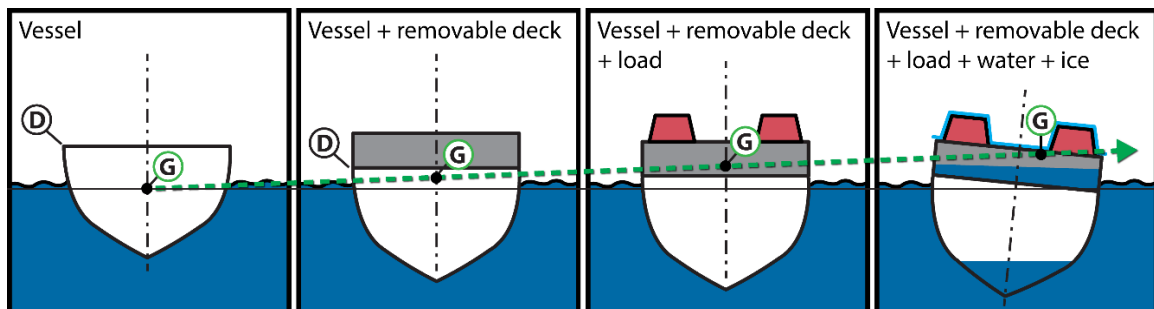
Stability refers to a vessel's ability to return to an upright position when disturbed by an external force, such as wind and waves or fishing operations. There are numerous factors that can affect a vessel's stability, such as its watertight integrity, the effects of additions or modifications, the amount and location of gear and catch on board, ice accumulation, its freeboard, and spaces where water can accumulate (Figure 7). All fishing vessels are required to have adequate stability to safely carry out fishing operations.<sup>34</sup>

Figure 7. Diagram of stability changes as the vessel acquires weight from modifications and operations, showing the position of the downflooding point (D) and how the freeboard decreases and the centre of gravity (G) rises (Source: TSB)

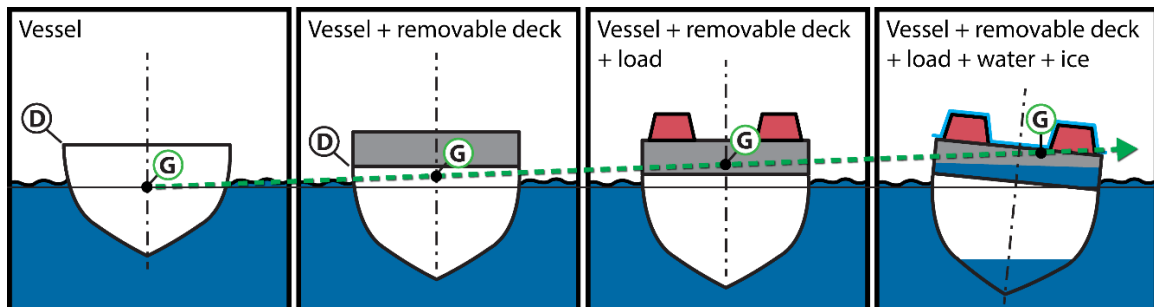
Past TSB investigation reports into stability-related accidents<sup>96</sup> have shown that it is usually a combination of factors that leads to a stability occurrence (Figure 8), as was the case with the *Tyhawk*.

Figure 8. Diagram of stability changes as the vessel acquires weight from modifications and operations, showing the position of the downflooding point (D) and how the freeboard decreases and the centre of gravity (G) rises. (Source: TSB)

The removable deck, unsecured gear, and accumulation of rain and freezing rain above the waterline caused the vessel's centre of gravity to be raised and the freeboard to be lowered.
