MARINE TRANSPORTATION SAFETY INVESTIGATION REPORT M21P0030

SINKING AND LOSS OF LIFE

Tug *Ingenika* and barge *Miller 204*
Gardner Canal, British Columbia
10 February 2021

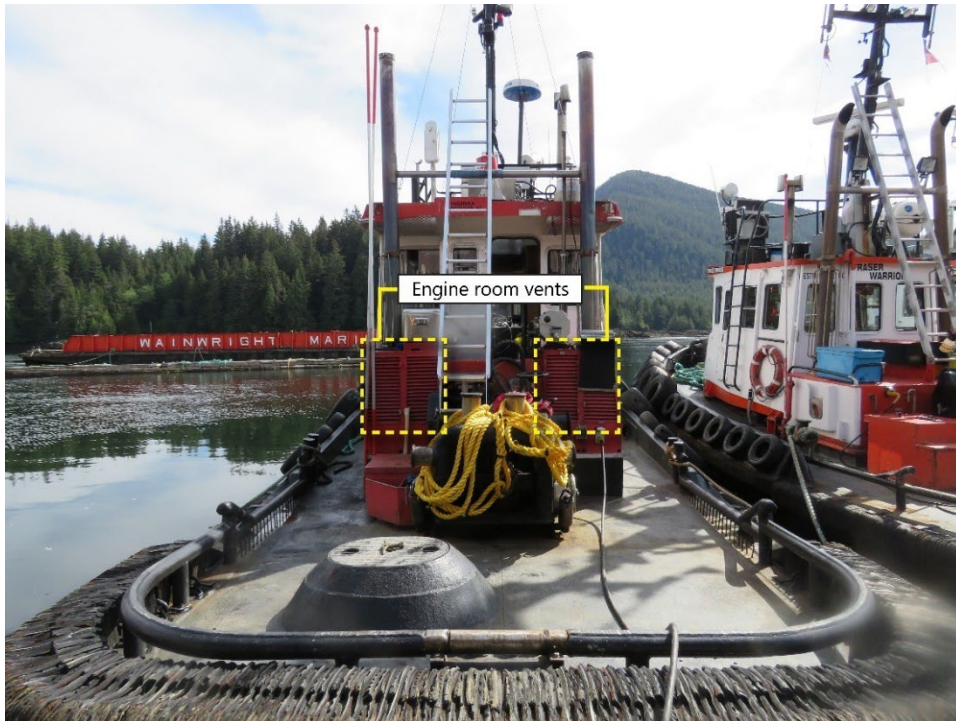
³ The exhaust vents were routinely left open to provide ventilation for the engine room.

Figure 2. View of the *Ingenika* from aft, showing engine room exhaust vents (Source: Third party with TSB annotations)

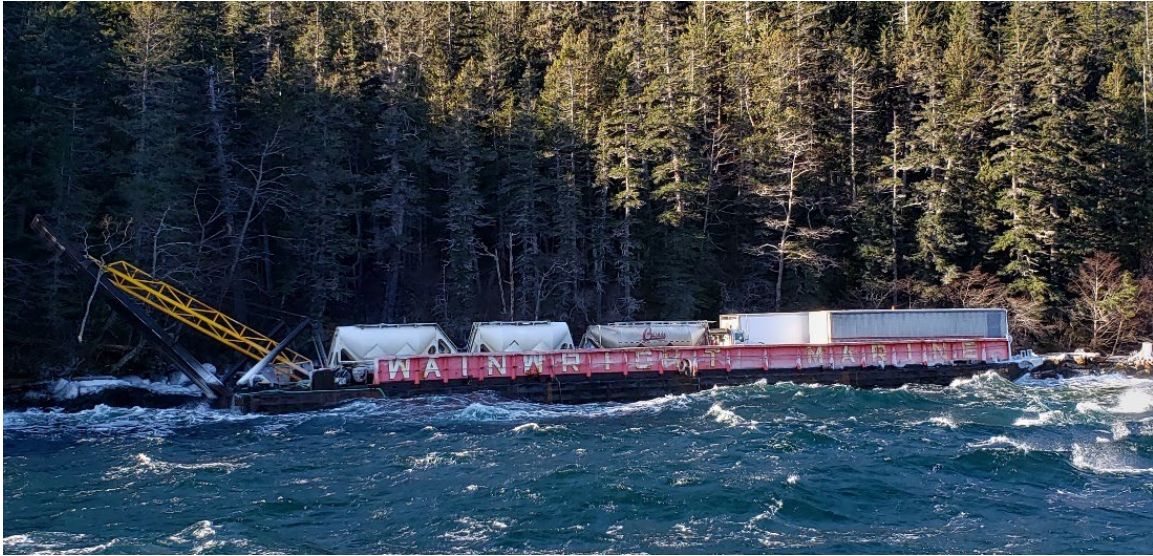
Figure 3. Barge aground with cargo (Source: Third party)

At 0250, SAR resources arrived in Europa Reach and began searching the area. At 0327, they located the *Miller 204*. It was aground about 4 NM west-southwest of Europa Reach. The towline was still attached to the barge but was trailing loose into the water and was no longer attached to the tug. Most of the cargo on the barge had shifted to the starboard side.

The *Ingenika* sank and could not be located. The *Miller 204* sustained damage to its hull sections as a result of pounding against the shoreline in the high winds.

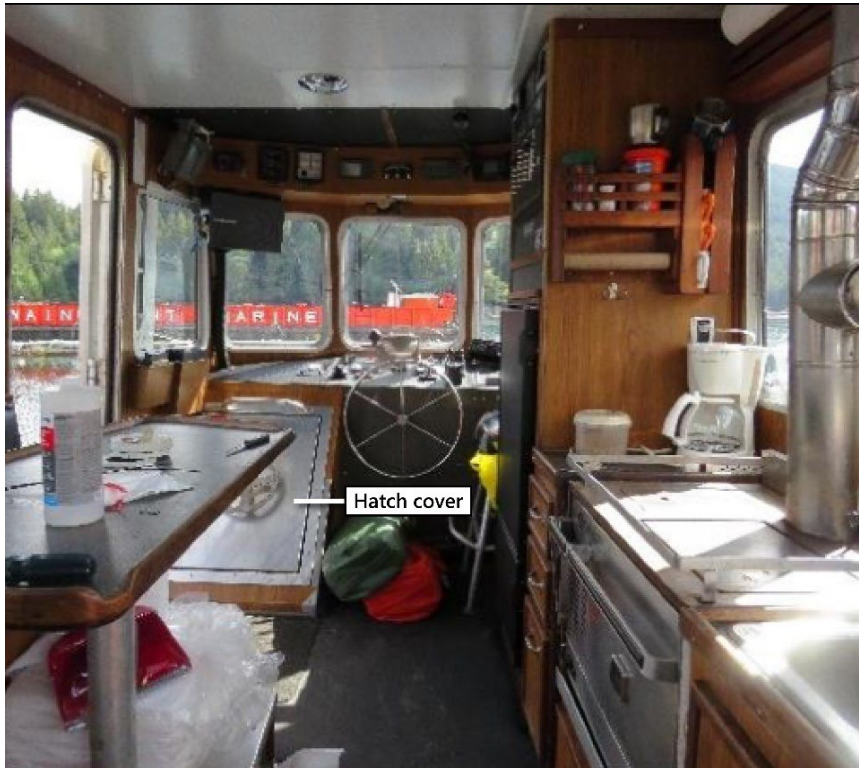
At some point, there was a loud bang and DH1, who was resting in the bunk, was suddenly thrown against the starboard side of the hull. When he stood up, he had to balance himself because the tug was heeled over to starboard by approximately 30°. Soon after, DH2 opened up the hatch cover leading to the accommodation (Figure 5) and asked DH1 to pass him the immersion suits.

Figure 5. View of wheelhouse showing hatch leading to the accommodation (Source: Third party, with TSB annotations)

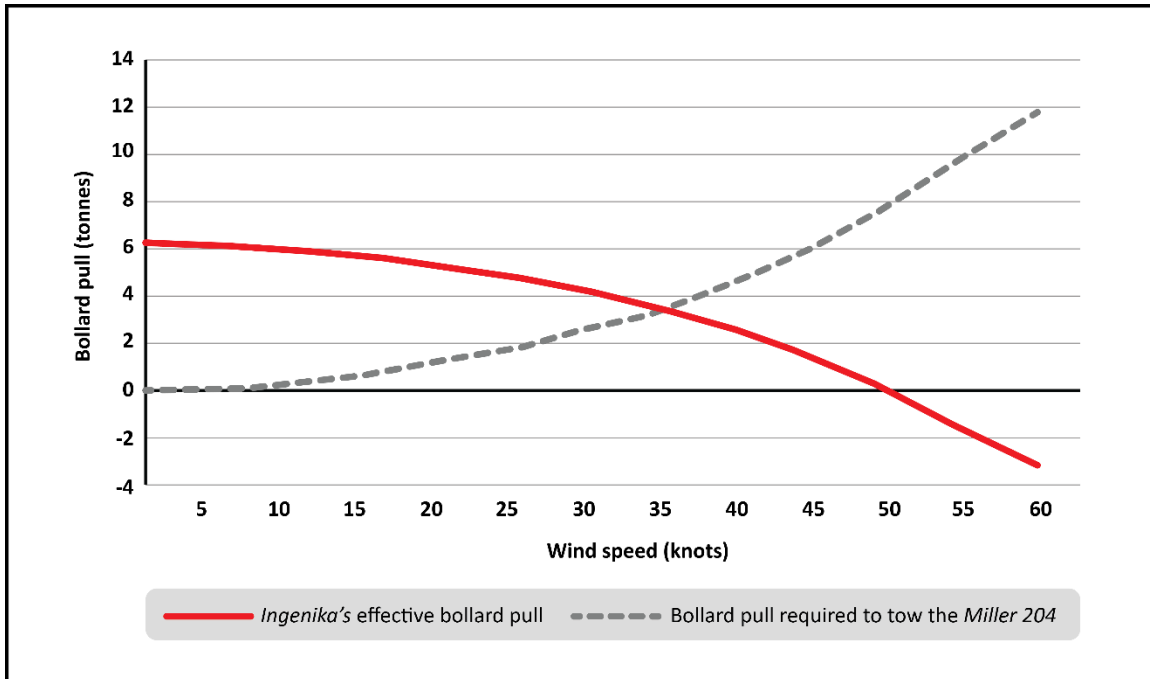
Using industry standards,¹⁷ the TSB calculated that the *Ingenika's* maximum bollard pull was likely around 8 tonnes.¹⁸ When taking into account an efficiency factor of 80%,¹⁹ the effective bollard pull of the tug was around 6 tonnes in calm waters (Figure 7). At the time of the occurrence, in the forecasted environment conditions, the bollard pull required for the *Miller 204* to maintain headway was approximately 12 tonnes.

Figure 7. Ingenika's effective bollard pull and the bollard pull required to tow the Miller 204 in various wind speeds (Source: TSB)

The exact sequence of events leading up to the sinking could not be reconstructed, but at some point, as the tug and barge were making the turn around Europa Point, the tug suddenly heeled to starboard and began to take on water. The TSB calculated that the *Ingenika's* maximum bollard pull was likely around 8 tonnes, with an effective bollard pull of around 6 tonnes in calm waters. At the time of the occurrence, in the forecasted environmental conditions, the bollard pull required for the *Miller 204* to maintain headway was approximately 12 tonnes. The TSB's calculations of bollard pull for the *Ingenika* demonstrate that, at the time of the occurrence in the prevailing weather conditions, the tug's effective bollard pull was not adequate to tow the barge.

When the tug left Kitimat, it was in following seas; however, as it started making the turn around Europa Point, it encountered opposing wind and current. These conditions likely caused the tug's effective bollard pull to decrease until it was insufficient to tow the barge. As the tug was attempting to make the turn, the heavily loaded barge may have continued on its trajectory instead of following behind the tug. This could have created a drag force on the tug that, combined with the tug's relatively low freeboard, may have caused the tug to heel over and the deck edge to submerge.
