## Marine Occurrence Report

### Striking

of the Ferry Wharf by the  
Passenger Vessel "GRAND FLEUVE"  
Rivière-du-Loup, Quebec  
04 June 1992

Report Number M92L3011

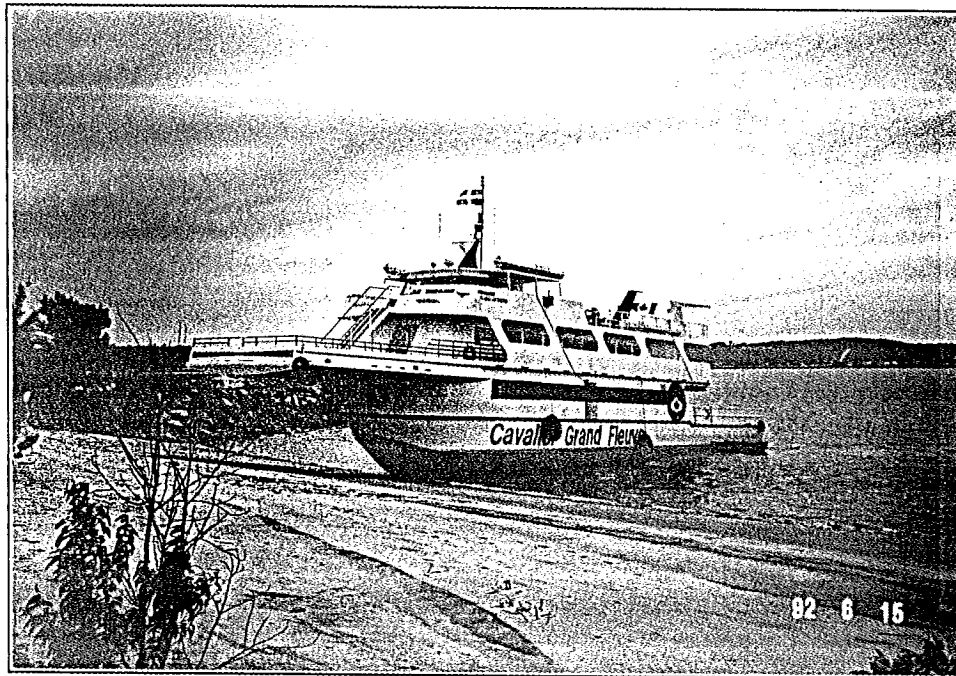
Because the railings along the forward observation platform's perimeter were the only handholds and because the large platform accommodates many passengers, the handholds were beyond the reach of some passengers. When the vessel moves in a seaway or during berthing/unberthing operations, passengers who are on the platform could be subjected to additional dangers associated with stumbling/falling because of a lack of sufficient handholds.

5. The male/female electrical connector was not provided with a locking mechanism.
6. The "GRAND FLEUVE" had recently undergone major structural alterations which included the addition, at the bow, of an observation platform which had railings only around its perimeter and no other handholds.

1. Change to the name of the vessel.
2. Observation platform added to the vessel.
