Marine Occurrence Report

Collision

Between the Ferry "QUEEN OF ALBERNI"
and the Bulk Carrier "SHINWA MARU"
Strait of Georgia, British Columbia
12 March 1992

Report Number M92W1022

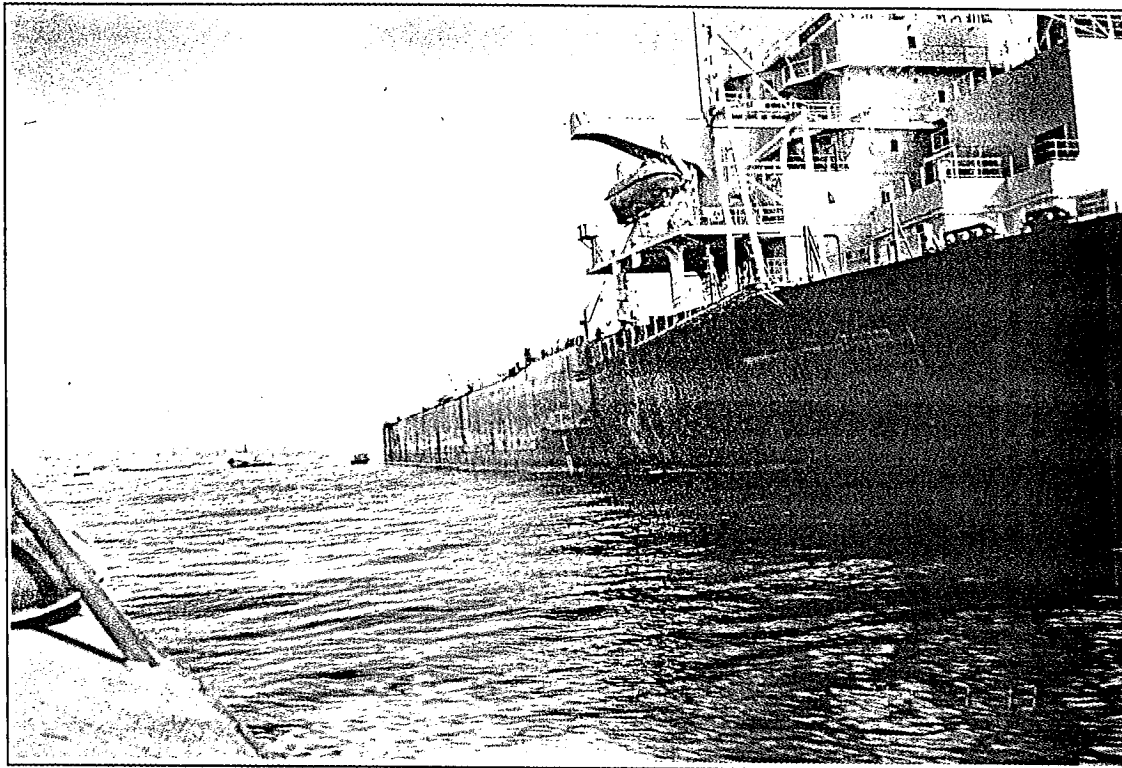
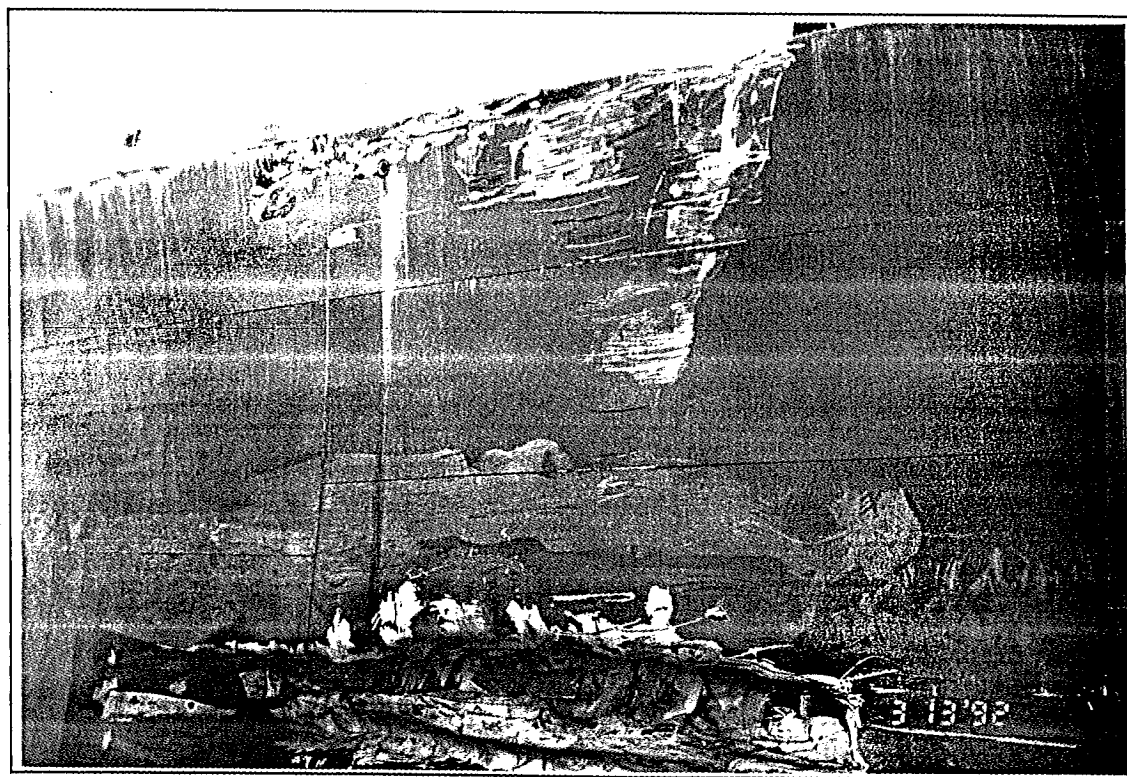
"SHINWA MARU"

The overhanging main deck plating of the "QUEEN OF ALBERNI" penetrated the port side shell plating in way of the No. 1 cargo hold and No. 1 topside ballast tank on the "SHINWA MARU". Plating was set in heavily and torn open in the respective compartments. Several frames, associated members and air pipes in way were also damaged.

Damage to the port side shell plating in way of No. 1 cargo hold and No. 1 topside ballast tank.

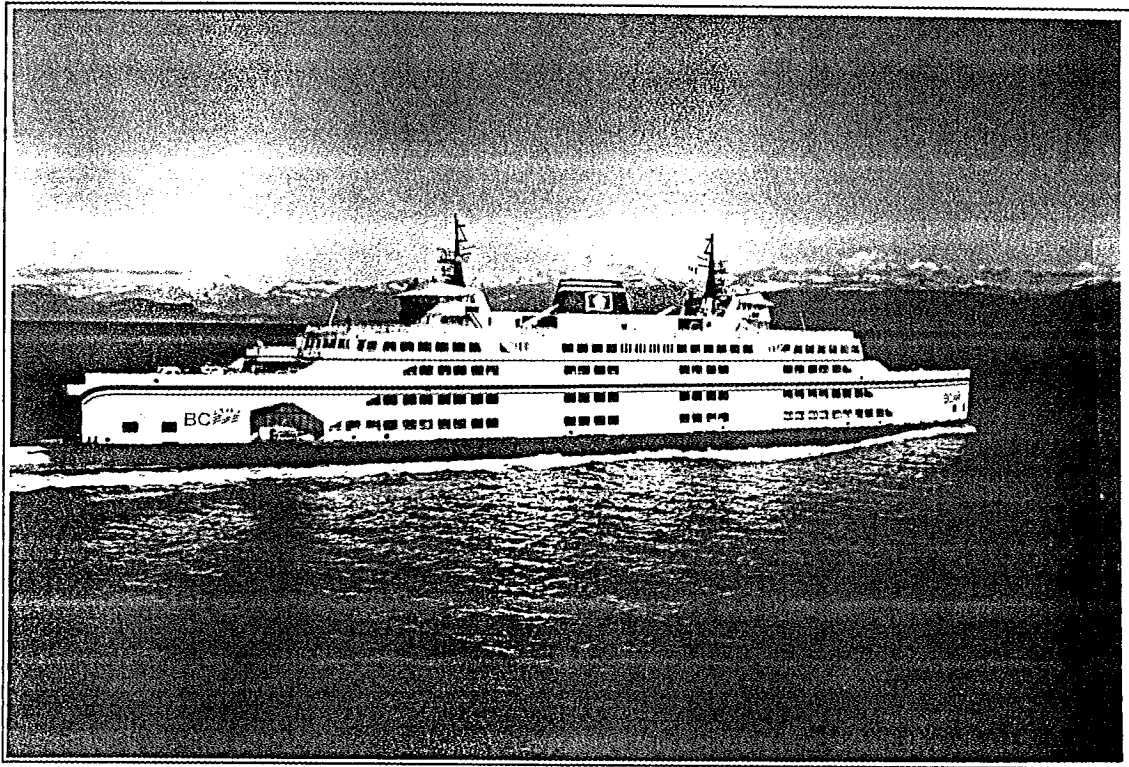
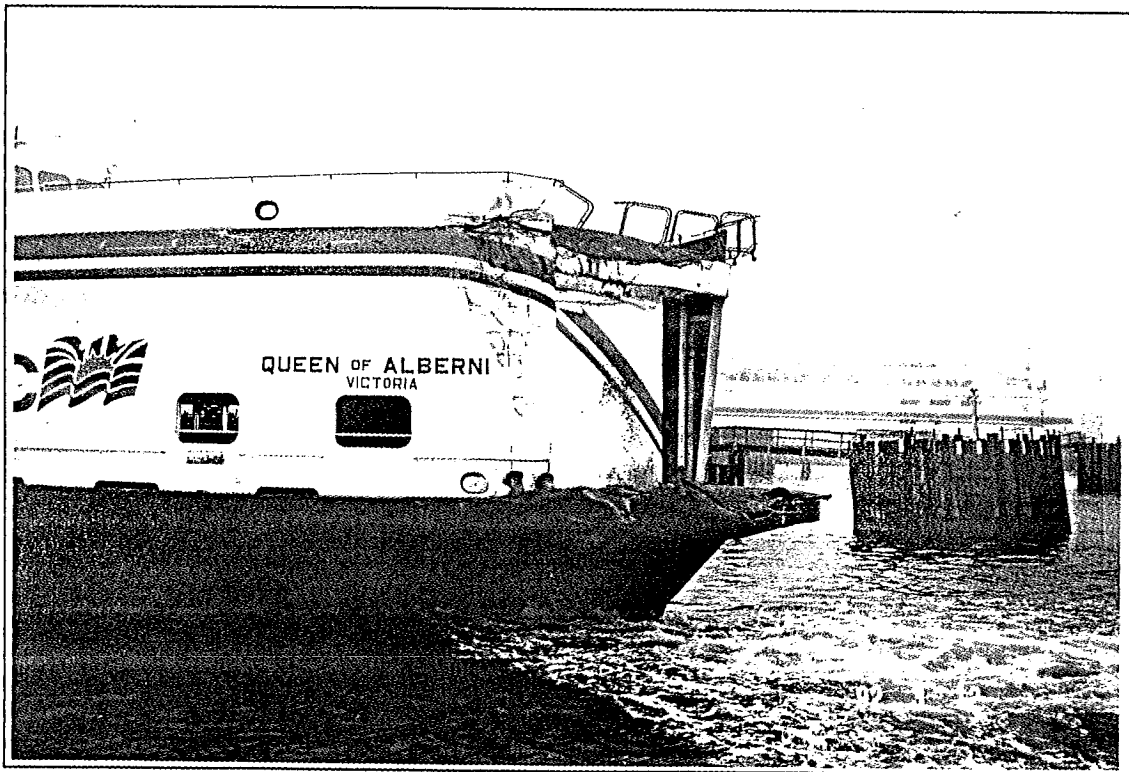
"QUEEN OF ALBERNI"

The ferry sustained structural damage to the shell plating, main deck apron, upper deck and sliding doors; all at No. 1 end. Some metal cabinets and food counters in the vessel's cafeteria, which were secured to the deck, had sheared off at the base and were displaced.

Damage to the main deck apron and upper deck area.
