Marine Occurrence Report

Fire with the Loss of One Life

in the Cargo Conveyor Tunnel of the
Self-unloading Bulk Carrier "HALIFAX"
St. Mary's River, Ontario
06 April 1993

Report Number M93C0001

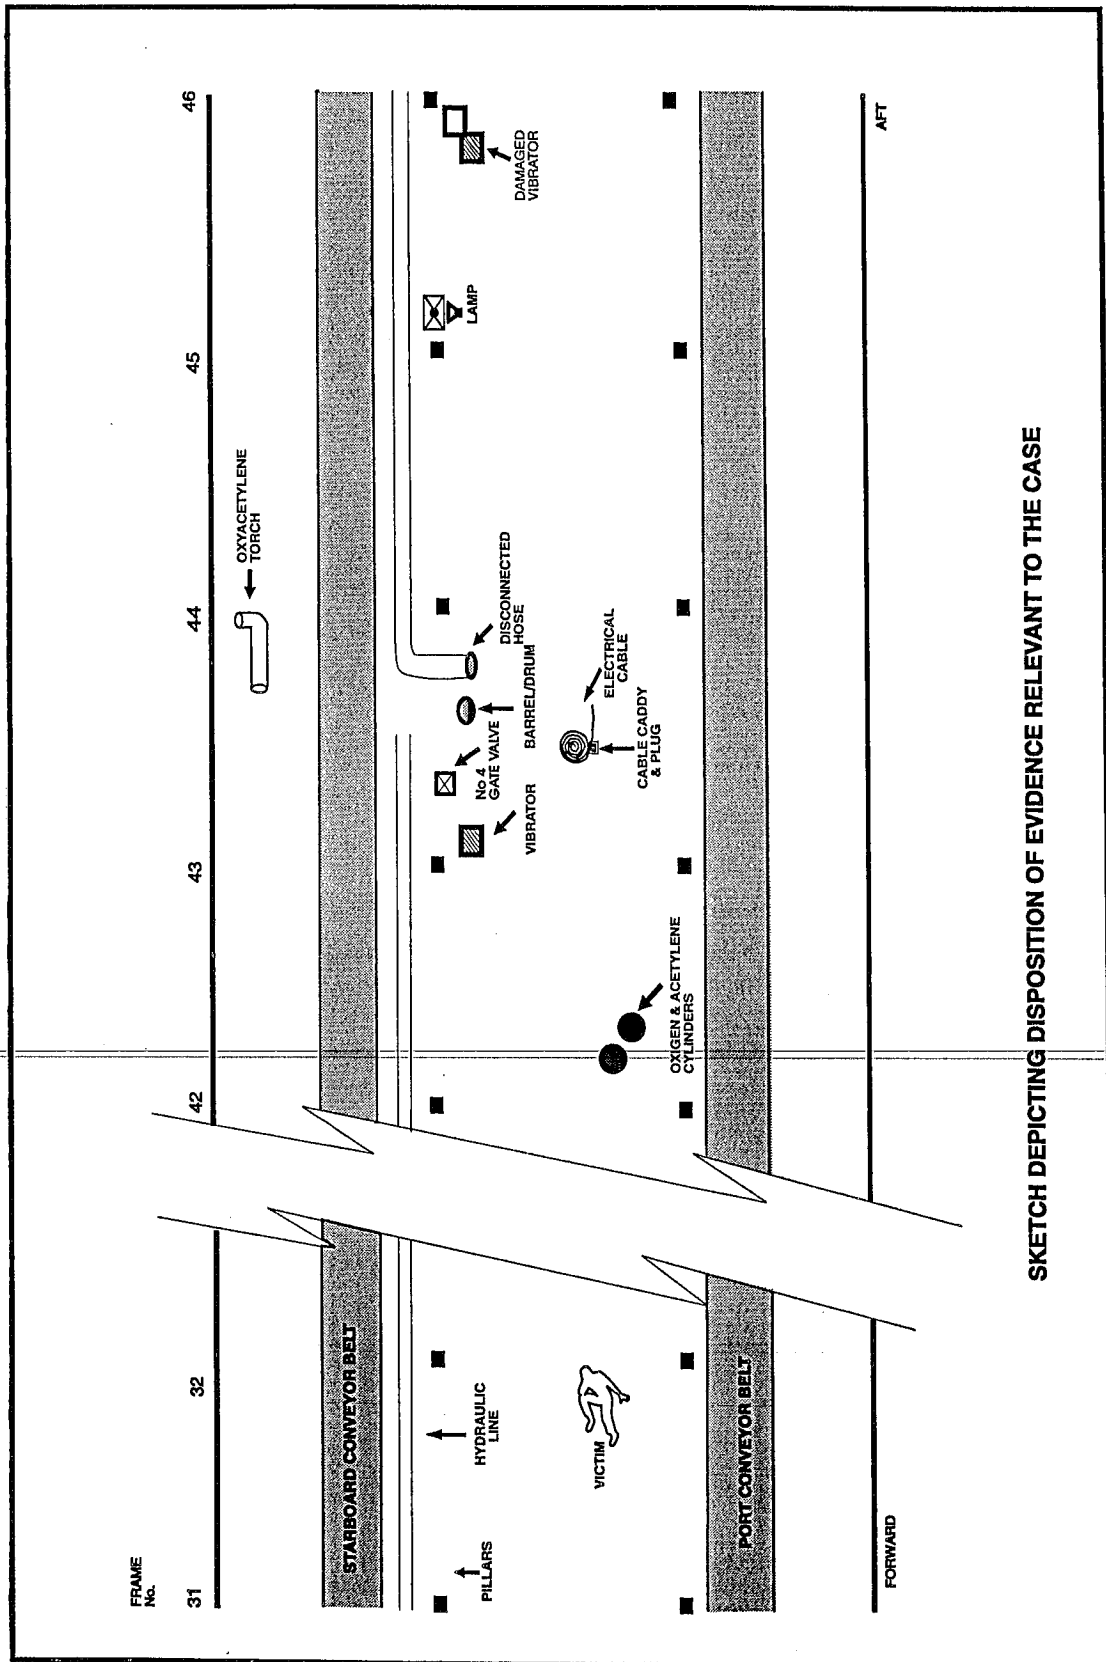
FIGURE 1

At the time of the fire, one full oxygen and two acetylene cylinders, one empty and the other nearly full, were present on the port side of the centre tunnel (Appendix B, Figure 1). One acetylene tank had been changed that morning. With the onset of the fire and with the oxyacetylene cylinder valves open and the hoses burnt, intense fire and heat were generated by the introduction of these flammable materials; the effects of which could be felt on the bridge of the vessel. There was no evidence to suggest explosion within the tunnel due to the presence of acetylene.

SKETCH DEPICTING DISPOSITION OF EVIDENCE RELEVANT TO THE CASE

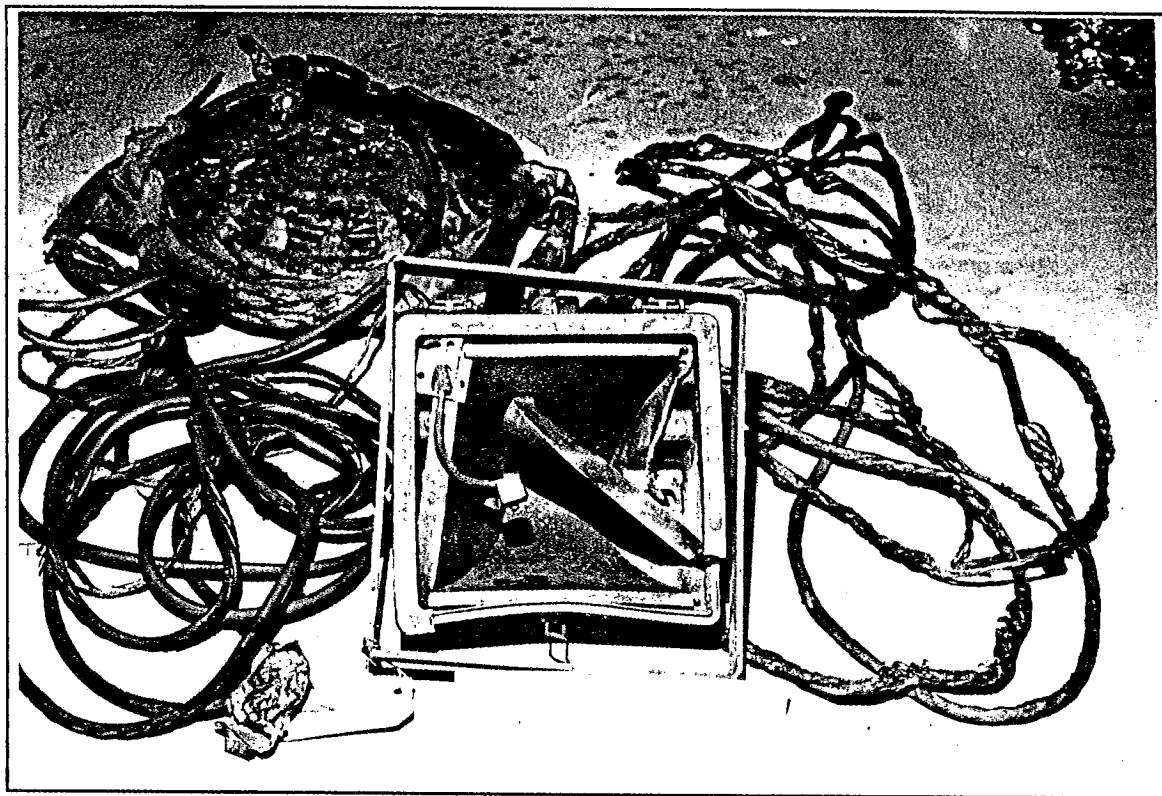
latches ensure consistent lens pressure. The halogen lamp was mounted on a steel bracket with an electrical junction box attached to the rear of the bracket and an extension cord hardwired into the junction box (see Appendix C, Figures 3A and 3B). In this instance, the halogen lamp fixture in use did not have the protective lens in place.

5. The hydraulic oil mist was ignited by the bare halogen lamp.
6. A flame observed in the vicinity of the work area by the tunnelman was the initiation of the hydraulic oil fire.

9. The lens temperature of the type of halogen lamp in use was in excess of the temperature permissible for handling lighting fixtures.
10. The acetylene cylinder in use had replaced an empty cylinder earlier on the day of the occurrence.

Figure 3A - Front view of the halogen lamp.

1. the need for compliance with Ship Safety Electrical Standards (TP 127, Section 18(4)) concerning the use of portable equipment;
2. the need for maintenance of all portable equipment in a safe working condition;
3. use of portable shipboard equipment in a safe environment aboard; and
4. the need for enclosure of fixtures in areas where there is a risk of spray or readily combustible material.

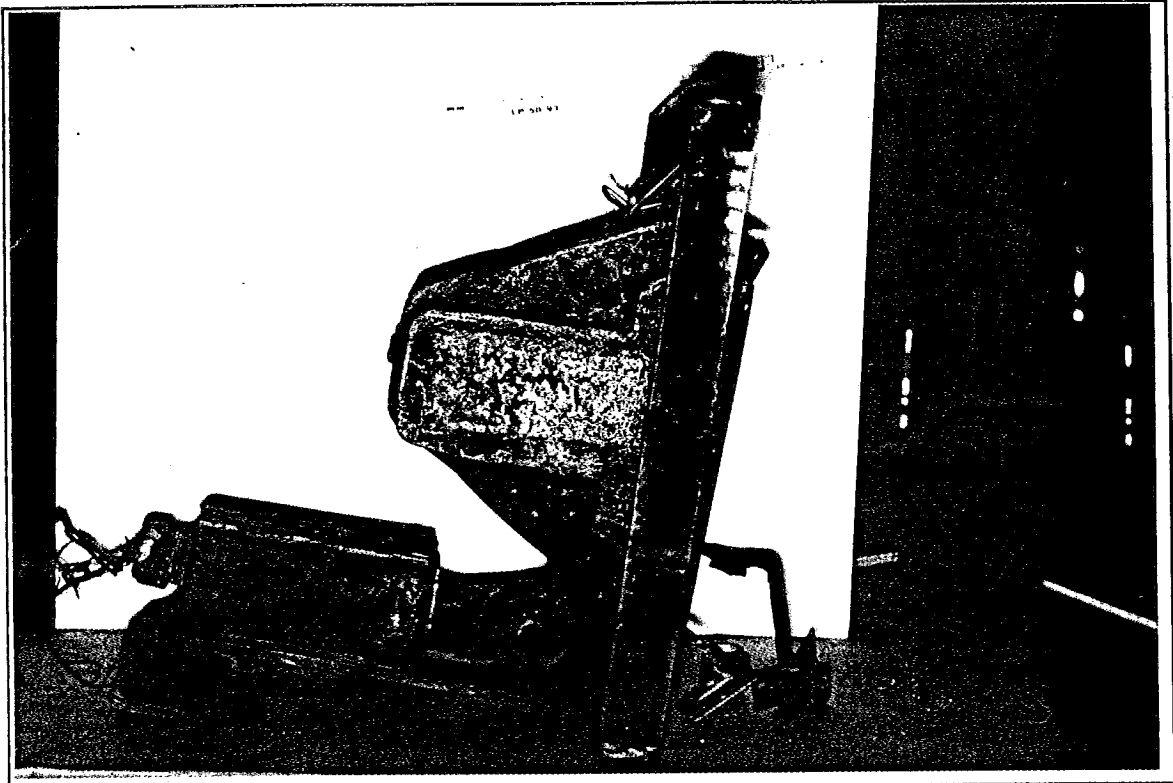
Figure 3B - Side view of the halogen lamp showing junction box.

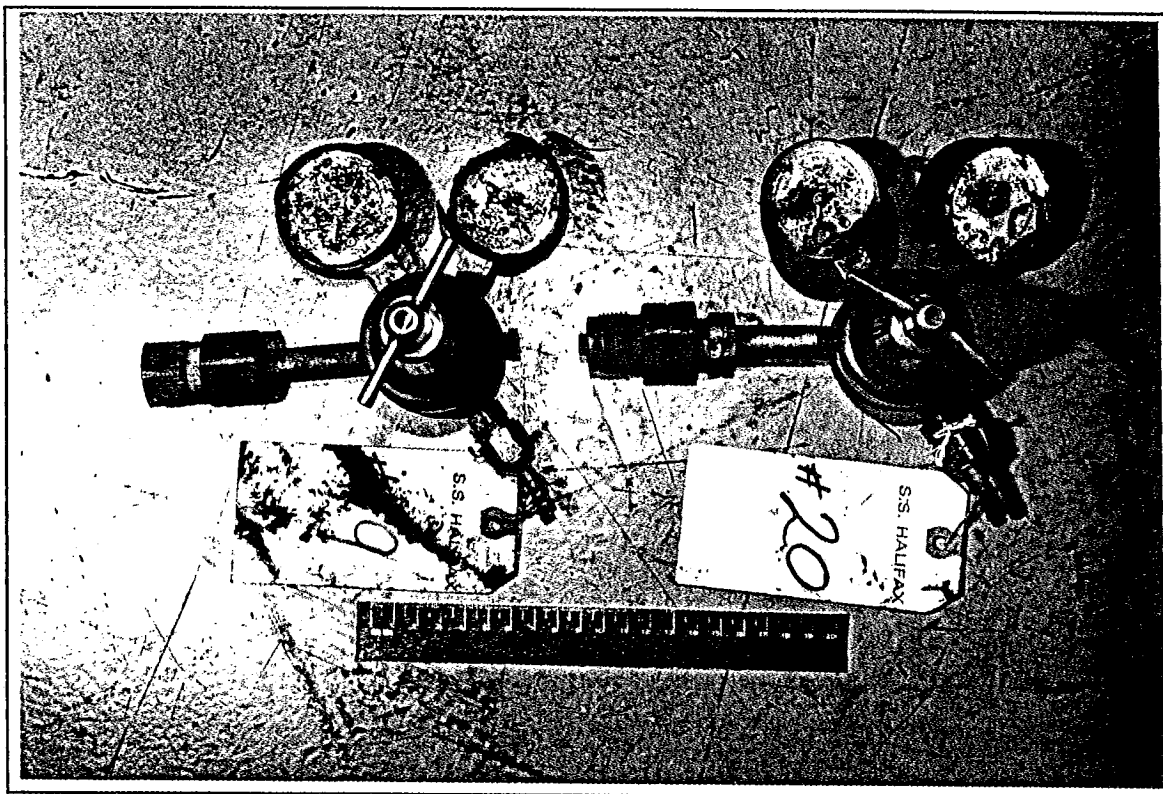
- There was a negligible quantity of oxygen and acetylene in the bottles.
- The handle of the oxygen shut-off valve was partially melted.
- The regulator gauges attached to the oxyacetylene cylinders were both partially melted (see Appendix C, Figure 4).
- The regulator fittings had tapered threads and the cylinder valve had straight threads requiring the use of an adapter.
- The hoses originally attached to the regulator were burned off with about 8 m remaining attached to the torch; the torch was located in the starboard tunnel (Appendix C, Figure 5).

Figure 4 - Regulators and gauges removed from oxyacetylene tanks.

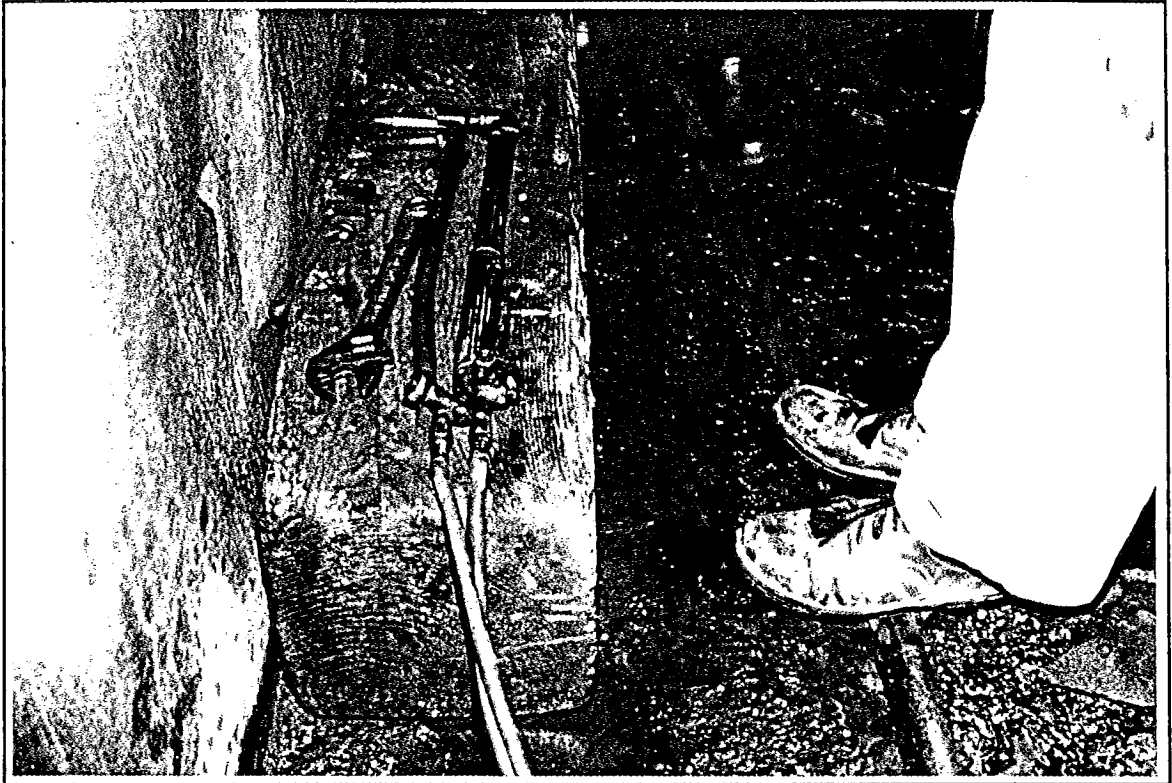
- There were no flashback arresters installed on the regulators nor are any required by regulations.
- The knob of the oxygen shut-off valve on the torch was missing and the valve stem was bent requiring a tool to turn the valve stem, but the tests showed the valve to be functioning satisfactorily.

- The acetylene valve on the torch was complete, the valve was closed and operated normally.
- The hose connections at the torch were tight and the tip nut was seated properly and in good condition.

- The hose connections at the torch did not have non-return valves installed nor are any required by regulations.
- The remaining hose, which had been in service for approximately two years, was in relatively good condition with no splices or crazing of the hose.

Figure 5 - Oxyacetylene torch as found in the starboard side of the tunnel after the fire (courtesy of CSL).
