Marine Occurrence Report

Grounding

"FEDERAL MACKENZIE"
Verchères-Contrecoeur Channel, Quebec
14 July 1993

Report Number M93L0002

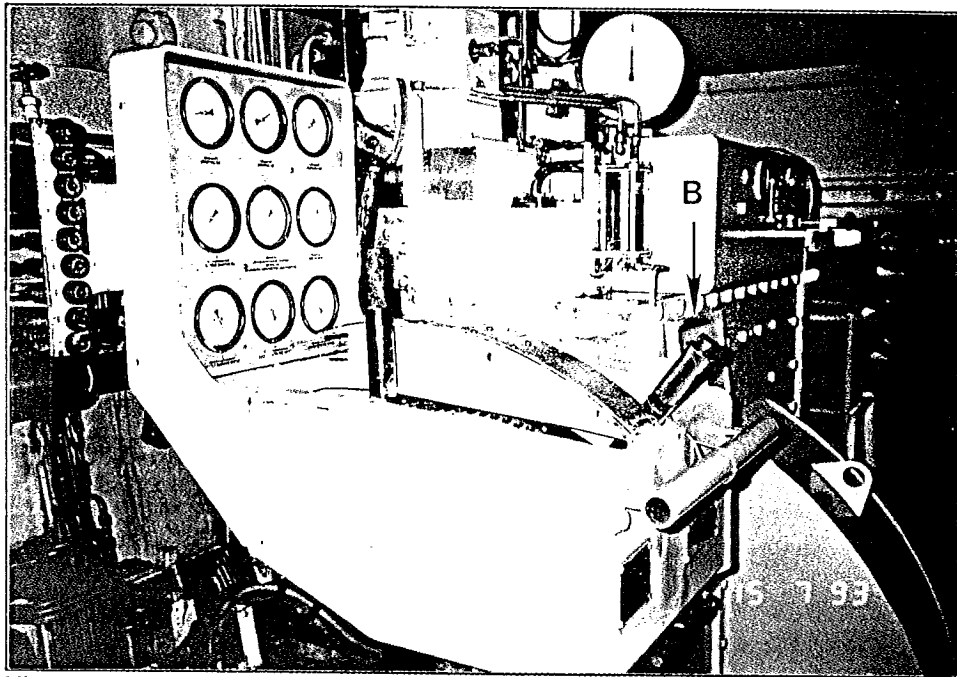
There are two levers at the emergency stand. Lever "A" controls the gear and is marked "Start", "Ahead", "Stop" and "Astern". Lever "B" controls fuel flow into the engine and is graduated 0 to 10. Below the "0" position is marked "Remote Control" at which position the lever is placed for such operation.

Lever "B" has a button control on its end which is used for operating a locking device. However, evidence indicated that the ratchet lock had worn down and had lost its effectiveness.

Shortly before the grounding, the vessel had experienced considerable vibration because of the effect on the propeller of the shallow water through which the vessel was moving. Because the ratchet used to hold the lever at a predetermined setting was worn, the vibration experienced could have been enough to displace the lever to the "0" position.

The emergency stand at the main engine.

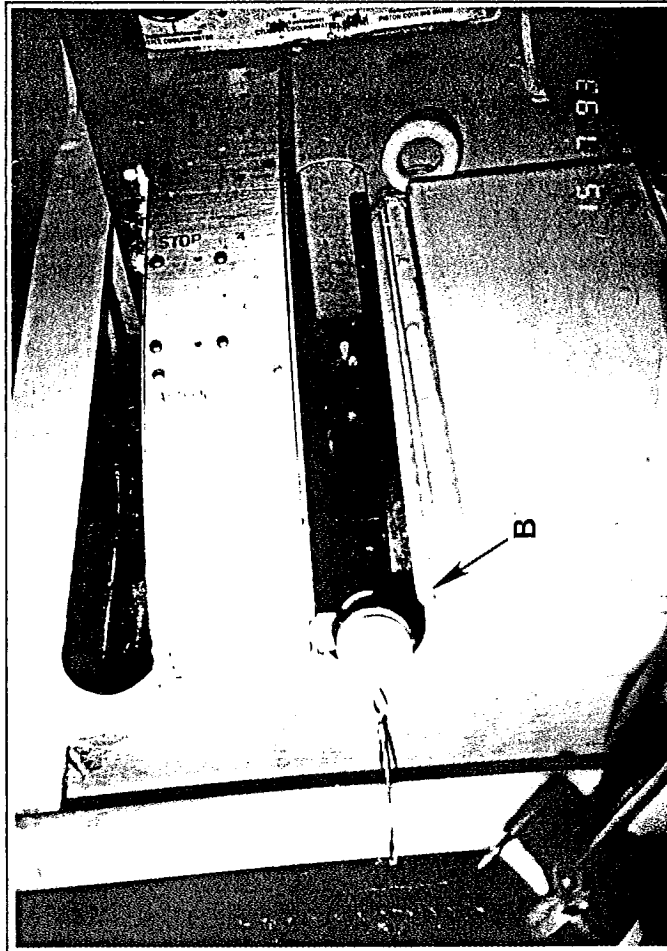
As no one in the engine-room had touched lever "B", it is most likely that it moved by itself from the "Remote Control" to the "0" position where it was found after the grounding.

When lever "B" moved to the "0" position, the engine stopped because of fuel starvation. Because the emergency stand controls override the other control stations, no subsequent movement of these other controls could correct the situation.

Note: The wire was fitted to lever "B" and the grab rail after the accident to prevent the lever from vibrating upward.
