Marine Occurrence Report

Striking of a Concrete Wall

Bulk Carrier "FRONTENAC"
Canal de la Rive Sud
St. Lawrence Seaway, Quebec
29 October 1993

Report Number M93L0005

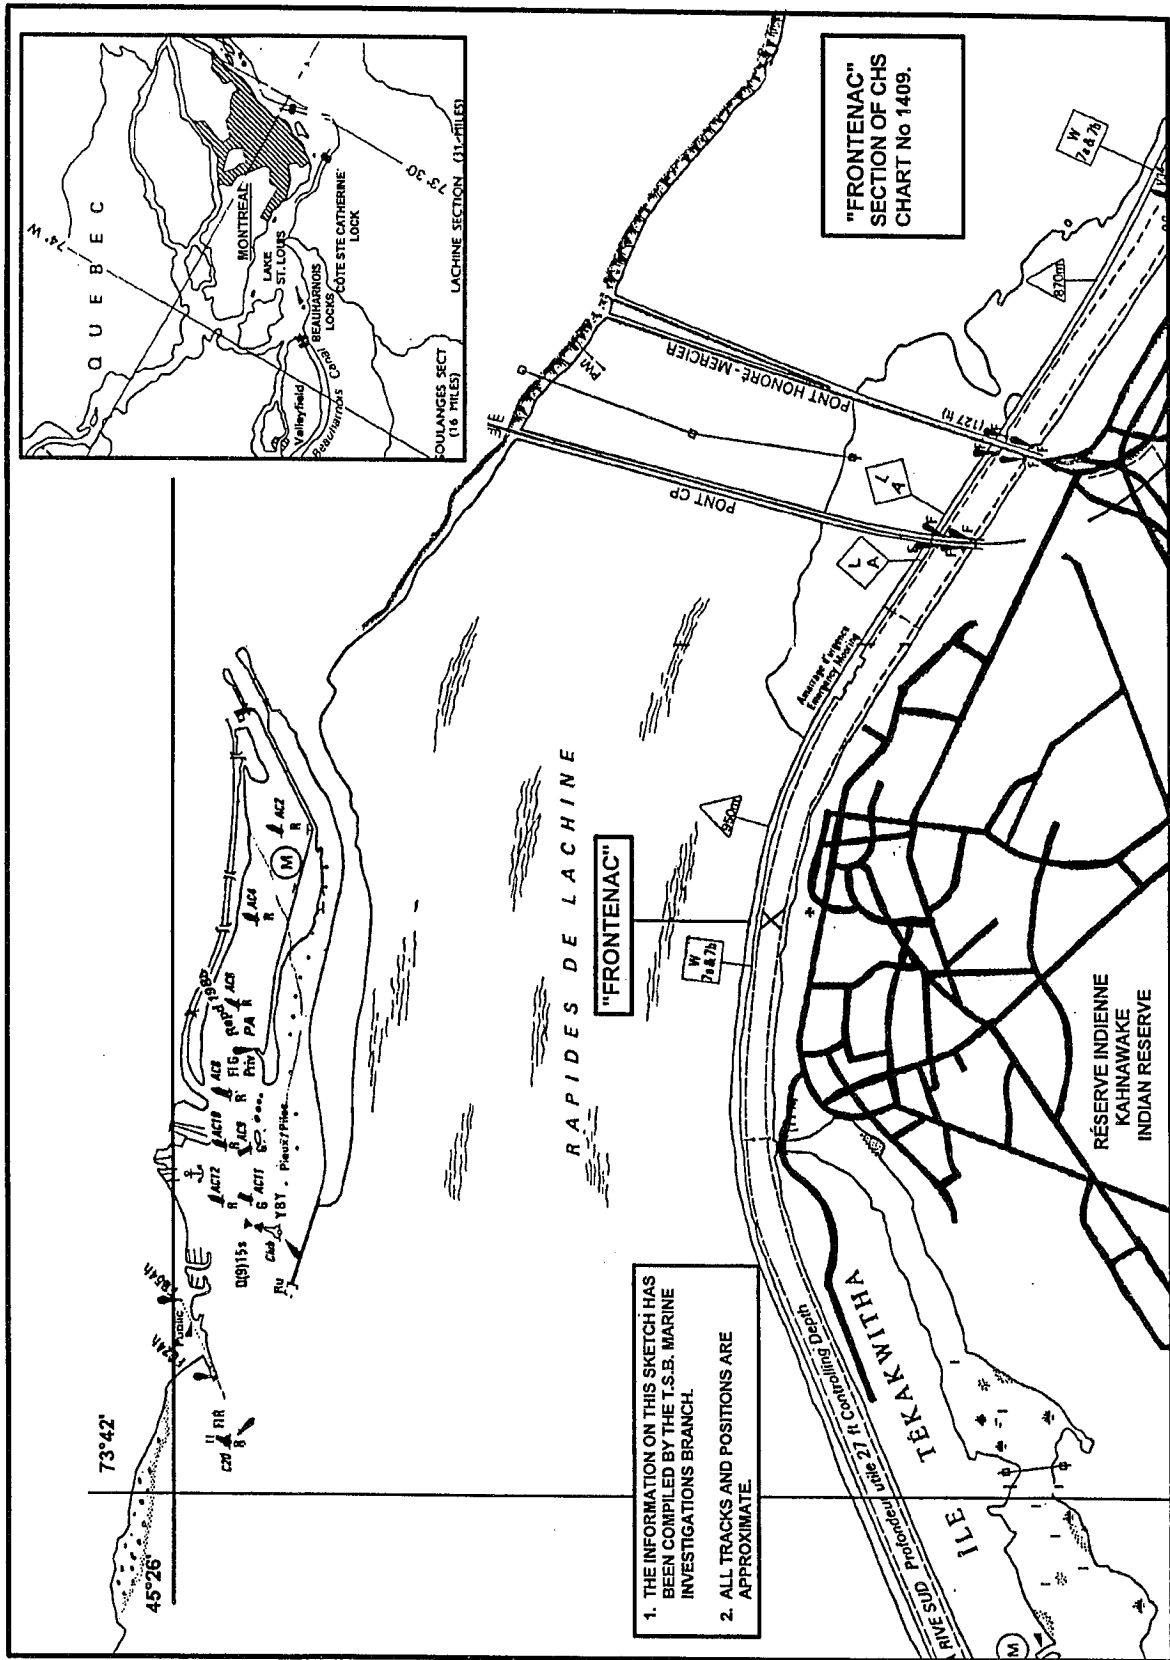
Appendix A - Sketch of the Occurrence Area

At about 0235, the pitch of the propeller was set to neutral. As the "FRONTENAC" was in a narrow passage in the canal, the bridge team had to try to steer the vessel using the anchors and the bow thruster. These manoeuvres, however, were not enough to keep the vessel in the centre of the canal, and at 0240, the "FRONTENAC" struck the concrete wall bordering the southern edge of the canal. Temporary repairs were carried out to enable the vessel to clear the Seaway and proceed to destination. Shipping was disrupted in the Canal de la Rive Sud for nine and a half hours.

In the canals of the Seaway, when a vessel is unable to reach a berth, it is virtually impossible to stop without striking one of the sides of the canal. The main engine had to be stopped because of engine problems when the "FRONTENAC" was in a confined section of the Canal de la Rive Sud and, therefore, the vessel was unable to avoid striking the wall of the canal.

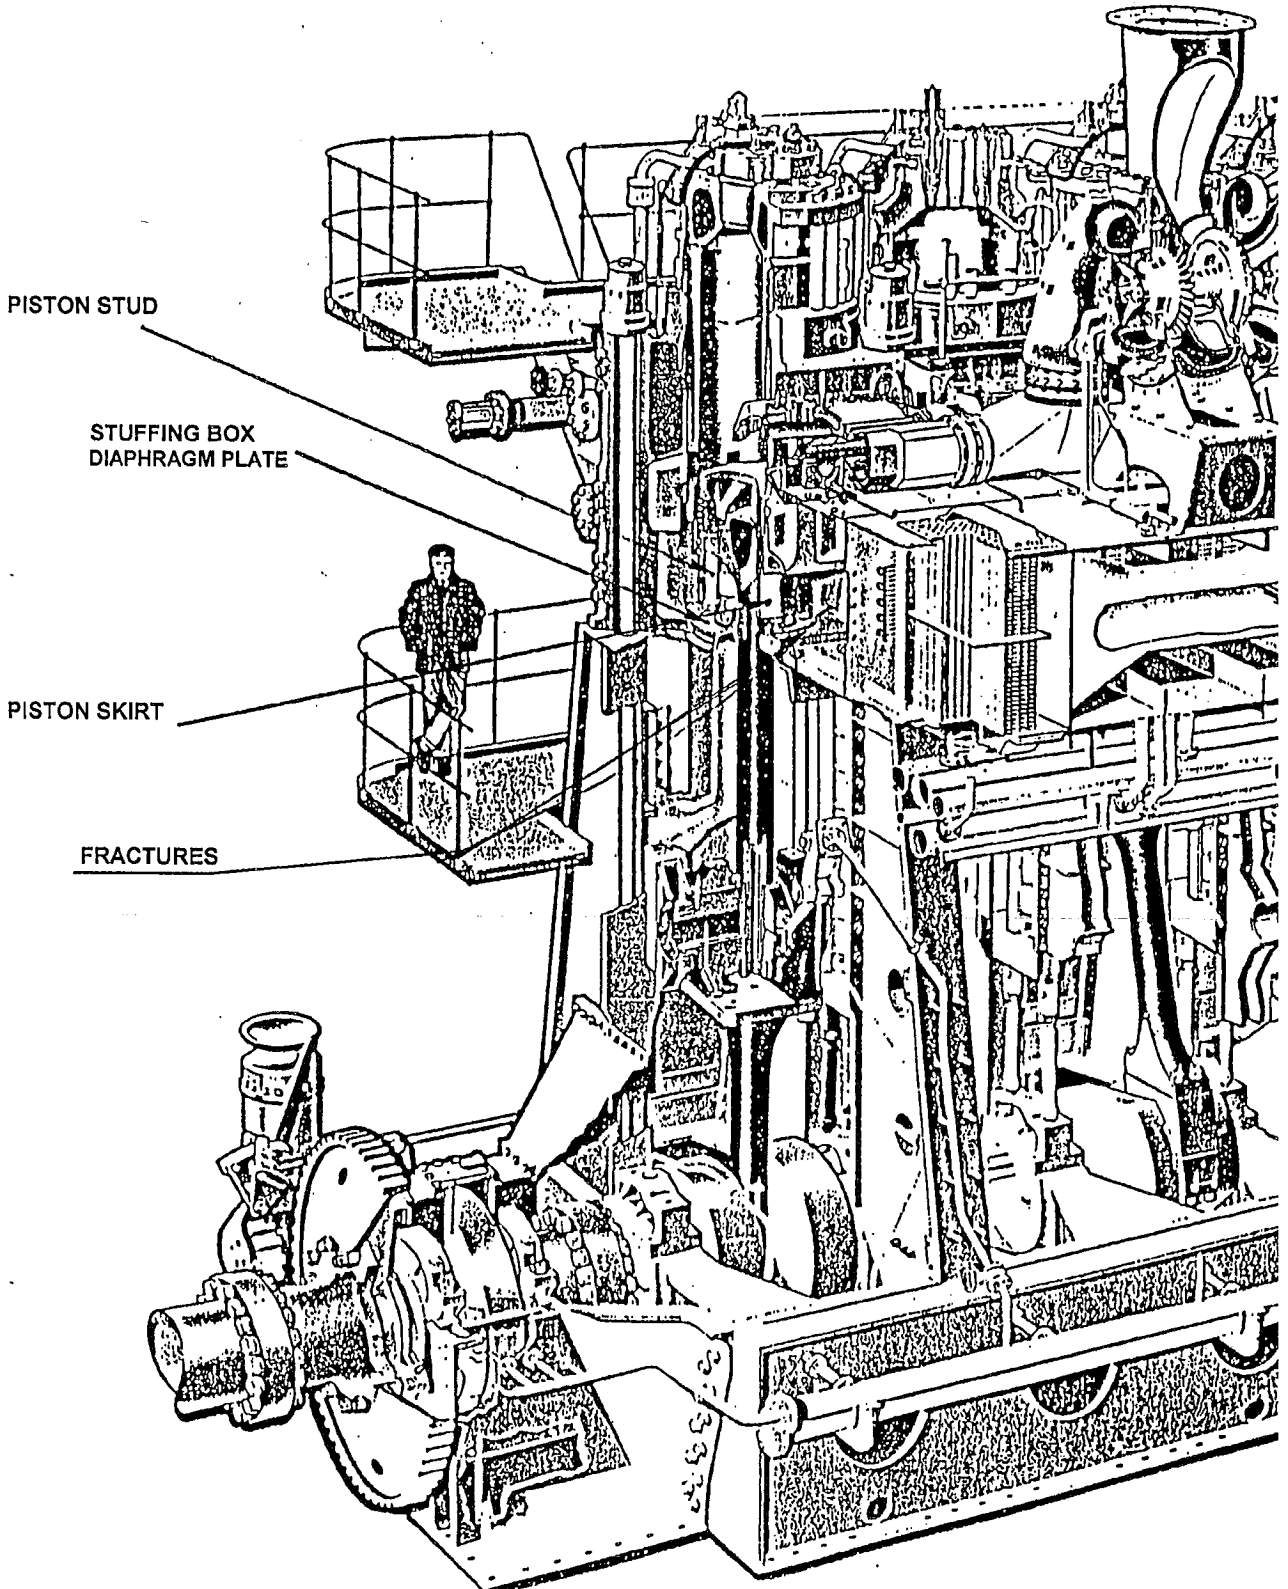
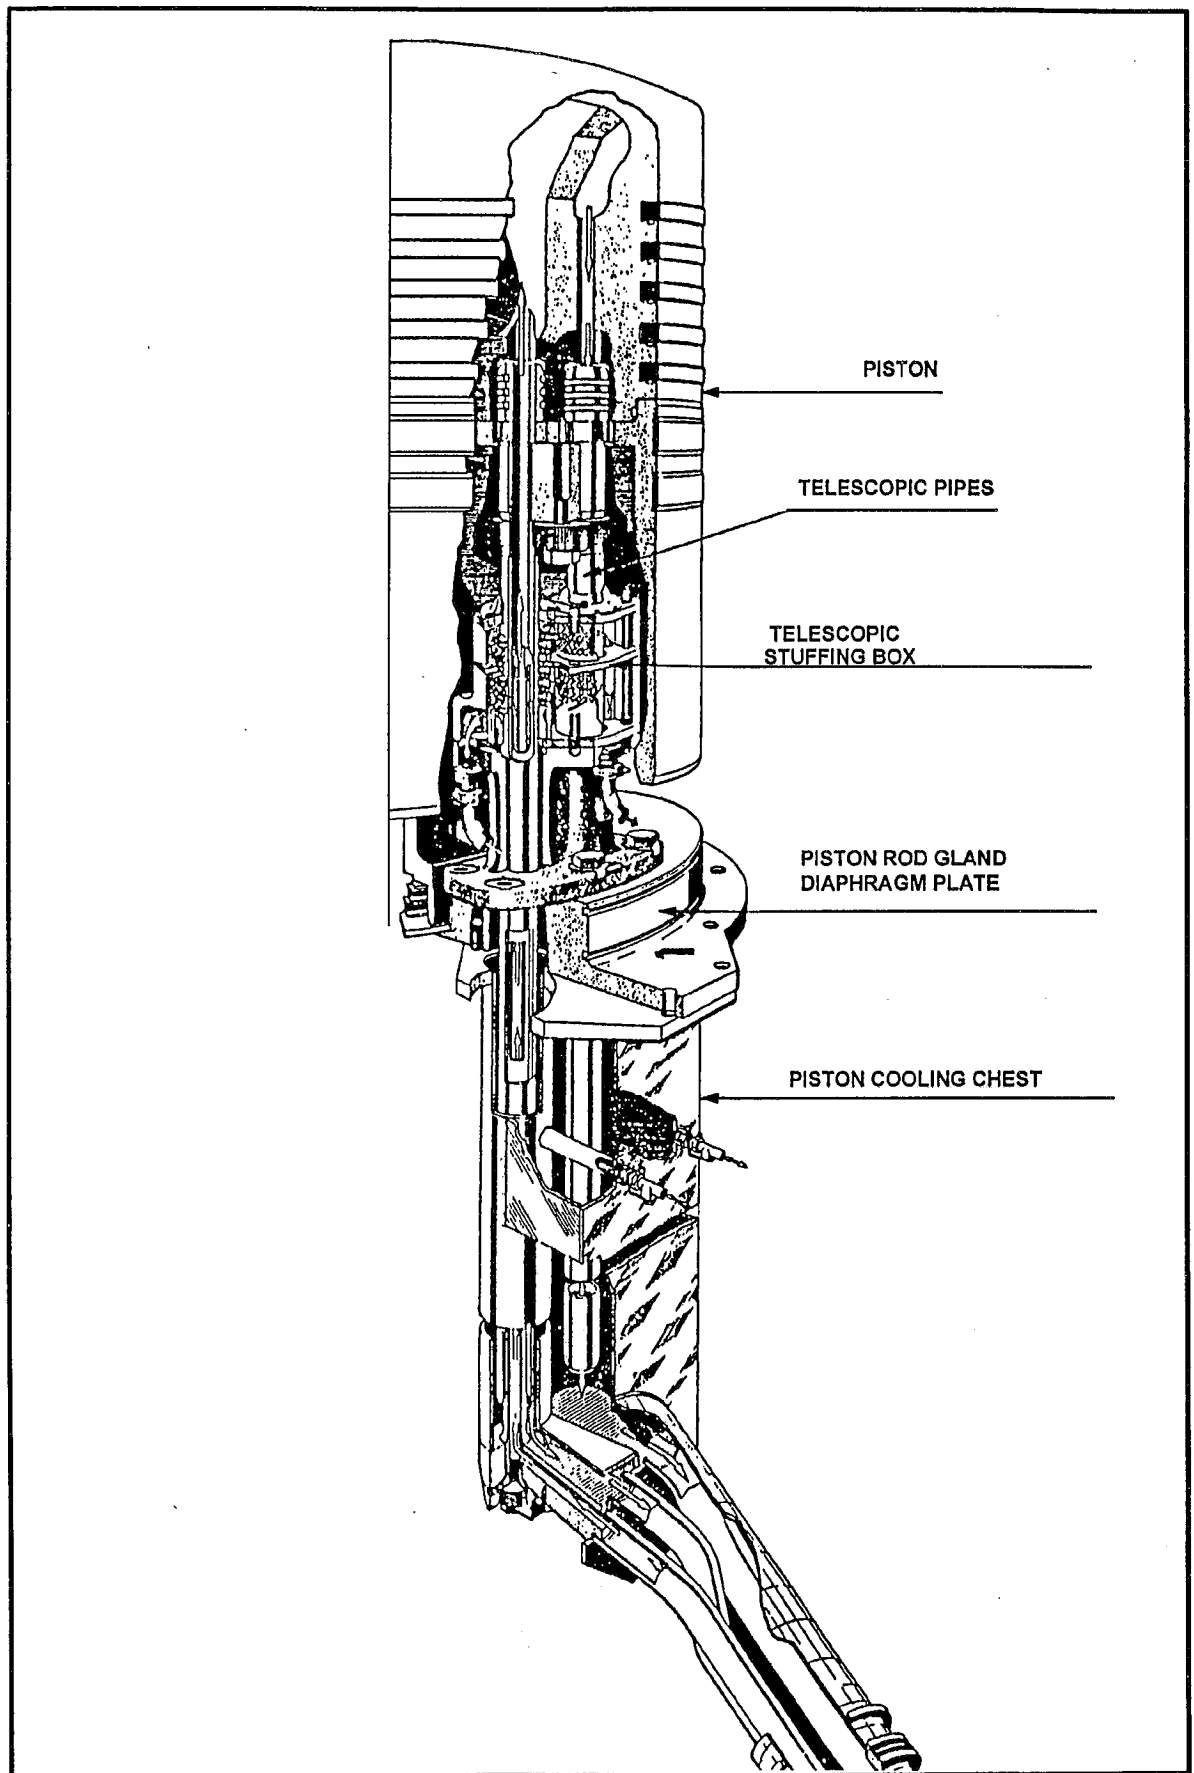
Appendix B - Main Engine Parts

When the vessel reached Hamilton, it was discovered that the preassembled spare unit used for the temporary repairs had a machining defect. The lower part of the piston, called the skirt, had not been machined precisely. There was insufficient clearance between the inside of the skirt and the stuffing box of the telescopic pipes (see Appendix B). This preassembled unit was not a part from the manufacturer (Sulzer).

Because of the machining defect of the spare part used for the temporary repairs, the No. 3 unit piston made contact with the telescopic stuffing box. The vessel proceeded to destination in this condition. The repeated hammering by the piston moved the parts out of alignment and probably caused further damage. It should be noted that the bottom of the stuffing box is situated inside the crankcase.

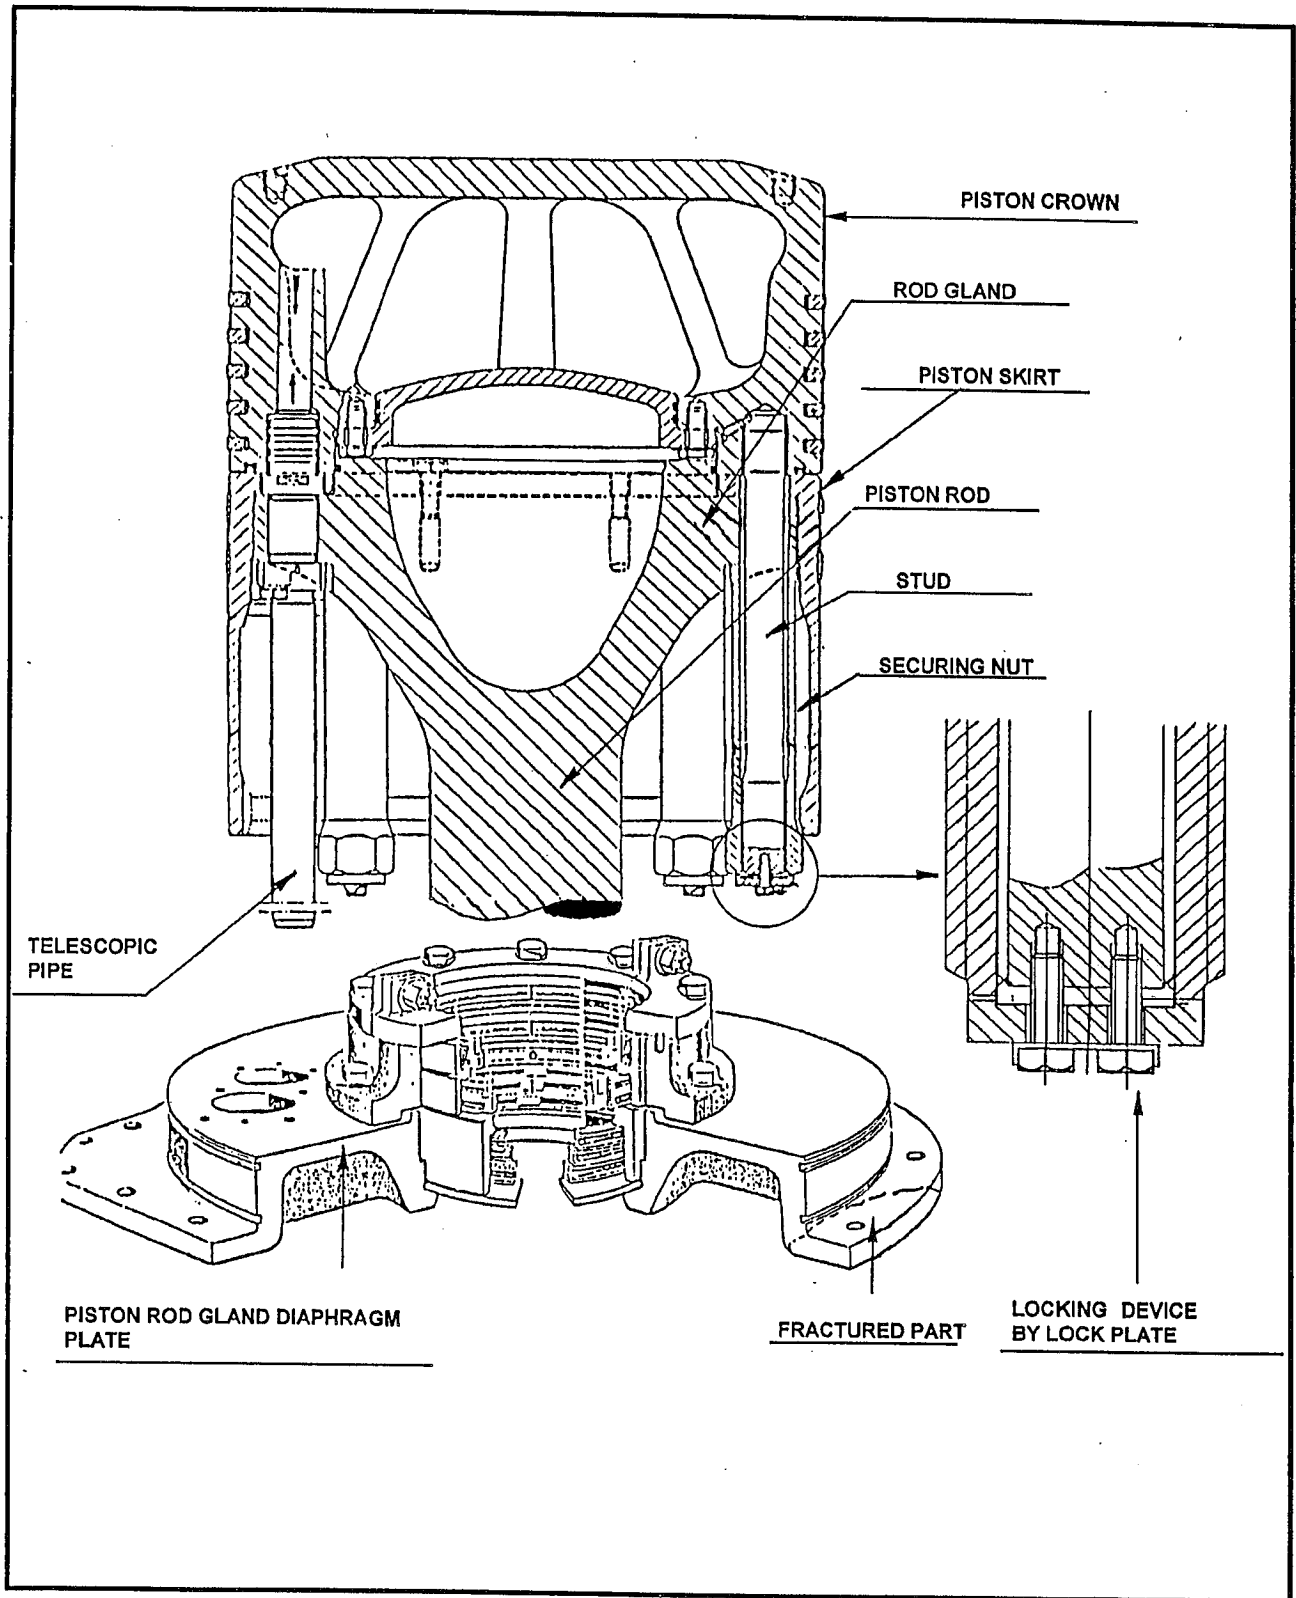
Appendix C - Sketch of the Faulty Unit

The engine problems began with a knocking in way of the No. 3 unit, which worried the engineer of the watch. When the engine was stopped and inspected, a piston stud securing nut was found to have backed off. It was hitting against the piston rod gland diaphragm plate whenever it reached bottom dead centre. The piston rod gland diaphragm plate fractured as a result of this repeated hammering by the loosened nut.

A preassembled unit comprising the piston and piston rod was installed to replace the defective parts. However, no spare was available for the piston rod gland diaphragm plate (see Appendix C). After consultation with a specialized firm, it was agreed to cut the fuel supply to the faulty cylinder and complete the voyage.

The engine problems resulted from one of the piston stud securing nuts of the No. 3 unit "backing off" and hammering against the piston rod gland diaphragm plate, which eventually fractured.

One of the repairs consisted in the remachining of the piston rod palm (upper part). Some 0.5 mm (0.020") was removed to correct the surface of the palm. This part had suffered some distortion over the years, and it had become impossible to properly adjust the unit comprising the piston crown, skirt and rod. As a result of the movement between these parts, the locking device of one of the piston securing nuts apparently failed. Without the locking device, the piston securing nuts can back off, and this appears to be what happened in this occurrence. The thread of the two bolts holding the lock plate of the locking device were found to have been stripped.
