## Marine Occurrence Report

### Man Overboard

Scallop Dragger "THE PAMELA & JENELLE L."  
Northumberland Strait, Prince Edward Island  
29 October 1993

Report Number M93M0007

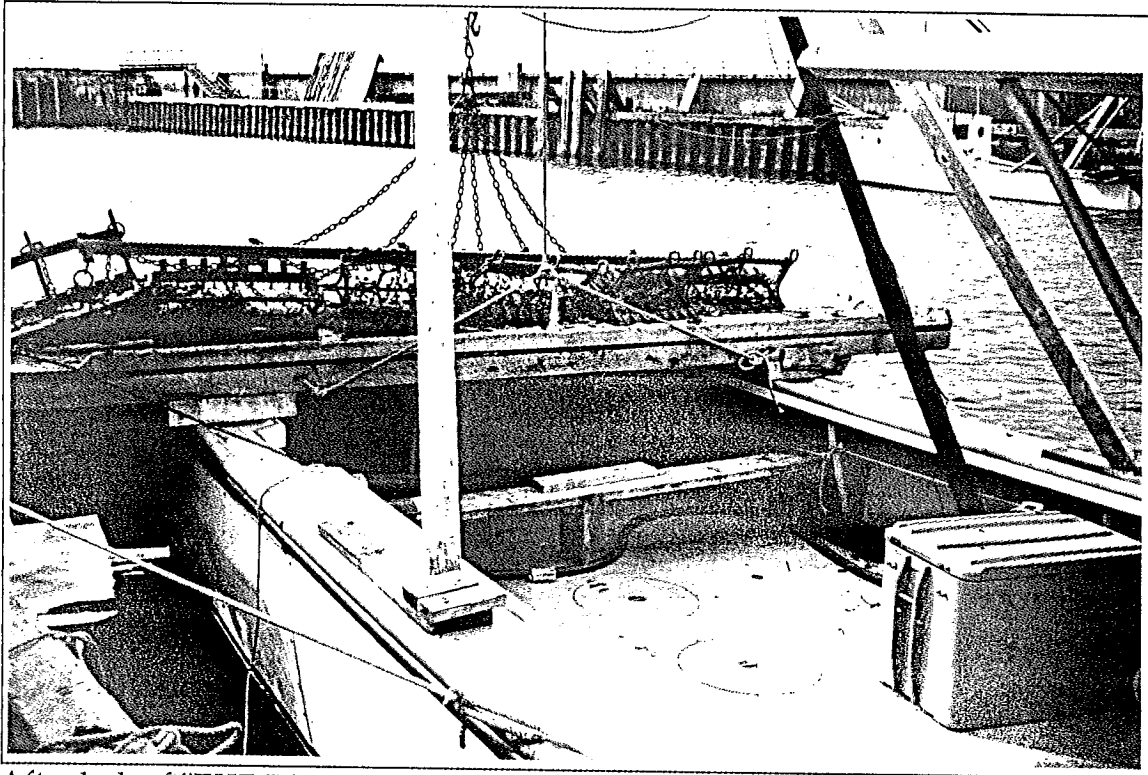
Afterdeck of "THE PAMELA & JENELLE L."

Note: Scallop rake stowed  
Lifebuoy on bench
