Marine Occurrence Report

Swamping and Foundering

Fishing Vessel "WHISKEY JACK"
off Fan Island, British Columbia
11 May 1993

Report Number M93W0004

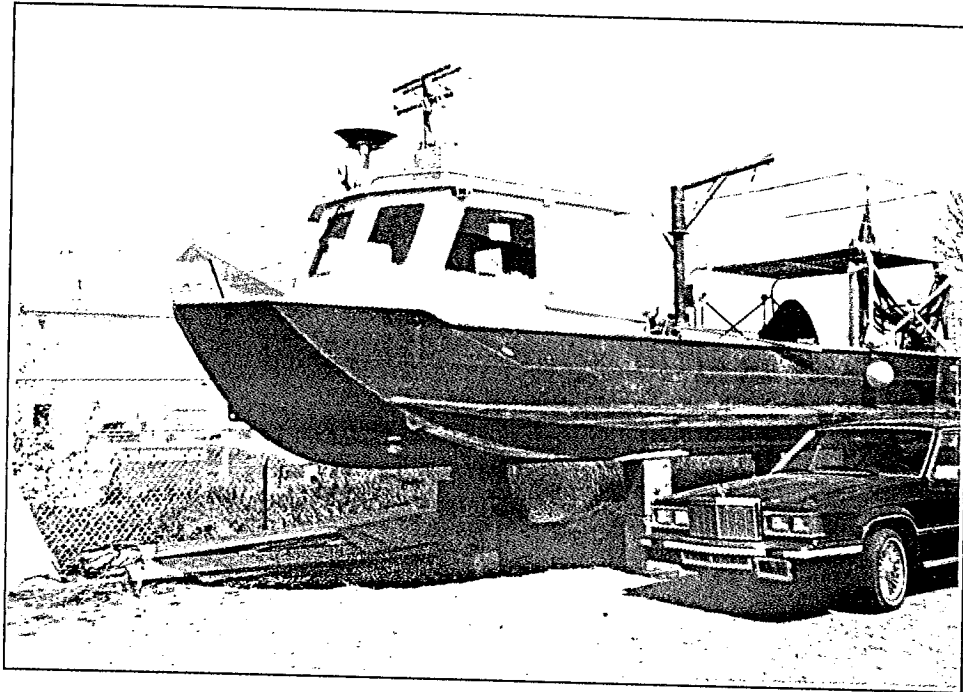
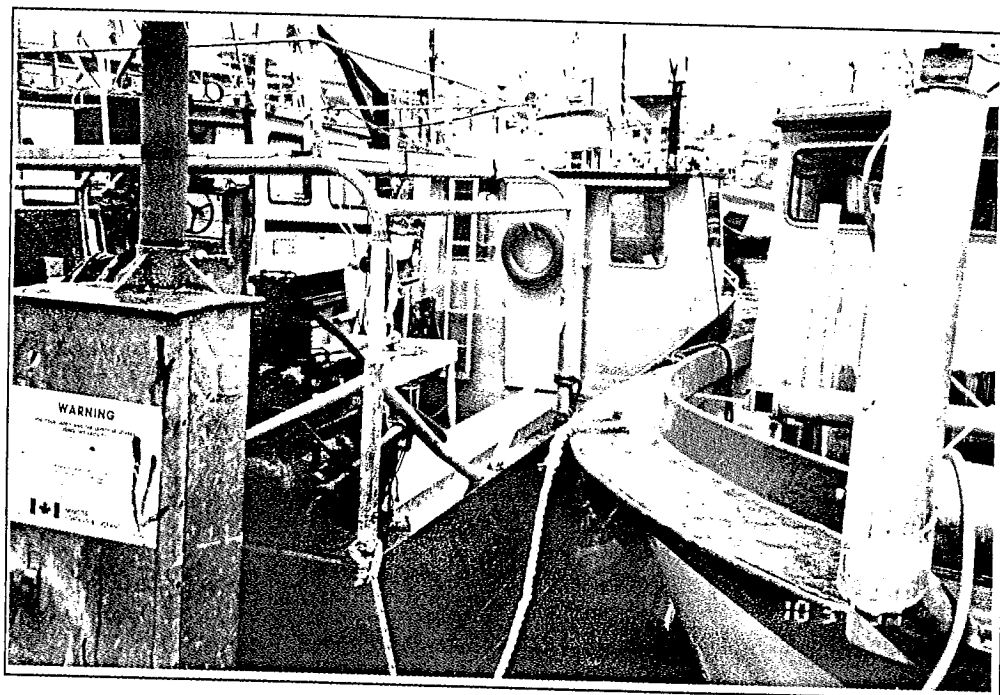
"WHISKEY JACK", January 1992

Free-surface effect of any liquid would have a detrimental effect on the intact stability characteristics of the vessel. However, photographs show that the engine compartment was much smaller than the full width of the well deck and, consequently, free-surface effect would be a relatively minor factor in the event of the engine compartment and/or well deck becoming partially flooded.
