## Marine Occurrence Report

### Crew Injury

Fishing Vessel "MONIKA"  
Fitz Hugh Sound, British Columbia  
22 October 1993

Report Number M93W0010

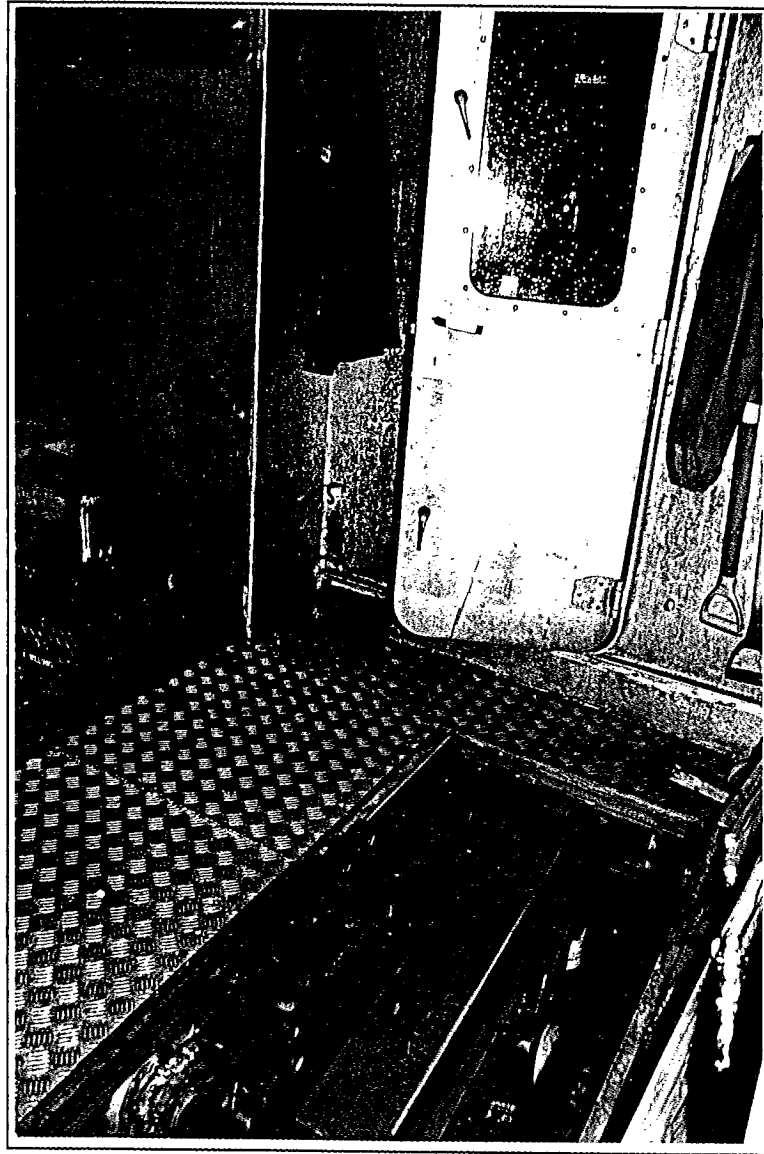
Engine compartment abaft wheel-house, hatch open.

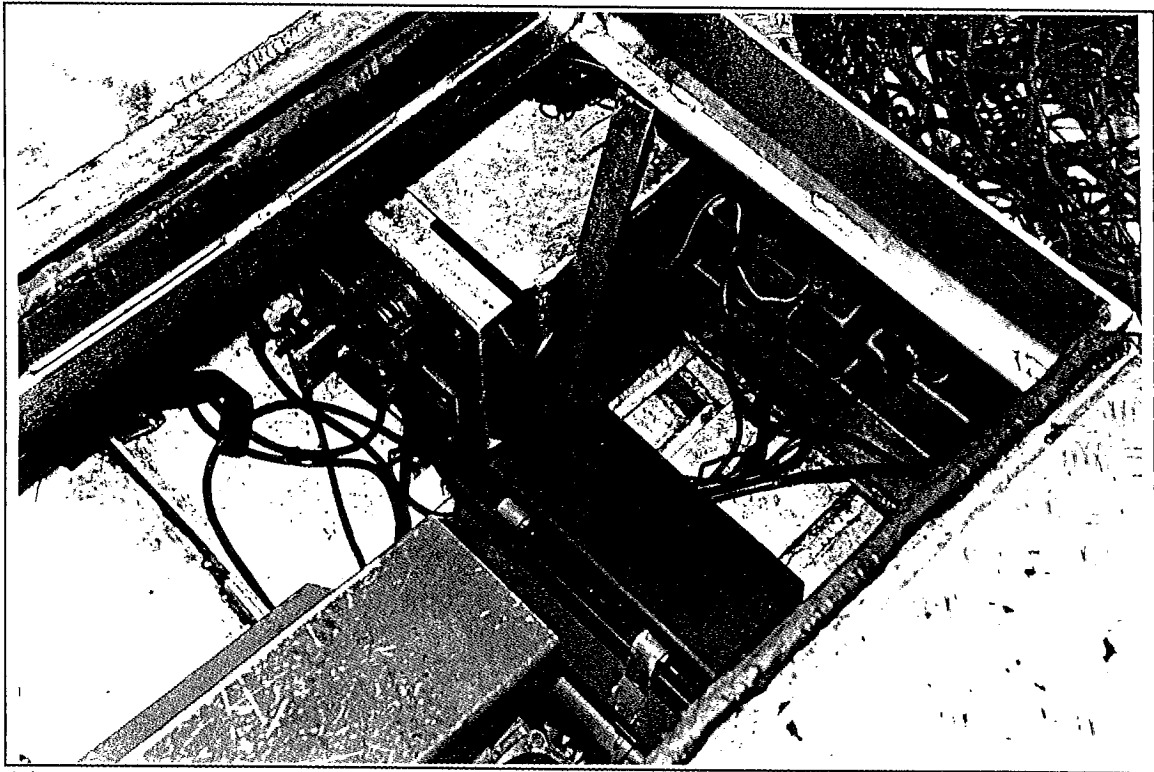
Propeller Shaft

There is not enough space in the engine compartment to fit deck plates to provide a level surface on which to stand. The interior of the sloping hull plating, which also serves as a bilge area, is smooth. Oil vapours from the engine and residual oil in the bilge make the hull plating slippery. Because the propeller shaft coupling was not guarded and the plating was slick, the engine compartment was a hazardous area in which to stand or move, particularly in rubber-soled running shoes. The vessel was certainly moving in the seas, adding to the operator's difficulties in maintaining his footing.

After end of engine compartment
