MARINE OCCURRENCE REPORT

M96L0069

FATAL ACCIDENT

INVOLVING A TOW TRUCK  
ABOARD THE FERRY "CAMILLE MARCOUX"  
BAIE-COMEAU TERMINAL, QUEBEC  
09 JULY 1996

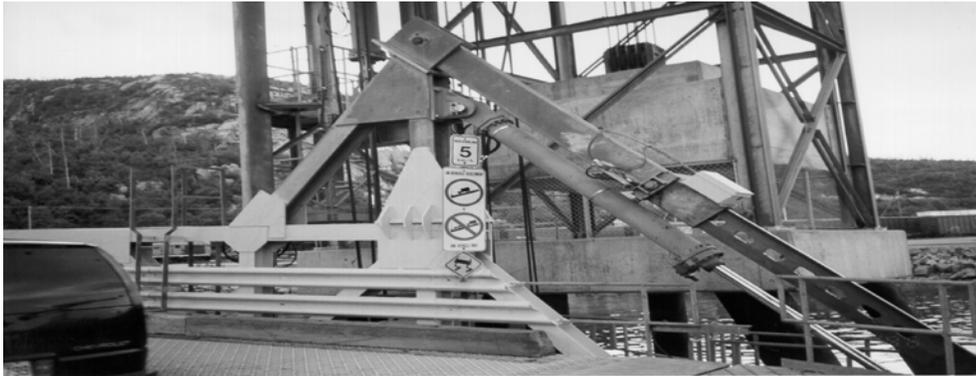
*Appendix  
B - Sketch  
of the  
Loading  
Ramp*

*According to eyewitnesses, the tow truck backed onto the apron at a speed exceeding the 5 km/h limit indicated on the traffic sign posted at the ferry exit.*

**View of the traffic signs posted at the entrance/exit of the loading ramp at Baie-Comeau, Quebec.  
The top sign indicates the speed limit for vehicles using the ramp.**

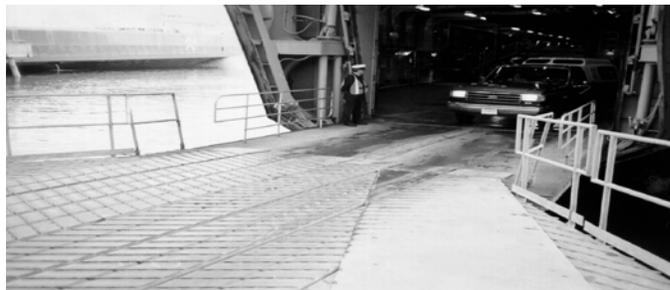
At the vessel end, the loading ramp extends into a hinged apron that rests on the bow ramp of the vessel. The apron is narrower than the loading ramp, and this section does not have a separate pedestrian lane.

**View of the exit through the bow visor of the CAMILLE MARCOUX.  
The photo was taken from the designated pedestrian lane on the ramp,  
looking toward the parking deck.**

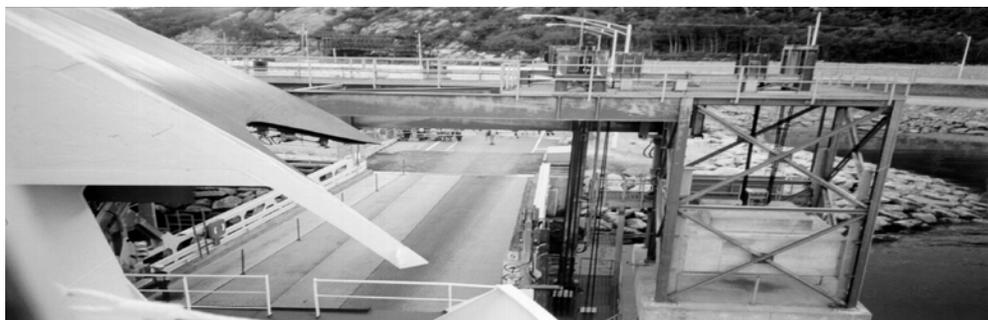
The loading ramp is hinged at the shore end to allow adjustment for the height of the tide. The pedestrian lane is roped off along the edge of the ramp and is covered with a non-slip mat.

**General view of the loading ramp at Baie-Comeau.  
The designated pedestrian lane along the ramp can be seen on the left.**

Since then, the operators of the Matane-North Shore route acknowledged the coroner's recommendations, and stated that they have already implemented them in part. At the Matane and the Baie-Comeau terminals, work has begun on a ramp to provide pedestrians with a direct access to the vessel that is separate from the vehicle ramp.
