MARINE INVESTIGATION REPORT

M97M0141

FALL FROM PILOT LADDER

BULK CARRIER "ATLANTIC ERIE"

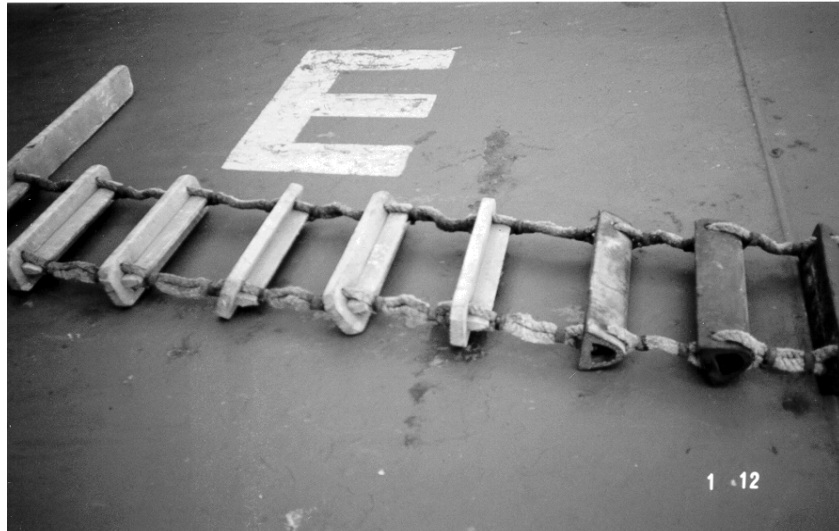
- The side ropes, the steps, and the batten of the pilot ladder were in a satisfactory condition.
- The steps of the pilot ladder were at various angles such that the ladder did not provide consistently horizontal surfaces.
- The lowest batten on the ladder was in line with the ninth step from the bottom.

The stowage of the ladder during loading operations subjected it to gypsum dust, although this is not considered to have been a factor in this occurrence. The location of the lowest batten indicates that the construction of the pilot ladder was not in accordance with regulatory guidelines. However, this is not considered to have been a contributing factor in this occurrence.

The pilot ladder that was used to disembark the pilot at Sydney 03 November 1997.

LOWER SECTION OF PILOT LADDER WITH THREE BOTTOM STEPS OF HARD RUBBER OF COMPARABLE STRENGTH OF HARDWOOD. NOTE STEPS AT VARIOUS ANGLES DUE TO SLACK CRIMPING. THE LOWEST BATTEN IS AT THE NINTH STEP INSTEAD OF FIFTH.

- The pilot boarding area was moved to midships.
- A chafing bar was installed at the sheer strake.
- Steel lug support brackets have been installed to facilitate four-point ladder fastening.
- The ship's pilot ladders have been replaced with ladders of better quality.

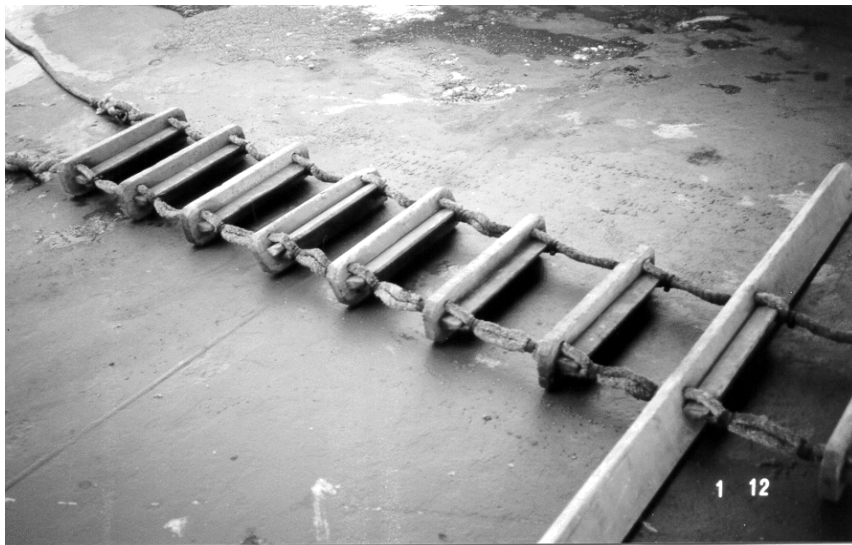
UPPER SECTION OF LADDER WITH STEPS AT VARIOUS ANGLES.
