MARINE INVESTIGATION REPORT

M99C0027

GROUNDING

PRODUCT CARRIER "SUNNY BLOSSOM"

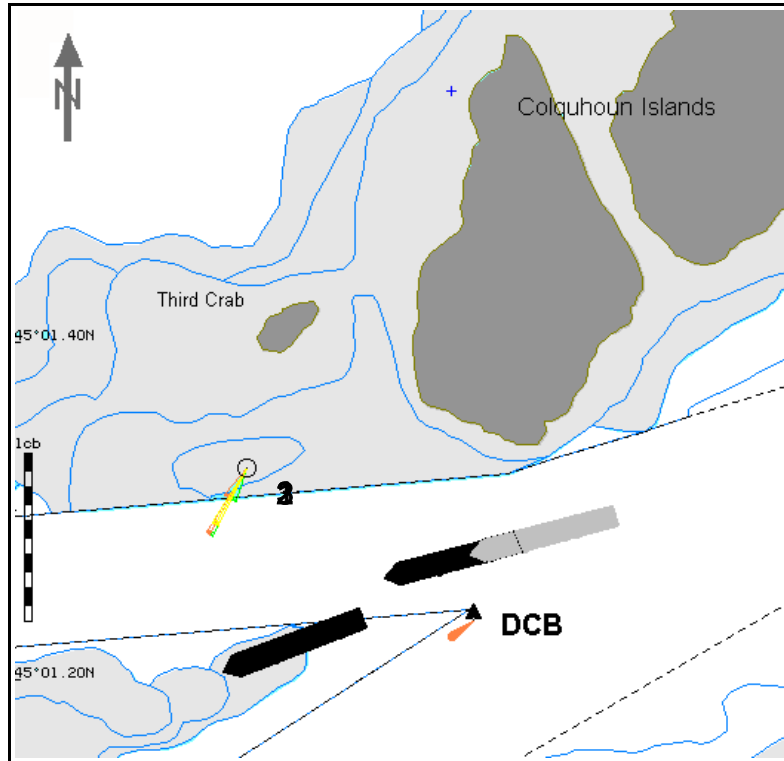
⁴ See position No. 3, Sketch 1 and Appendix A.

Notwithstanding the differences of opinion on why the helm was put to port, all those on the bridge agreed that the vessel went aground as a result of the helm being put over to port instead of to starboard, and that this occurred at a critical time during the course alteration. Between the time that the helm was put to port, about 1154, and the movement of the vessel to port, some time elapsed.⁵ It is estimated that the “SUNNY BLOSSOM” would have taken about 25 seconds to start its swing to port from the time that the initial helm order was given. At 8 knots, the distance covered would have been about 103 m. From the position at 1154, the 103 m covered on a course of 255°(G) would have placed the vessel in an unrecoverable position, given that the rudder was at this time 20 degrees to port with the engine full ahead and a port swing started, and notwithstanding a current setting at 060°(T) at this position.⁶

⁵ See Sketch No. 1, position 1.

⁶ See Sketch No. 1, position 2.

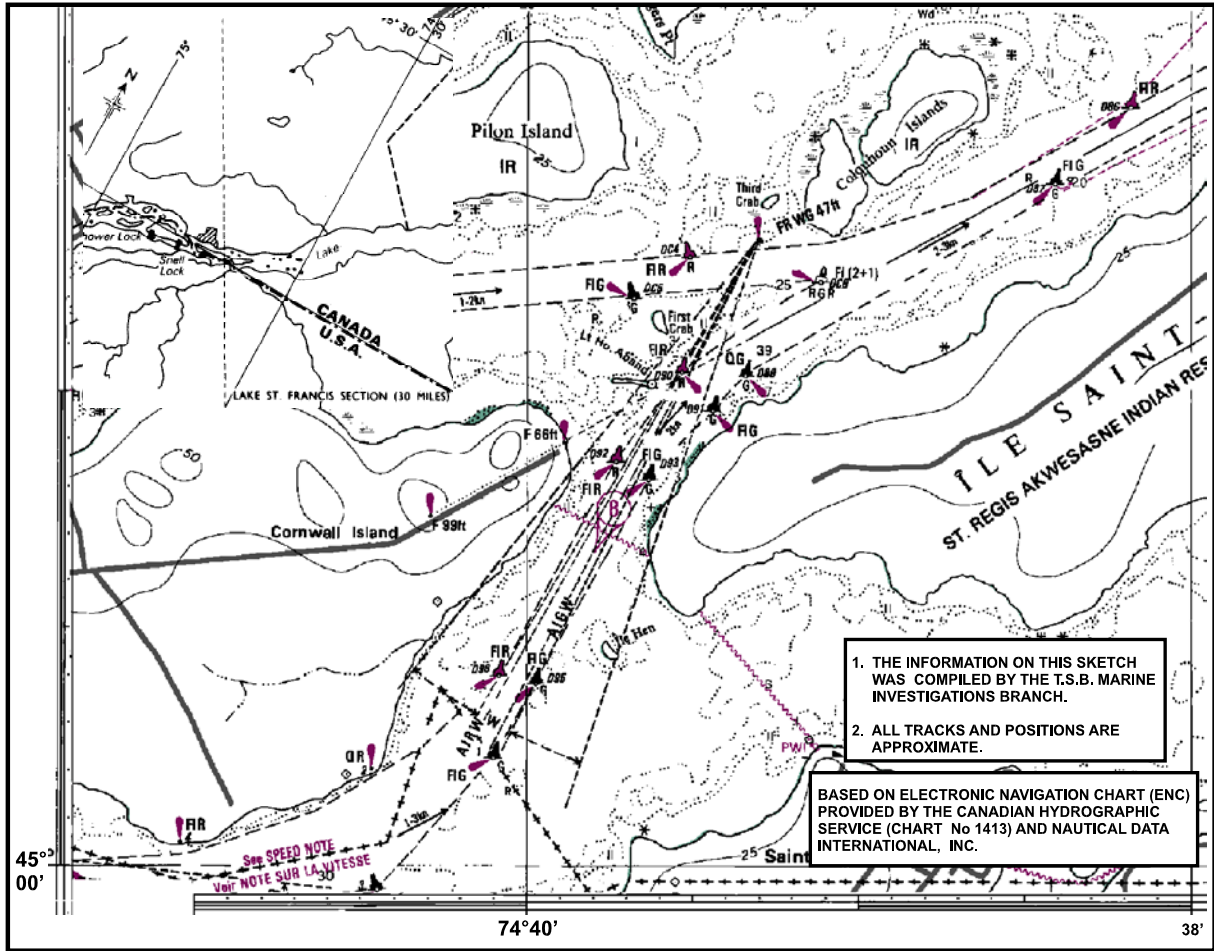
Appendix A - Sketch of the Occurrence Area

The "SUNNY BLOSSOM" ran aground on the south bank of the Cornwall channel when, at a critical moment of an alteration of course to starboard, the helm was put to port.

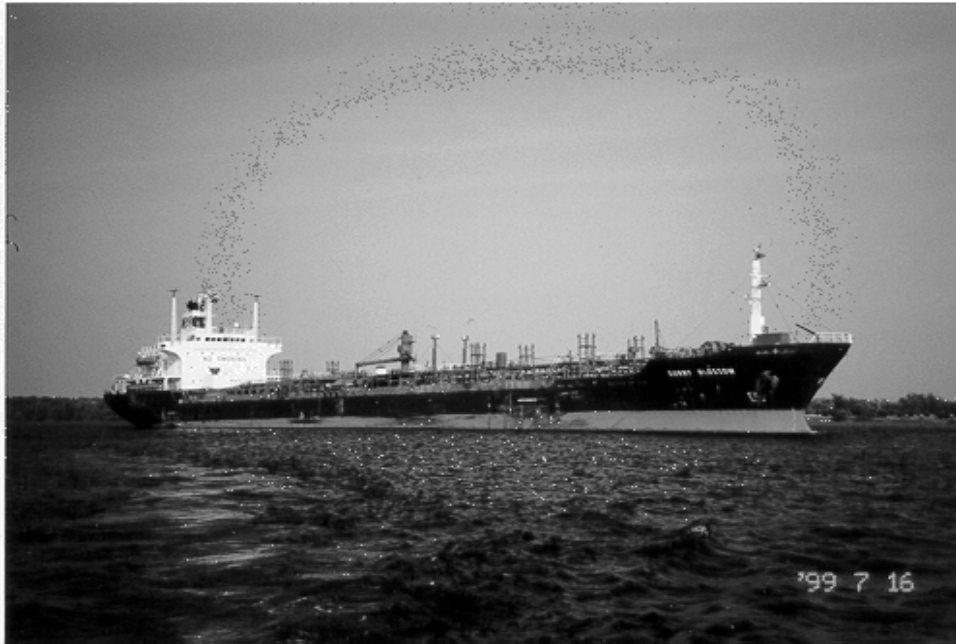
"SUNNY BLOSSOM" AGROUND OUTSIDE THE CORNWALL CHANNEL

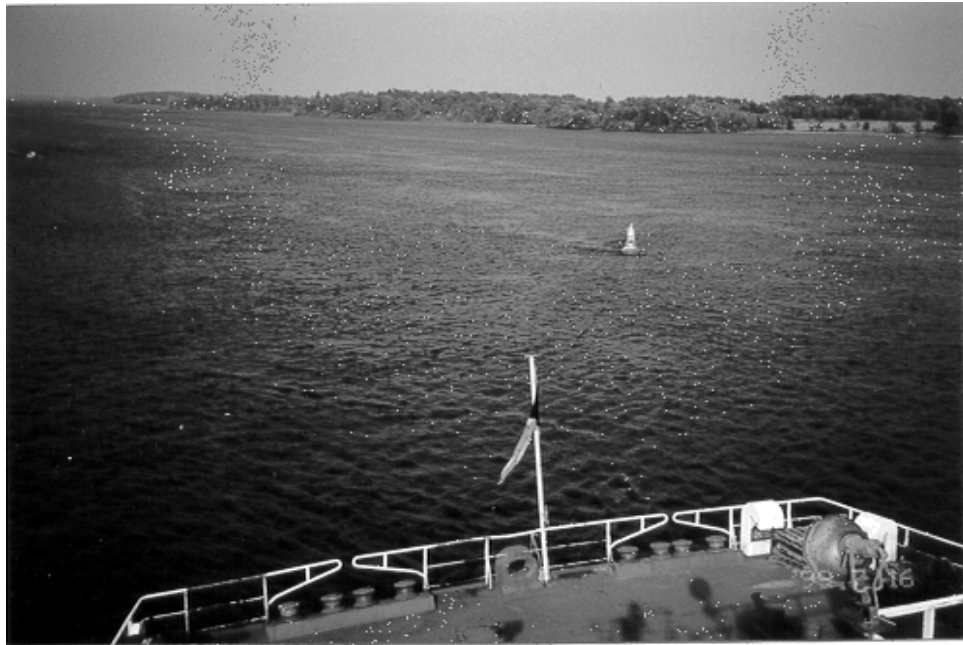
BUOY DCB OFF THE PORT QUARTER
