MARINE INVESTIGATION REPORT (AMENDED)

M99F0042

STRIKING OF A DOCK WITH AN UNLOADING BOOM

THE SELF-UNLOADING BULK CARRIER "ALGOBAY"
POE LOCK, SAULT STE. MARIE, MICHIGAN, UNITED STATES

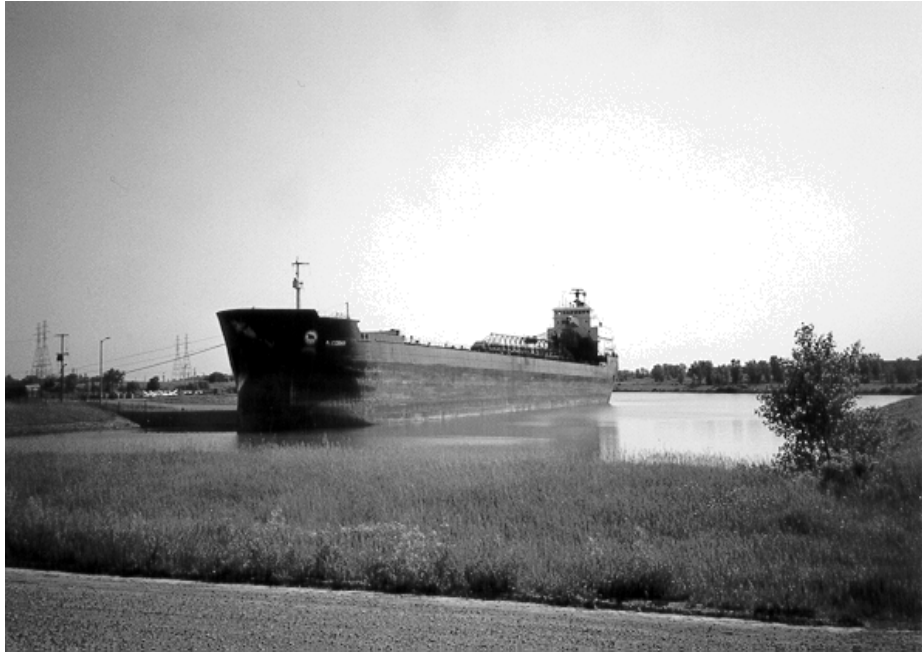
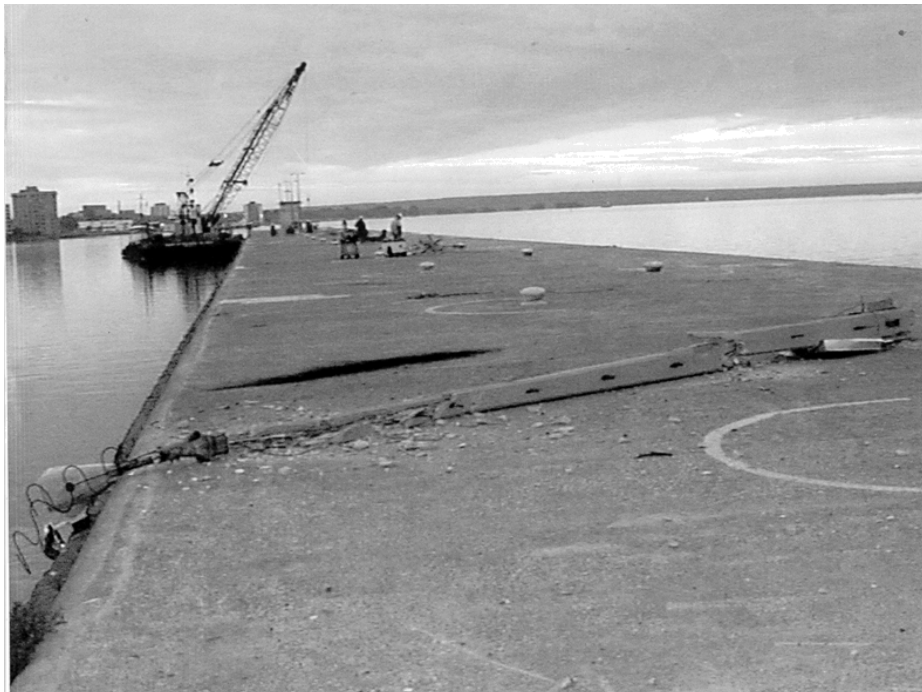
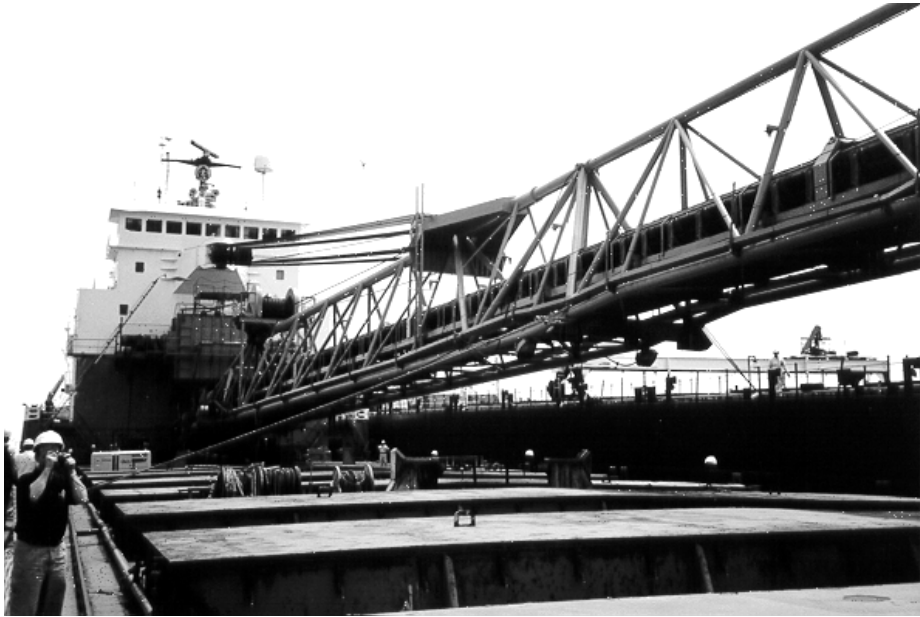
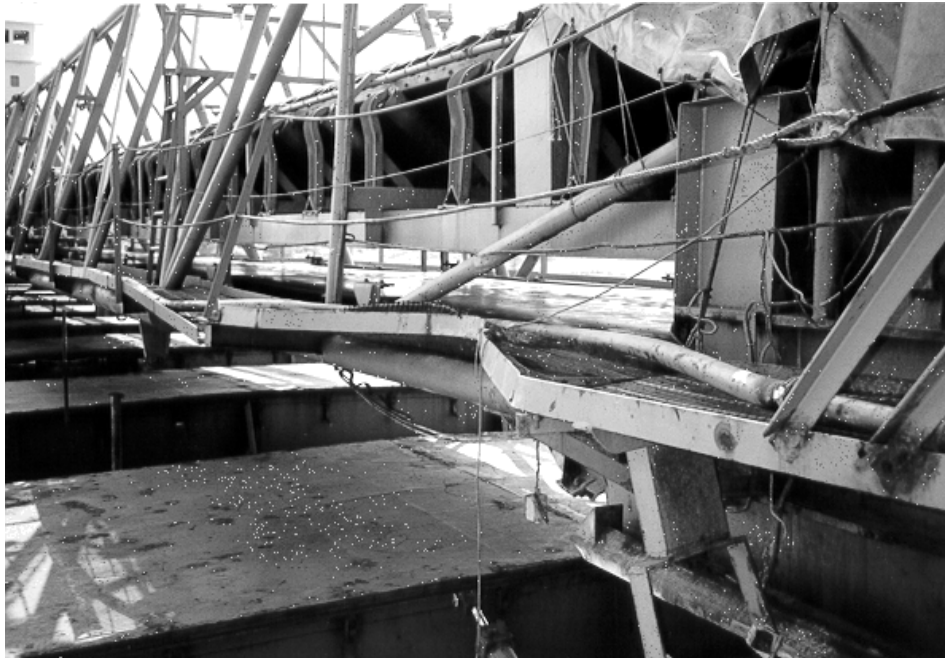
Appendix B - Photographs

Five light standards on the approach wharf were knocked down and damaged.

The unloading boom suffered extensive damage to its port forward and starboard after slewing cylinders when air trapped in the hydraulic slewing rams compressed and fractured the cylinders. The unloading hopper was damaged, as were the starboard catwalk and lower longitudinal, which were set in at the point of contact with the light standards.
