MARINE INVESTIGATION REPORT

M99L0099

PILOT OVERBOARD

WHILE DISEMBARKING FROM THE
CONTAINER SHIP "CANMAR VALOUR"
APPROACHING THE
LES ESCOUMINS PILOT STATION, QUEBEC
25 SEPTEMBER 1999

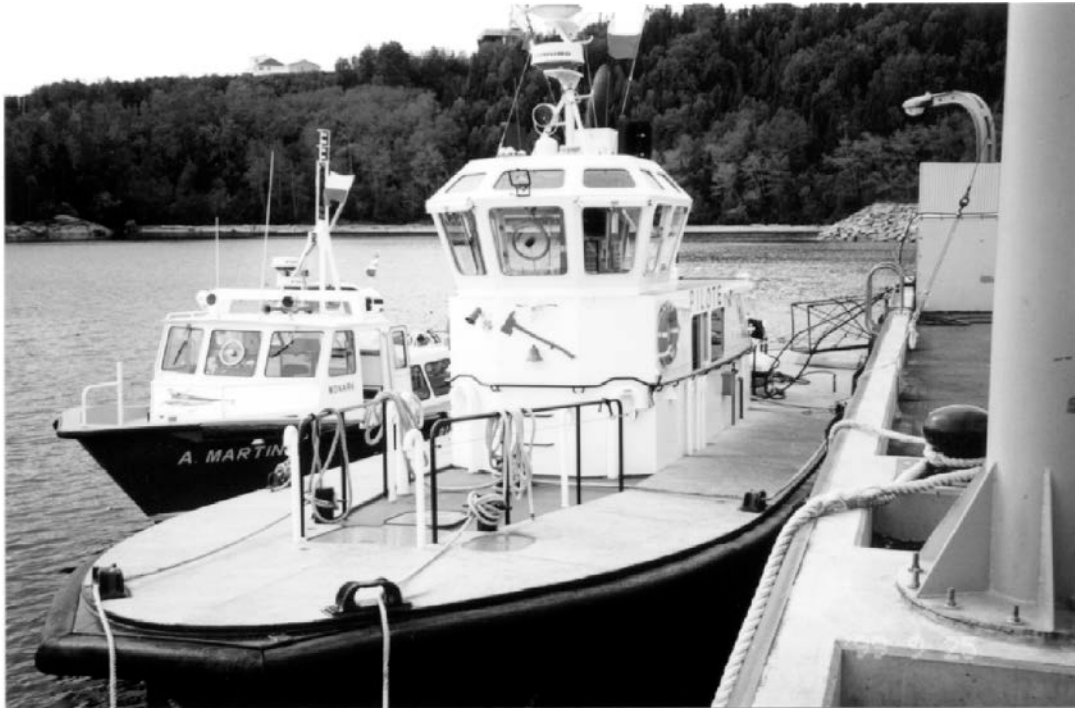
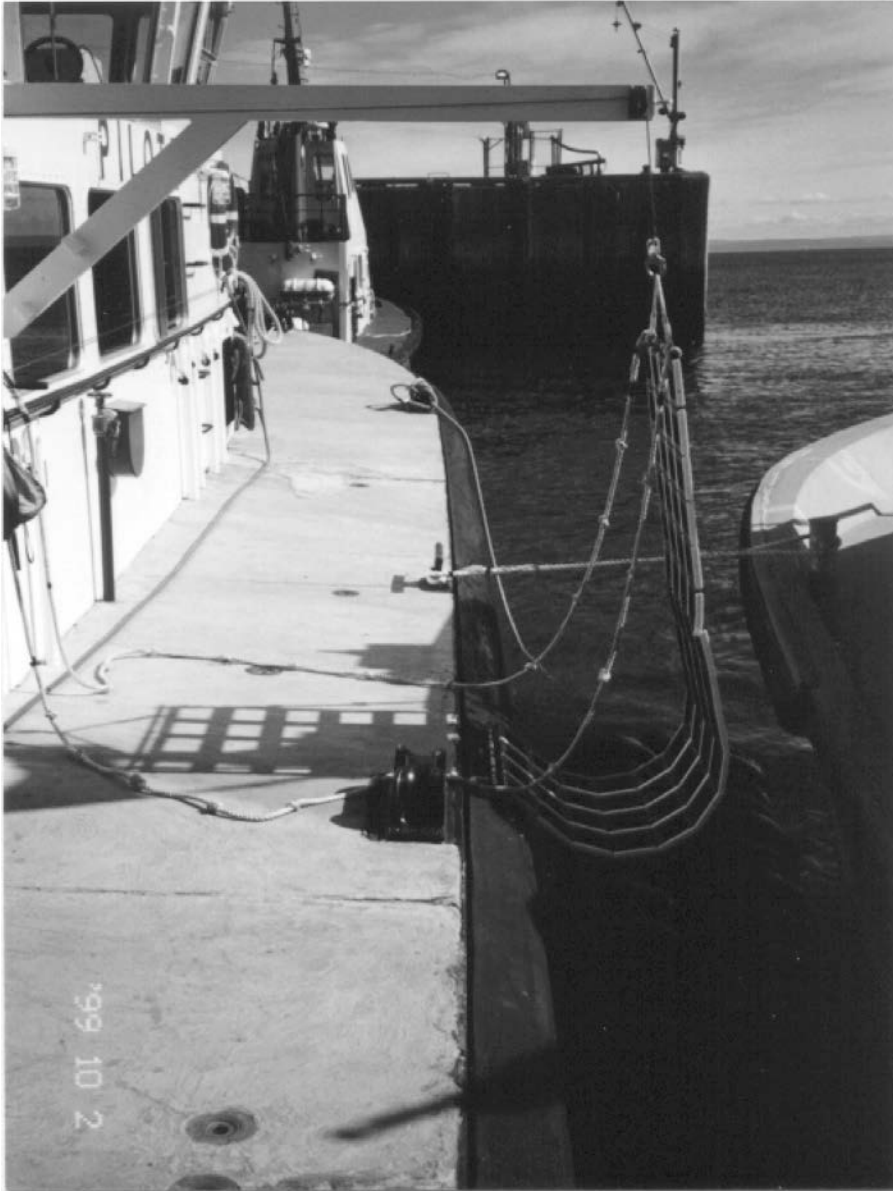
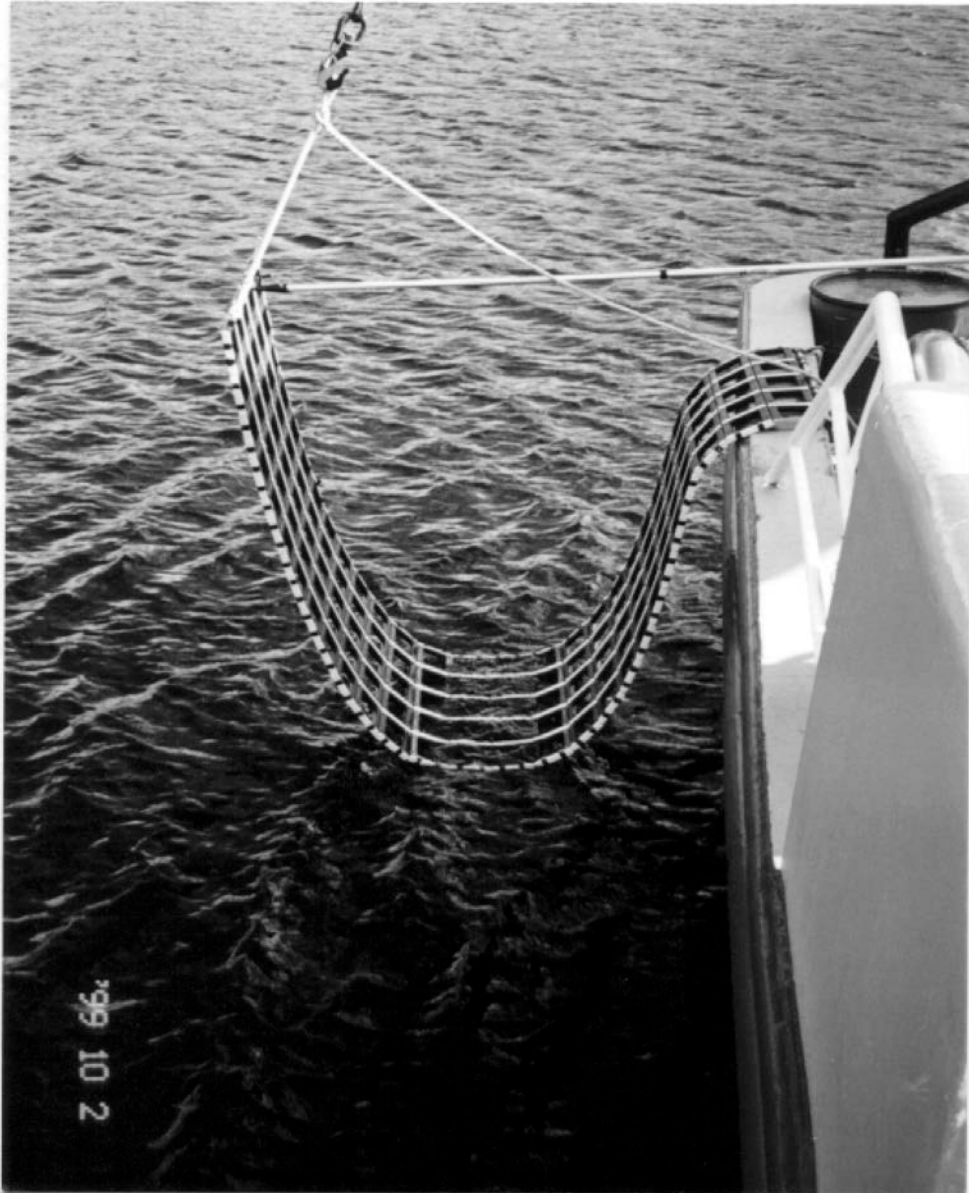
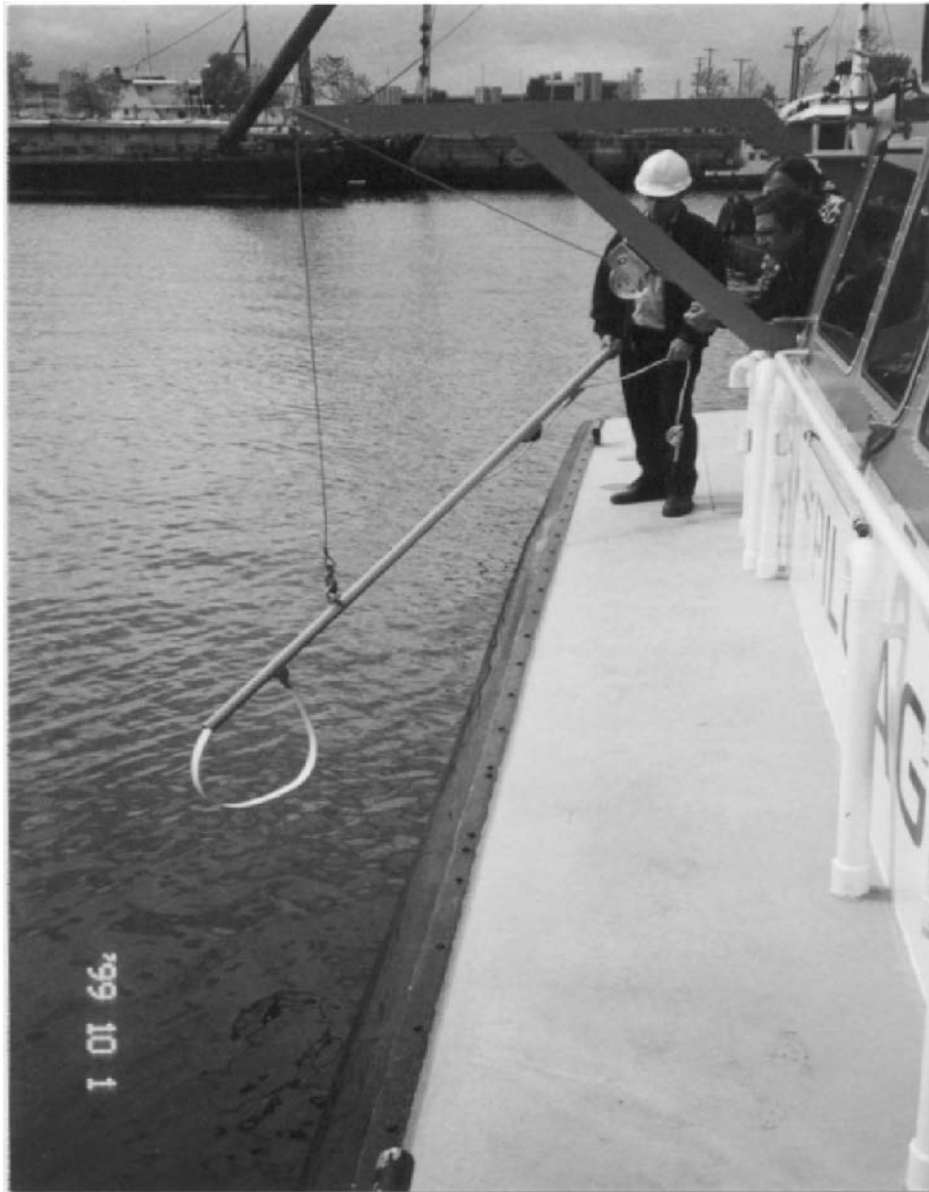
Appendix A – Photographs

A Jason’s cradle (articulated ladder) was installed on the deck of the “CHARLEVOIX”, and the manoeuvres to rescue the pilot began. Since the pilot boat operator cannot execute the manoeuvres by himself from the bridge, engine orders were given to the engineer by headphone, and he executed them manually from the engine compartment. The pilot boat was able to get close to the pilot. A boat hook was used to reach out to the pilot and pull him in close to the aft port side. Since he could not be held in place because of the tide current, combined with the thrust of the propellers, he was moved to the starboard side and the Jason’s cradle was rigged on the quarter. The device was rigged so that the lines that are normally at the bottom of the ladder can be used to secure the ladder to the mooring bitts at the middle of the aft deck (see Appendix A).

fitted with a locking device that prevents the cable attached to the lower end of the cradle from unreeling. Tension on the crank is maintained by hand when hoisting the rescued person. It is difficult and risky for one person to operate the cradle alone in foul weather or to help the rescued person to climb aboard.

The Jason's cradle (recovery ladder) on the "CHARLEVOIX" is stowed in a compartment on the main deck. Thus, it must be retrieved from the compartment, opened, and rigged by hooking two snap links through the eyes provided on the deck edge. To deploy the device in the shape of a cradle, the bottom of the ladder must be held in place by the line coming from the boom winch.

- The Jason’s cradle will be installed permanently on the “CHARLEVOIX” when it next goes into dry dock.
- The hand winches were modified in the days following the occurrence.
- An exercise program and calendar were prepared, and a chart posted on the boat must be signed by the master after each exercise.
