## PIPELINE INVESTIGATION REPORT

P00H0061

### NATURAL GAS COMPRESSOR STATION OCCURRENCE

GAZODUC TQM INC.  
EAST HEREFORD COMPRESSOR STATION  
KILOMETRE POST 217,094 ON LINE 3000  
APPROXIMATELY 80 km SE OF MAGOG, QUEBEC  
EAST HEREFORD, QUEBEC  
28 DECEMBER 2000

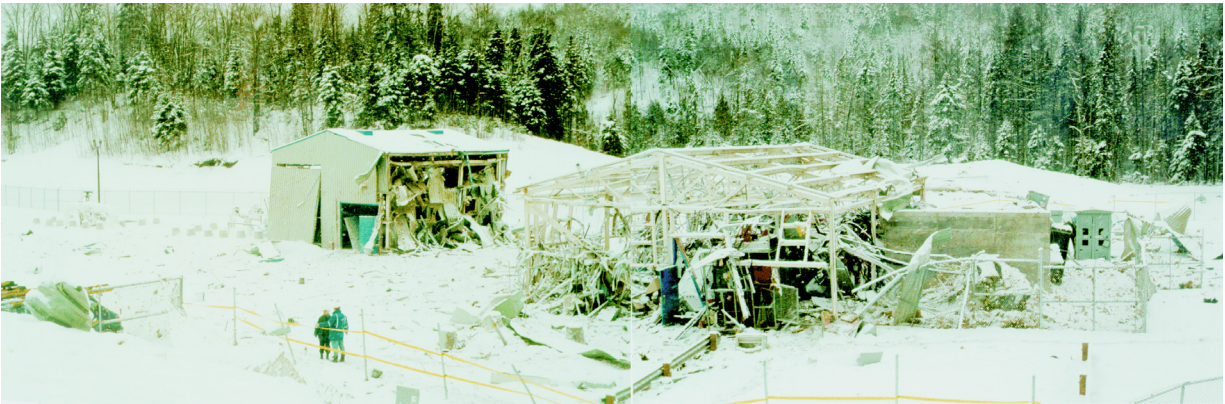
**Photo 1.** Panoramic view of East Hereford compressor station (after explosion)

Damage to TQM's East Hereford station was extensive. The main components were completely destroyed or damaged as follows:

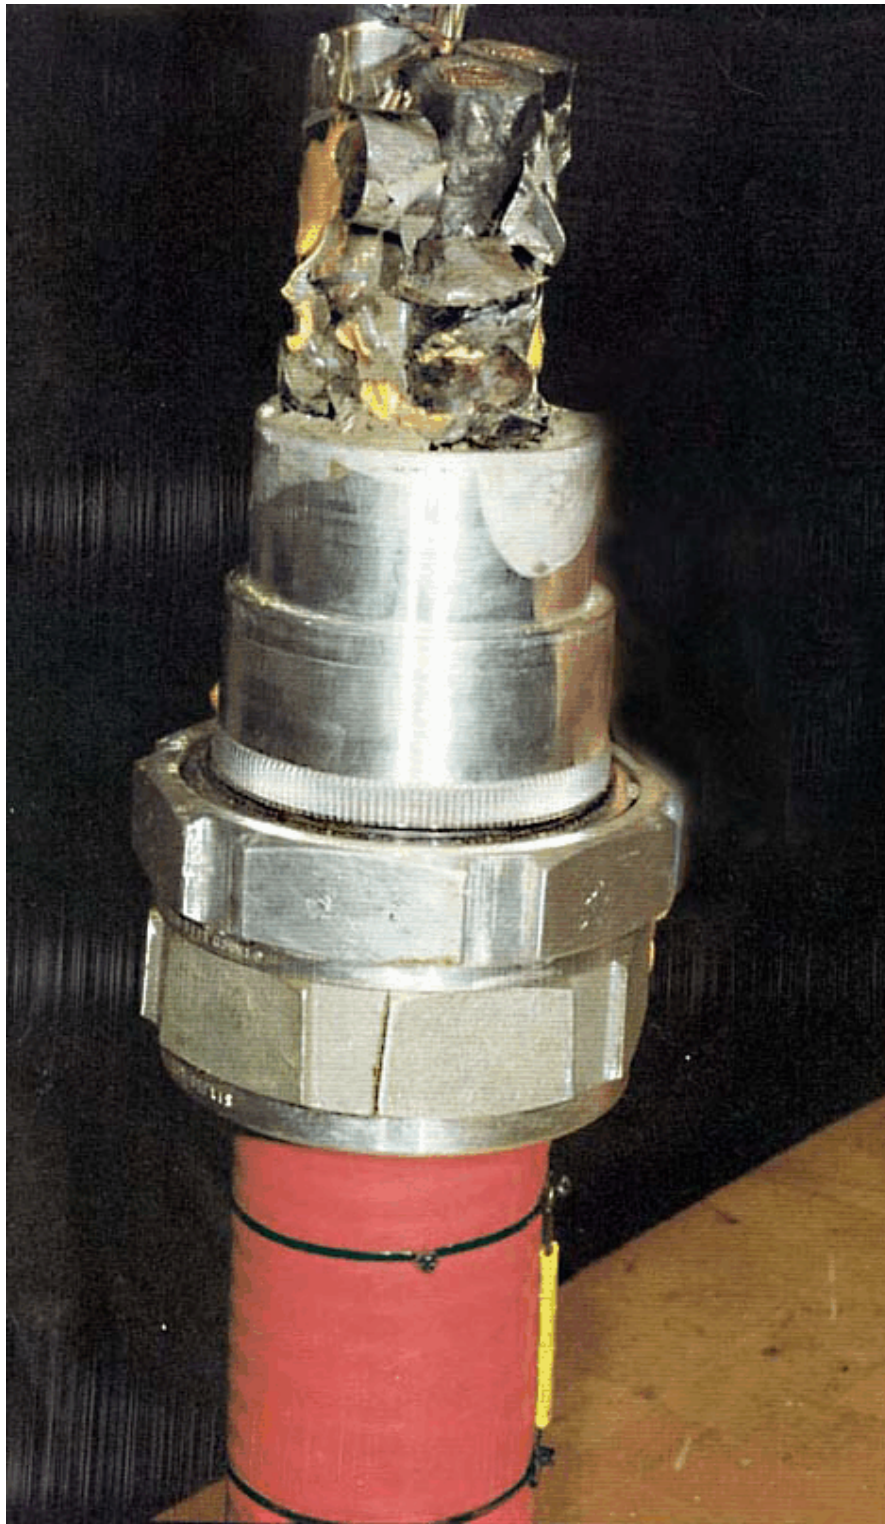
*Appendix E— Bottom Plate Fitting for the Terminal Junction Box (Scale: 1 to 2)*

An integral part of the MOPICO motor/compressor unit is the Passthru flange, a high-pressure sealing flange between the motor and the TJB. The fitting shown in Appendix E does not form part of the MOPICO, but is the physical means for power delivery from the ESB. The Passthru flange mechanically seals and permits electrical connections from the TJB, which operates at atmospheric pressure, to the electric motor, which operates at the midway pressure between compressor suction and discharge pressure. It is built of stainless steel and features 12 specially designed Passthru penetrations, through which an electrical conductor passes. Referred to as a "Passthru element," each electrical conductor consists of two O-rings made of a synthetic, flexible compound called Viton-Type "A" (Viton), a copper rod, a long brass outer ring, and an epoxy filler. Each Passthru element is used to conduct electric power to the motor from the connection points inside the TJB. Each Passthru element is designed to fit into one of the Passthru flange penetrations to form a tight, mechanical seal that is further protected from any gas leaks by the two Viton O-rings.

The fitting design was approved by both the CSA and UL for use in Class I, Division 2, Group D hazardous areas. This design provides a number of special features for connecting and disconnecting the Teck cables from the TJB during maintenance and general servicing. First, the fittings safely anchor the two Teck cables to the bottom of the TJB. Once secured to the TJB, the Teck cables can be easily disconnected for maintenance and reconnected without a major reinstallation process. Second, the fittings also furnish a seal where the cables enter the TJB. While these fittings were not designed to be gas tight, the seal at the ends of Teck cables was designed to inhibit or prevent an explosion inside the TJB from migrating through the Teck cables, thus preventing an extension of a dangerous situation into the ESB. The fitting was designed to diffuse hot gases in a controlled manner, which lowers the temperature, thereby preventing explosions inside an enclosure from propagating to atmosphere outside the enclosure. However, the fitting was not designed for continuous pressure service, as was the case with the TJB. Since there was no effective means of preventing any buildup of hot or cold gas from migrating out of the TJB along the two Teck cables, the pressure transmitter would not function as intended.

During a laboratory test, the TJB was inspected to identify any surface and structural damage that could indicate a potential escape route for natural gas. There was no surface or structural damage noted on the TJB, the door and the associated flanged connections located at the back of the box. The two fitting/Teck cable assemblies from the bottom of the TJB and the associated pieces of Teck cables were visually inspected and then each was physically dismantled by machine sawing through each assembly lengthwise. One of the two fitting/Teck cable assemblies did not have the recommended sealing compound and it had been improperly installed. The inner jacket of the cable was not skinned off to expose the conductors in the sealing chamber of the fitting as stated in the supplier's instructions, and a felt barrier had not been placed in the assembly. A chemical analysis determined the material to be "Chico," a commonly available material used in the electrical industry in Canada. While there had been an attempt to install a felt barrier, the second fitting/Teck cable assembly had no sealing compound. A felt barrier is installed before any sealing material to hold the material in place until it solidifies. In both cases, the entry points into the bottom of the TJB were covered by another sealing compound, which is normally used to protect against the progression of a flame and is referred to as "flame guard." An inspection performed during laboratory testing determined that it had been poorly installed and did not provide any sealing capability.

2. The failure to properly install sealing compounds and the failure to skin off the inner jacket of the cables to expose the conductors inside the sealing chamber in two electrical fittings affixed to the electrical TJB for the compressor unit provided an open channel for the free flow of natural gas through two electrical Teck cables between the explosion proof-rated compressor building and the non-explosion proof-rated electrical and services building (ESB); that was not in conformity with the requirements of *Canadian Electrical Code* (CEC) 22.1.
