PIPELINE INVESTIGATION REPORT

P09H0084

CRUDE OIL PIPELINE LEAK

ENBRIDGE PIPELINES INC.

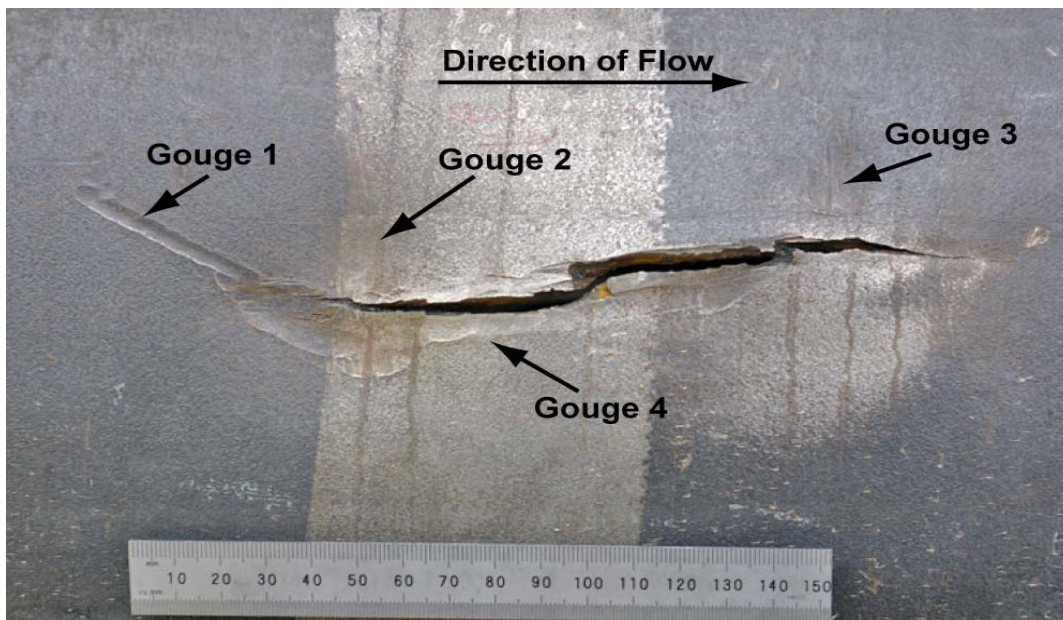
Photo 1. Damaged pipe section

- Pipe diameter, ovality and wall thickness measurements met the specification in place at the time of pipe installation.
- Chemical composition and material properties (including strength) of the pipe met the specification in effect at the time the pipe was manufactured.
- The leak occurred at a 160 mm long crack associated with a dent and gouge located at the 6 o'clock position on the pipe. The maximum depth of the dent was 3.1 mm (0.51 per cent of the pipe diameter).
- The coating in the immediate vicinity of the leak was missing. However, the coating on the rest of the pipe section was in relatively good condition.

- Gouges in four separate directions were present in the immediate vicinity of the crack (see Photo 1). One of the gouges crossed into a relatively shiny circumferential band on the pipe that contained less carbon and oxygen than the surrounding black pipe surface. Cracking had initiated at three major points from the base of the depression formed by the gouge that was parallel to the pipe axis. The maximum depth of this gouge was approximately 0.4 mm. The outer pipe surface in the vicinity of this gouge exhibited high hardness.

- Most of the crack surface was mechanically damaged, the result of a growing crack closing in on itself due to compressive stresses associated with cyclic loading. The rough crack surface and presence of secondary cracks were consistent with fatigue crack propagation under high stress/low cycle conditions.

The pipeline failure occurred at a location where dents and gouges had been present prior to the pipe being coated in the field. Mechanical damage in the form of dents and gouges can occur either during or after construction. Mechanical damage after construction typically occurs on the top of the pipe from third-party excavation activities between the 8 and 4 o'clock positions and results in coating and pipe damage. In this occurrence, the dent and gouges occurred at the 6 o'clock position. Judging from the nature and location of the damage, it likely occurred at the time of construction.

Following the initial hydrostatic pressure test in 1953, the dent would have re-rounded to some degree, resulting in high tensile strains in the root of the gouged area. The pipe material deformation from the gouge resulted in high hardness near the pipe surface which contributed to crack initiation. Because the dent did not fully re-round, it continued to fluctuate with changes in normal line operations and operating pressures. The crack progressed through-wall by pressure cycle induced fatigue.

1. The pipeline failure occurred at a location where dents and gouges had been present from the time the line was constructed in 1953.
2. The dents and gouges created a work-hardened area where a crack initiated. The crack then progressed through-wall by pressure cycle induced fatigue during operations that are typical to Line 2.

The failed section of pipe was cut out and replaced with pre-tested pipe. When Line 2 was returned to service on 1 October 2009, Enbridge voluntarily implemented a pressure restriction on the Line 2 discharge at Odessa pump station equal to 80 per cent of the highest pressure in the 30 days prior to the release. Enbridge committed to maintain the discharge pressure at that level until it received concurrence from the National Energy Board (NEB) to increase the operating pressure to the previously established levels.

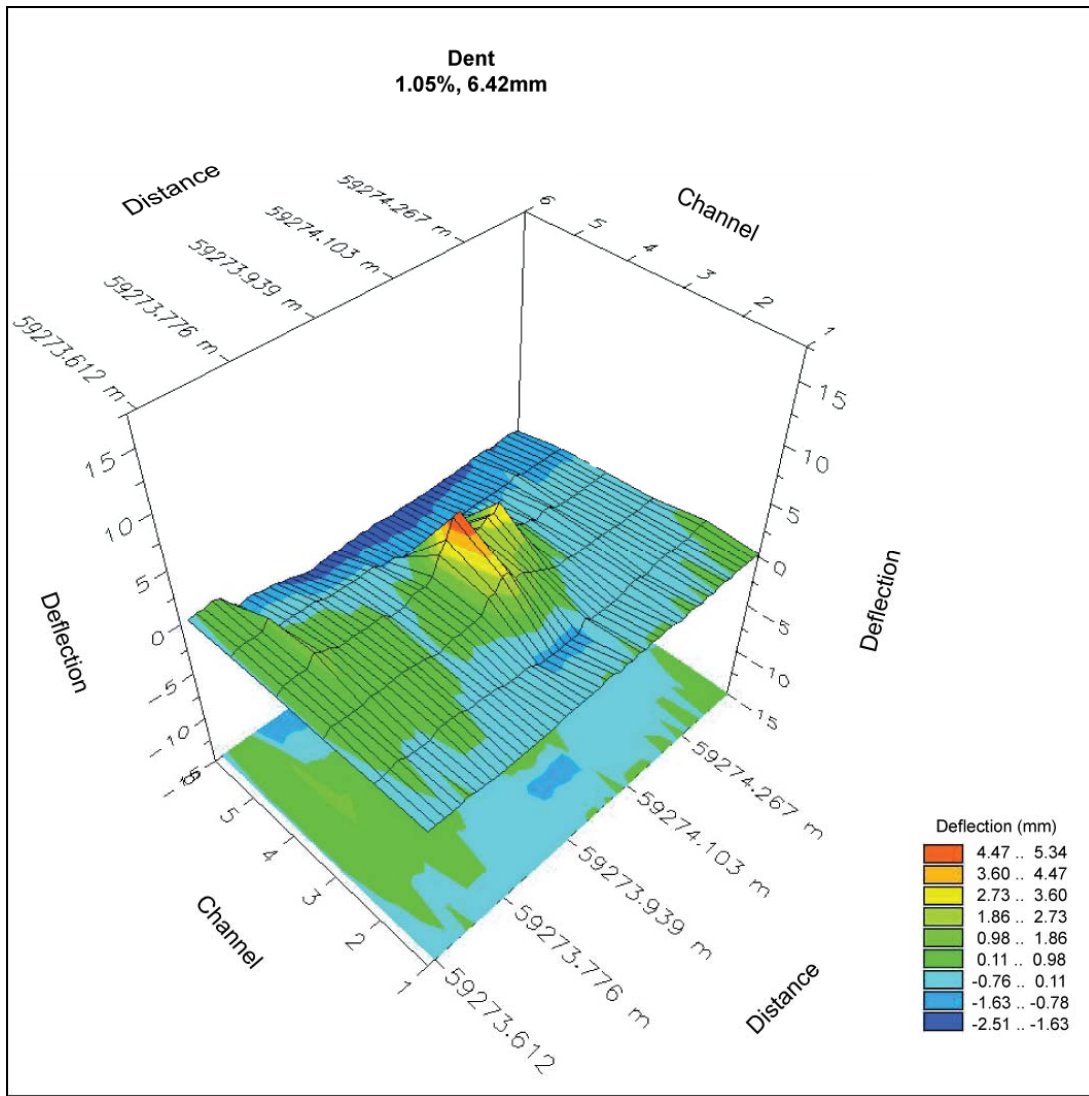
Figure 2. 3D screen capture of dent location from 2008 geometrical discontinuity in-line inspection

The caliper tool used in 2008 detected a double apex dent at the location of the leak. However, the dent was not reported to Enbridge since the measured deflection was below the reporting threshold of two per cent.

Following the leak, Enbridge re-examined data from the 2004 MFL and the 2008 caliper ILI to identify any unique features of the dent that failed and to identify other locations that exhibited the same features. From the 2008 geometrical discontinuity ILI, the plot of the failed dent exhibited a complex shape (i.e., a double apex) (see Figure 2).

4. Although the dent was detected during the 2008 geometrical discontinuity in-line inspection, it did not meet Enbridge's damage reporting criteria and was not flagged for further follow-up.

5. At the time of the 2008 geometry in-line inspection, although Enbridge recognized that stress risers (such as those associated with mechanical damage) could potentially be present in double apex dents or dents in close proximity, it had not determined that all such dents, regardless of their depth, should be included in its reporting criteria.

Following this re-evaluation, Enbridge identified and excavated all locations where there were known dents with multiple apexes or in close proximity to one another, regardless of their depth.

- in-line inspection vendor reporting criteria were revised to include dents with multiple apexes or dents in close proximity to each other, regardless of depth;
- guideline documents were developed to incorporate the modified reporting criteria data into its mechanical damage program; and
- its construction group was informed of the lessons learned from this occurrence.
