Pipeline Transportation Safety Investigation Report P20H0017

RELEASE OF CRUDE OIL INCIDENT

Enbridge Pipelines Inc.
Herschel pump station
Near Herschel, Saskatchewan
30 April 2020

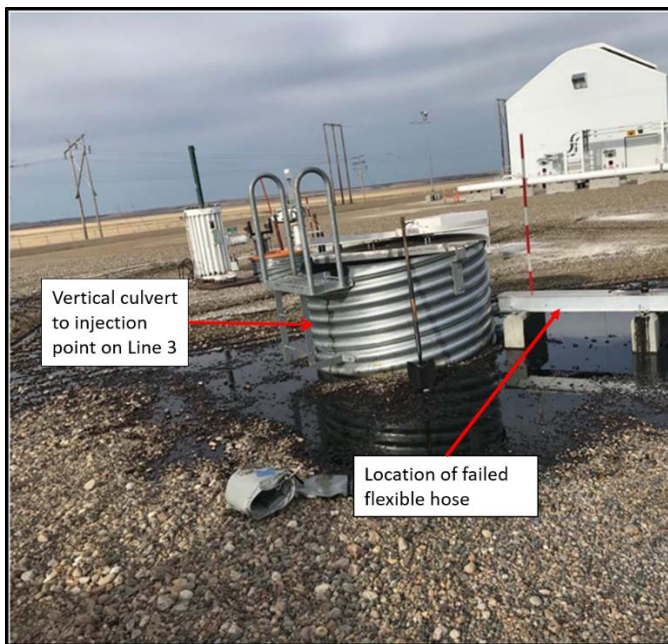
The crude oil released from a 3/4-inch flexible braided hose that is part of an above-ground auxiliary system used to inject drag reducing agents (DRA)² into Enbridge's NPS³ 34 Line 3 pipeline (Figures 2 and 3).

Figure 2. Released product observed at Herschel pump station (Source: Enbridge, with TSB annotations)

An estimated 50 m³ of crude oil was released,⁴ with approximately 10 m³ migrating off company property into a roadway ditch next to the station.

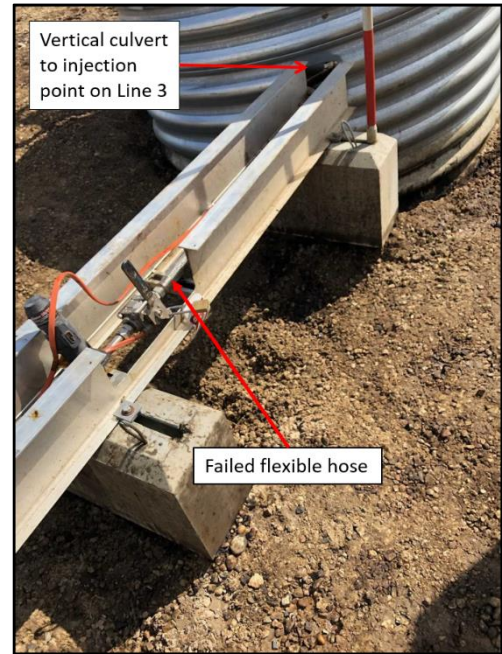
Figure 3. Location of the failed ¾-inch flexible braided hose (Source: Canada Energy Regulator, with TSB annotations)

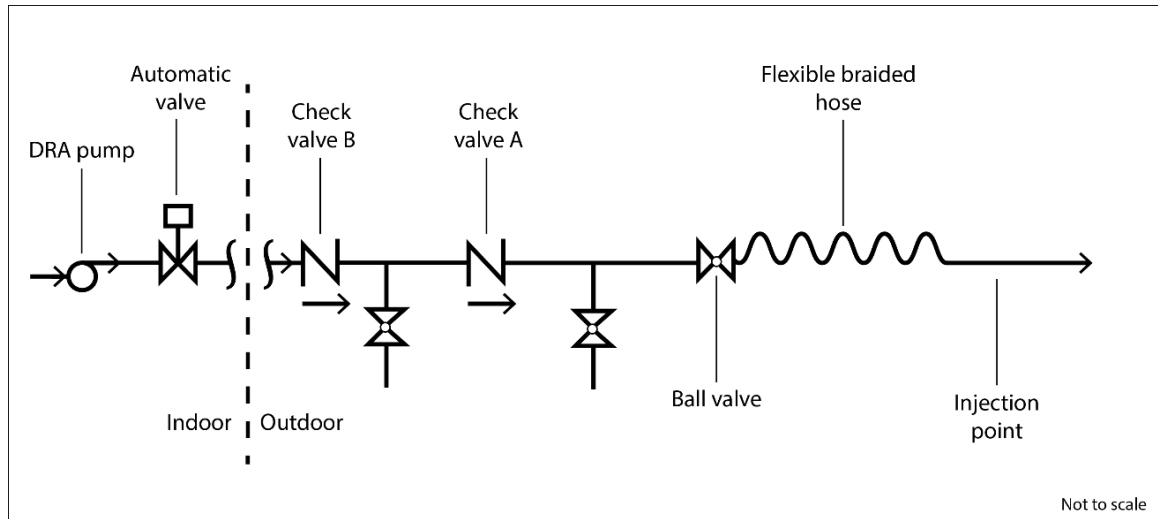
The outlet piping from this building (Figure 4) includes ¾-inch stainless steel tubing and a flexible braided hose that run inside a support tray to the injection point in the Enbridge Line 3 pipeline. The outlet piping is also fitted with electrical heat tracing and thermal insulation to keep the piping system above a set temperature. This way, if DRA product remains stagnant, the piping system temperature is maintained above the freezing point.

The outlet piping also contains a check valve (marked as “check valve A” in Figure 4) upstream of the ¾-inch flexible braided hose. It prevents the backflow of crude oil from the Line 3 pipeline into the DRA injection system. In this design, it is possible for crude oil to backflow from the Line 3 pipeline through the ¾-inch flexible braided hose and up to check valve A.

Figure 4. Schematic of the outlet piping for the DRA injection system at the Herschel pump station (Source: TSB)

However, the HAZOP did not identify that the design of the DRA injection system piping allows crude oil to backflow from the injection point to the check valve. Consequently, it also did not identify that, should the piping, including the ¾-inch flexible braided hose, freeze and rupture, there could be a

release of crude oil. Therefore, no control measures were implemented to prevent crude oil from being released due to a failure of either the piping or the ¾-inch flexible braided hose.

- developed procedures for flushing intermittently operated DRA injection systems to prevent blockages and freezing;
- revised the design standard for DRA injection systems to ensure the check valve is located downstream of the flexible braided hose; and
- revised the preventative maintenance procedures for DRA injection systems and their components.

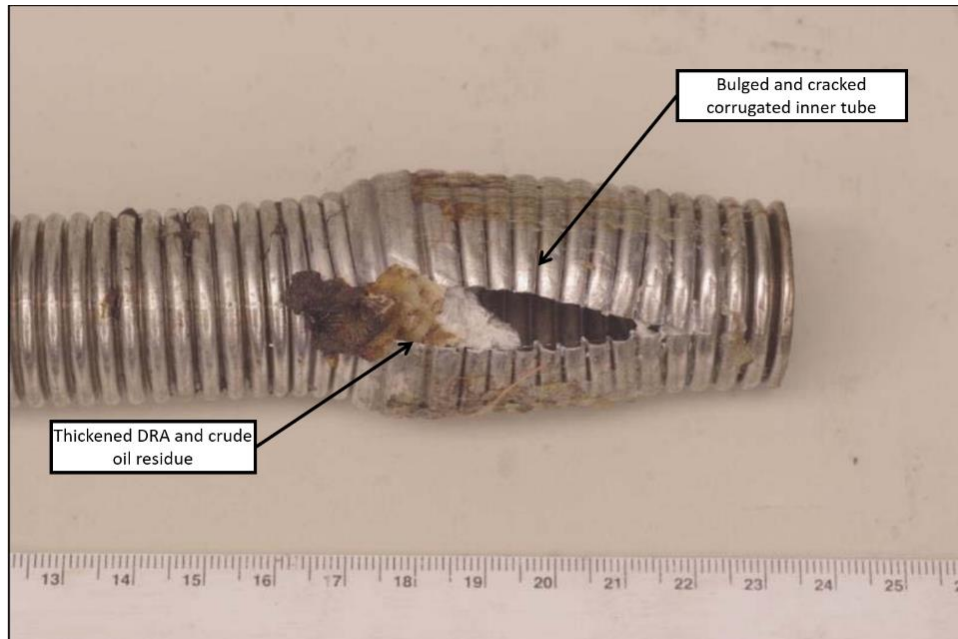
The ¾-inch flexible braided hose was removed and sent to an independent engineering laboratory for a detailed examination. A bulge and a crack about 5 cm long were found on the hose's corrugated inner tube, which is made of type 316L stainless steel. The crack was along the longitudinal weld centreline, in the section of tubing next to the ball valve. At the location of the bulge, the hose was plugged with a semi-solid material that was thickened DRA and crude oil residue (Figure 5). It is likely that freezing occurred when the heat tracing system malfunctioned.

Figure 5. Failed corrugated inner tube of the ¾-inch flexible braided hose (braid removed), showing thickened DRA and crude oil residue (Source: Enbridge, with TSB annotations)

The examination determined that no material anomaly caused the failure of the flexible braided hose; however, significant necking⁵ had occurred due to plastic deformation in the hoop direction prior to fracture. It was concluded that the crack initiated due to an instantaneous ductile fracture at the weld of the 316L stainless steel braided hose.

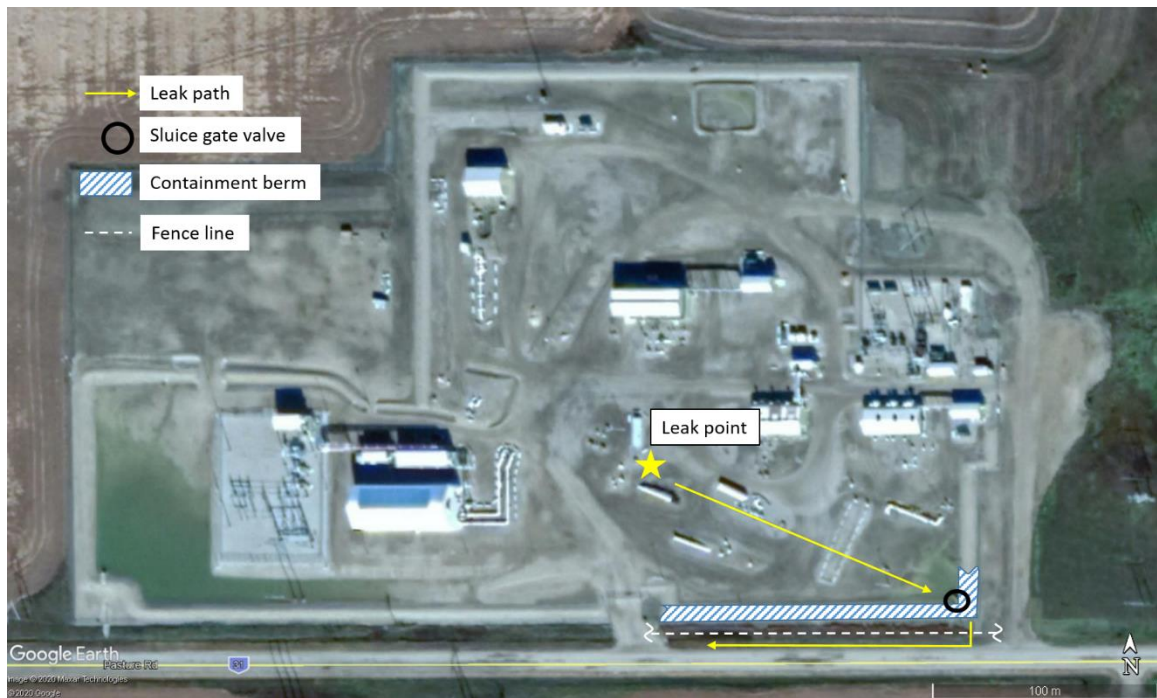
The crude oil migrated off site through an open drainage valve, which is used to drain accumulated storm water, from the station into an adjacent ditch.

At the southeast corner of the Herschel pump station, storm water that accumulates in the containment berm is discharged by way of a sluice gate valve.⁸ On 29 April 2020, this valve was manually opened to drain accumulated storm water. The valve was inadvertently left open at the end of the operators' shift. As a result, the crude oil released from the ¾-inch flexible braided hose into the containment berm and was released into the roadway ditch off site (Figure 6).

Figure 6. Overview of Herschel pump station indicating the release path (Source: Google Earth, with TSB annotations)

Enbridge's procedure for the discharge of storm water off site requires that a form⁹ be completed every time. In this occurrence, the form was not completed when storm water was discharged on 29 April 2020.

Enbridge's storm water discharge procedure does not include detailed instructions on the operation of discharge valves, including when to open and close each valve.

Following the occurrence, Enbridge initiated a review of its storm water management procedures and documentation to identify areas for improvements. Enbridge also
