PIPELINE TRANSPORTATION SAFETY INVESTIGATION REPORT P21H0143

THIRD-PARTY DAMAGE TO A NATURAL GAS PIPELINE

Minell 6-inch natural gas pipeline

Near McAuley, Manitoba

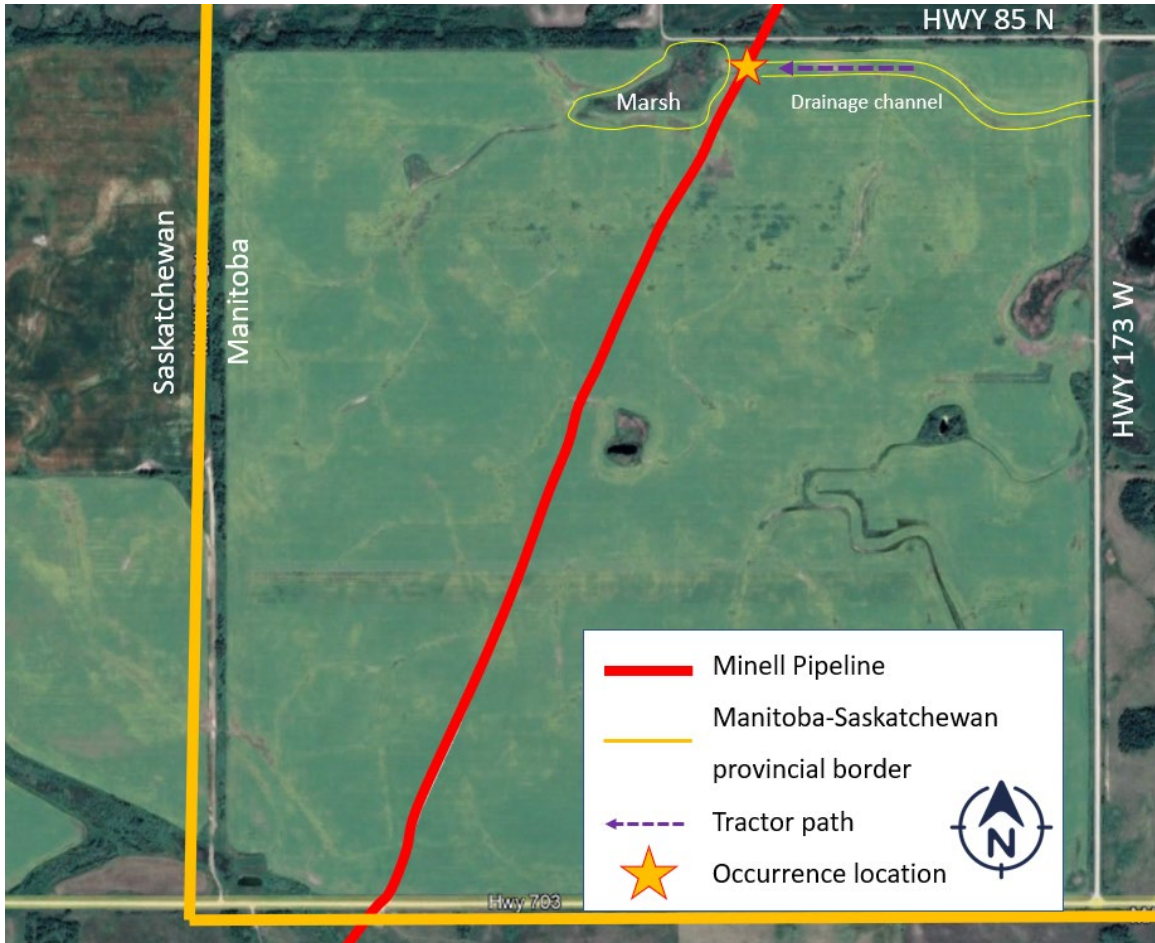
Figure 2. Map showing the landowner's agricultural field, including the location of the Minell Pipeline, the drainage channel, and the marsh area (Source: Google Earth, with TSB annotations)

In the area of the occurrence, there is a drainage channel to the east of the pipeline; this channel crosses the pipeline and connects to a small marsh area with weeds (Figure 2).

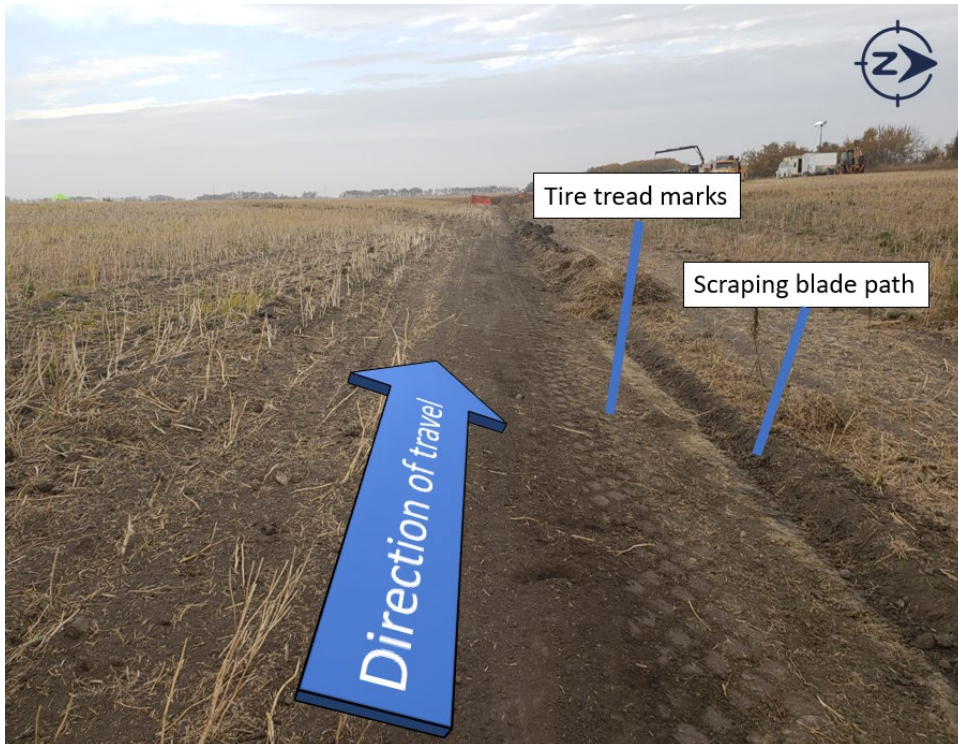
Figure 3. Tire tread marks and disturbed soil indicating the path of the tractor and ground-scraping blade (Source: TSB)

In the vicinity of the occurrence, the land was mostly flat and there were remnants of harvested canola stalks at ground level.⁸ The path of the tractor and ground-scraping blade was indicated by tire tread marks and by disturbed soil where the blade had scraped the surface (Figure 3). The ground scraping followed the path of the drainage channel west toward and across the pipeline, parallel to Road 85 N.

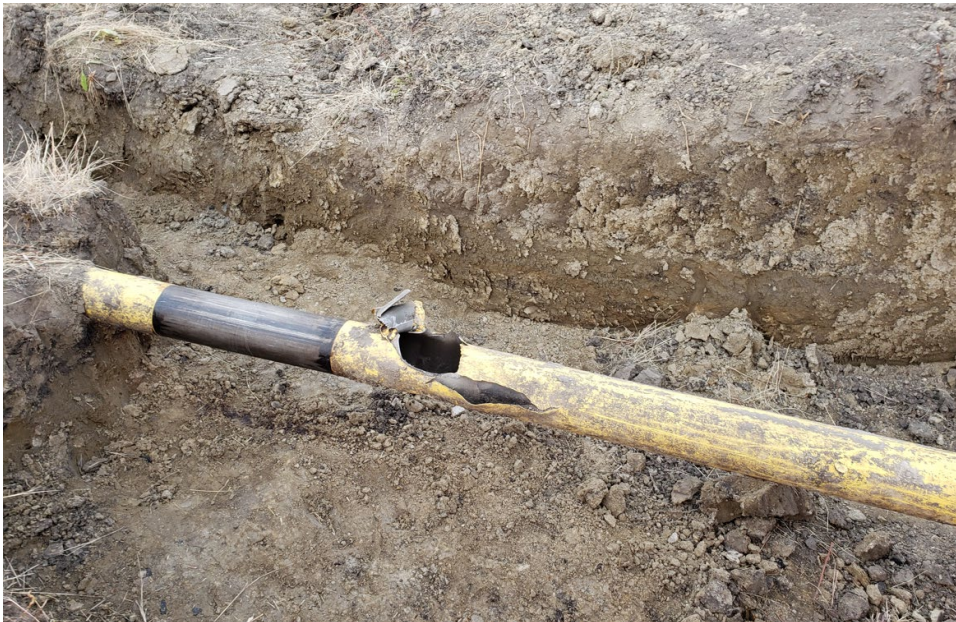
Figure 4. Excavated area showing the damaged section of pipeline (Source: TSB)

Following the occurrence, a rectangular area was excavated around the damaged section of pipeline (Figure 4). The depth of cover over the pipe where the blade made contact was determined to be less than 0.12 m.

The exposed pipe showed an oval-shaped rupture; the impacted material was bent and still attached to the pipe. The pipe coating was intact, except for the immediate area of the

damage and where it had been removed by Manitoba Hydro during the excavation. There was no visible damage to any of the surrounding landscape.

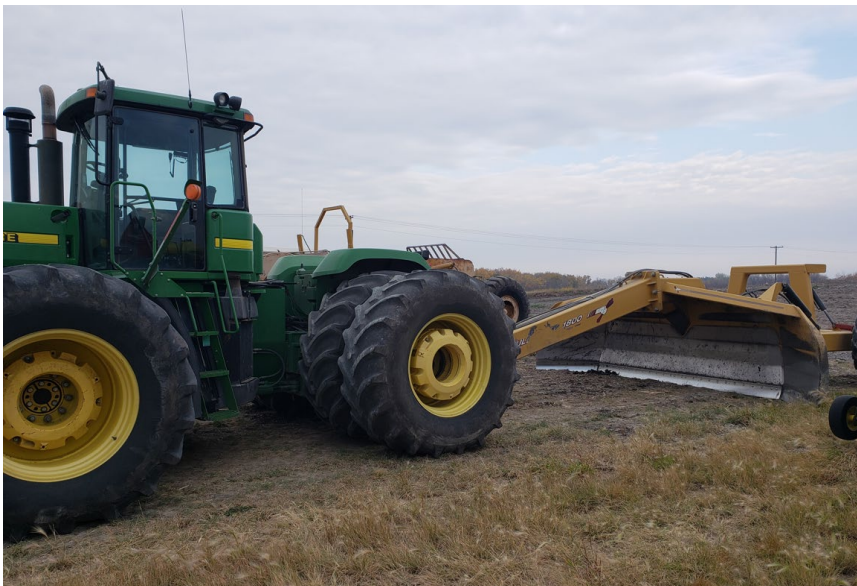
Figure 5. Farm equipment operated by the landowner at the time of the occurrence (Source: TSB)

The ground-scraping blade is supported by an articulated wheeled base (Figure 5). At the time of the occurrence, the blade was in the flat position,¹⁰ which has a maximum blade depth of 0.26 m according to the manufacturer.

The Minell Pipeline was required by regulation to be buried to a depth of at least 0.61 m when it was constructed in 1960, to protect it from external damage. The maximum depth at which the ground-scraping blade is designed to operate is 0.26 m, and it was determined to be penetrating the ground less than 0.12 m when it contacted the Minell Pipeline.

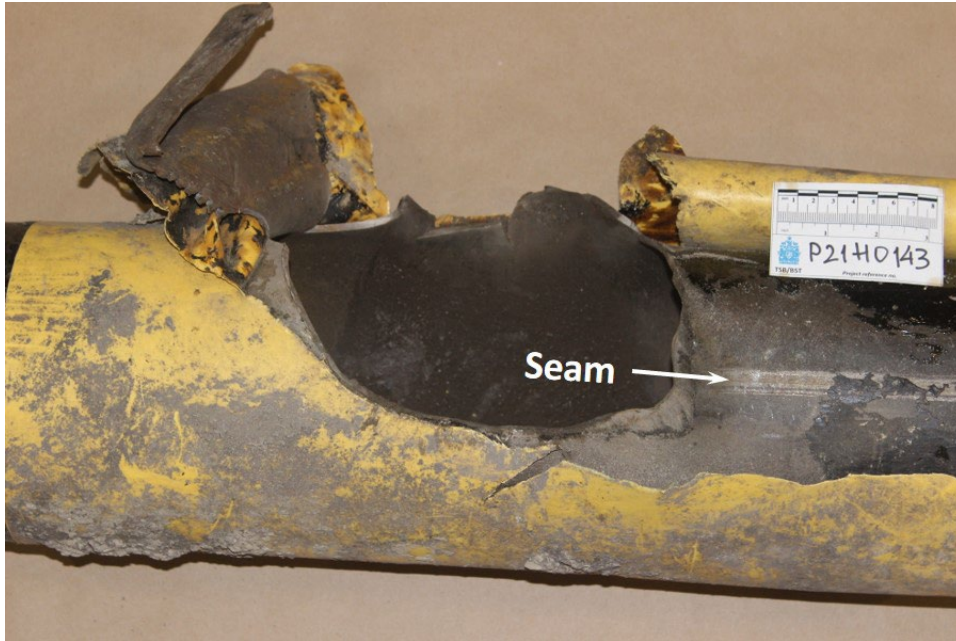
Figure 8. Segment of pipe where damage occurred (Source: TSB)

The nature of the damage observed on the pipe (Figure 8) was consistent with a low-speed strike by a hard, external object. Therefore, it was determined that this damage was done by the ground-scraping blade pulled by the tractor. The low-speed intrusion caused the pipe to open without generating sparks, avoiding ignition.
