RAILWAY INVESTIGATION REPORT

R00M0044

MAIN-TRACK DERAILMENT

BLUE BELL, NEW BRUNSWICK

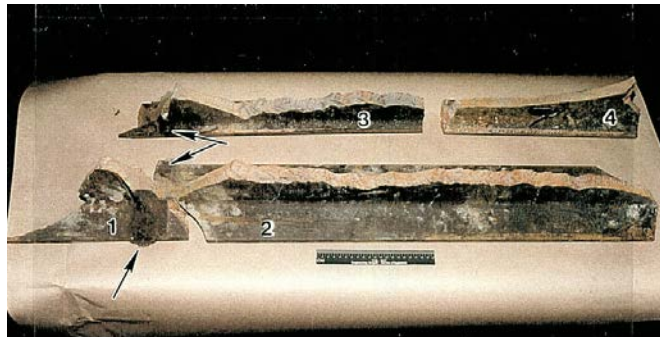
Several pieces of broken rail from the high rail of the curve were found at, or near, a fractured thermite weld. A review of railway records revealed that a temporary plug¹ rail was installed in the derailment area to correct a track buckle in the spring of 1999. In October 1999, the plug rail was replaced with a longer piece of rail (21 feet) that was thermite-welded in place. In the summer of 2000, the high rail in the curve was destressed². During the destressing process, two and one-half inches of rail was cut and the rail anchors removed. At the time the rail was re-anchored, the rail temperature was 83 degrees Fahrenheit (F). The preferred rail laying temperature ranges from 80 to 95 °F. After the destressing was completed, the entire curve was mechanically resurfaced.

Four pieces from the high rail were removed from the derailment site and sent to the TSB Engineering Laboratory for further examination (report LP 136/00).

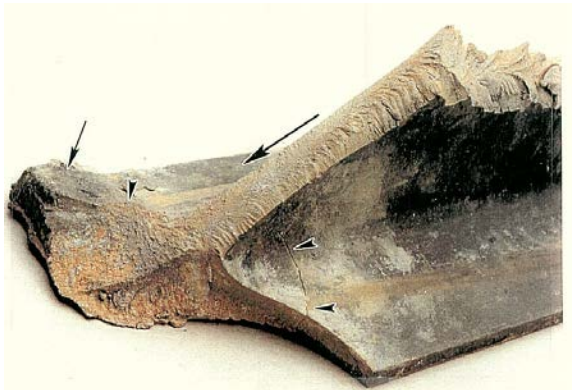
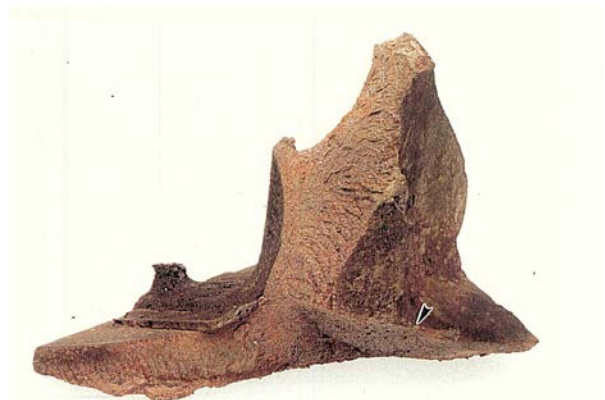
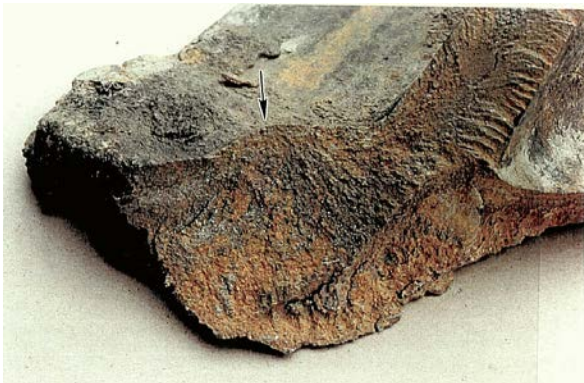
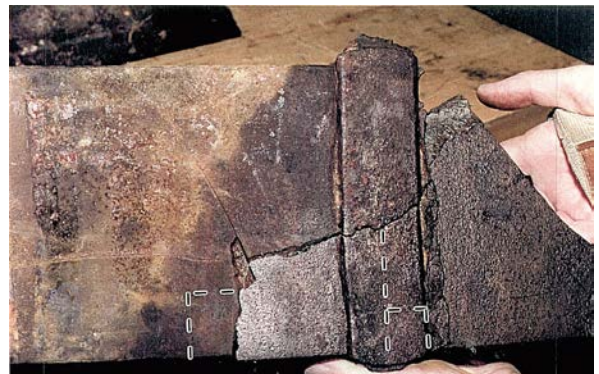
- The four rail pieces failed as a result of overstress. No pre-cracking was observed on any of the pieces received.
- The overstress failure initiated in the thermite weld, on top of the base of the rail, field side, indicating that the rail was in tension at that location, and consistent with a force applied from the gauge side of the rail.
- Material and hardness results observed on the rail sections were typical of rail material.
- Vertical wear was 9.5 mm, and combined vertical and lateral wear was 19 mm. Both measurements were within allowable wear limits.
- There was light micro-shrinkage porosity in the thermite weld area.
- Microstructure grain size was relatively large within the thermite weld area as compared to the fine grain size in the base metal. The larger grain size of the thermite weld area may facilitate crack propagation once a crack is initiated.

Lateral wear on the high rail was indicative of in-train curving forces exerted upon the rail, creating tensile stresses on the field side of the rail. As the temperature was very low, contraction caused high tensile stresses³ in the rail. The combination of tensile stresses generated by in-train curving forces, stresses introduced through surfacing and the low temperature was sufficient to initiate a fracture in the field side of a thermite weld, where large grain size steel microstructure and micro-shrinkage porosity were present.
