RAILWAY INVESTIGATION REPORT

R00T0257

CROSSING ACCIDENT

VIA RAIL CANADA INC.

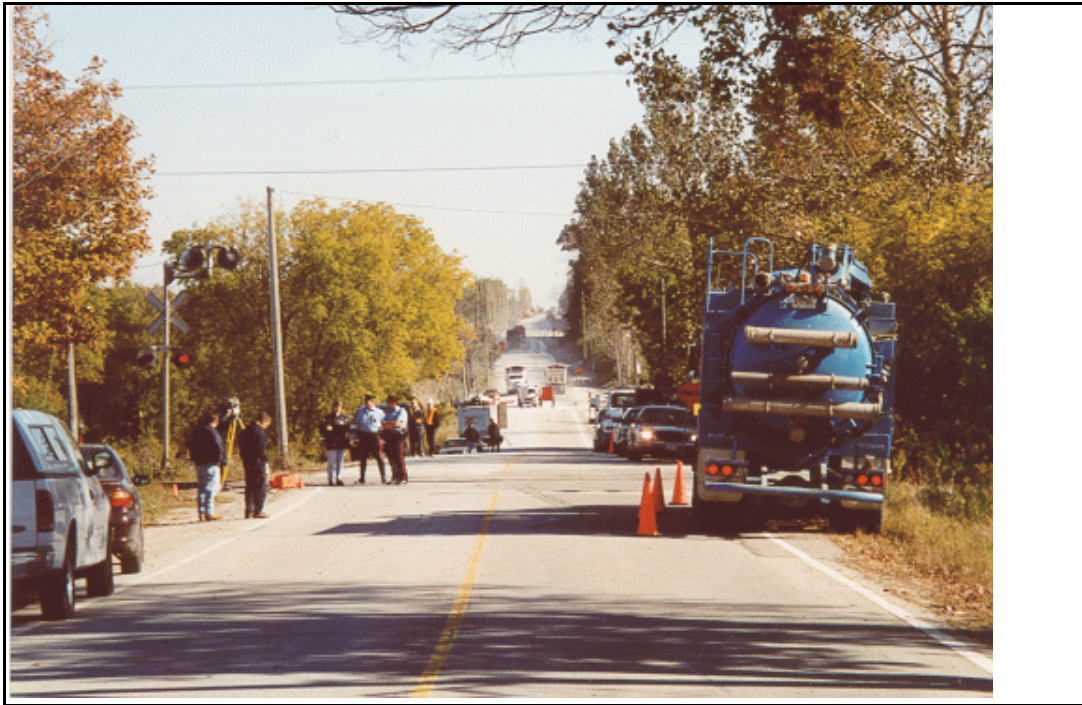
On the day of the occurrence, a job and safety briefing had been planned for 0630 in Acton, Ontario (Mile 5.3), with the 360networks TOP foreman, a 360networks sub-foreman and another 360networks employee, three A. van Egmond Construction Ltd. employees, two Ontario Excavac Inc. employees, and a CN signal maintenance person. This briefing was rescheduled, however, and was then to be held at the work site. The nine workers travelled to the work site in six vehicles—five light trucks and the Ontario Excavac Inc. truck. The light trucks were parked to the south of the crossing—four on the west side of the roadway and one on the east side (see Appendix A). The Ontario Excavac Inc. truck was parked and left running just to the north of the crossing at the expected work location. As per company policy, the driver placed pylons on the roadway to direct vehicular traffic around the truck. The truck was 10.9 m (36 feet) long, 2.6 m (8 feet 4 inches) wide, and 4.1 m (13 feet 5 inches) high (see Figure 1).

This situation meant that southbound highway drivers would have to use part of the northbound lane to pass the Ontario Excavac Inc. truck.

The northwest crossing light signals were blocked by the truck and not visible to the driver. The rising sun obscured visibility of the southeast crossing light signals, and the driver's attention may have been distracted from these warning devices as he neared the crossing. The driver turned his head and looked to the right as he passed the front of the truck, indicating that his attention was directed away from the activated signal and the approaching train, both of which were to his left.
