RAILWAY INVESTIGATION REPORT

R01T0129

PEDESTRIAN FATALITY

MILE 47.95, HALTON SUBDIVISION

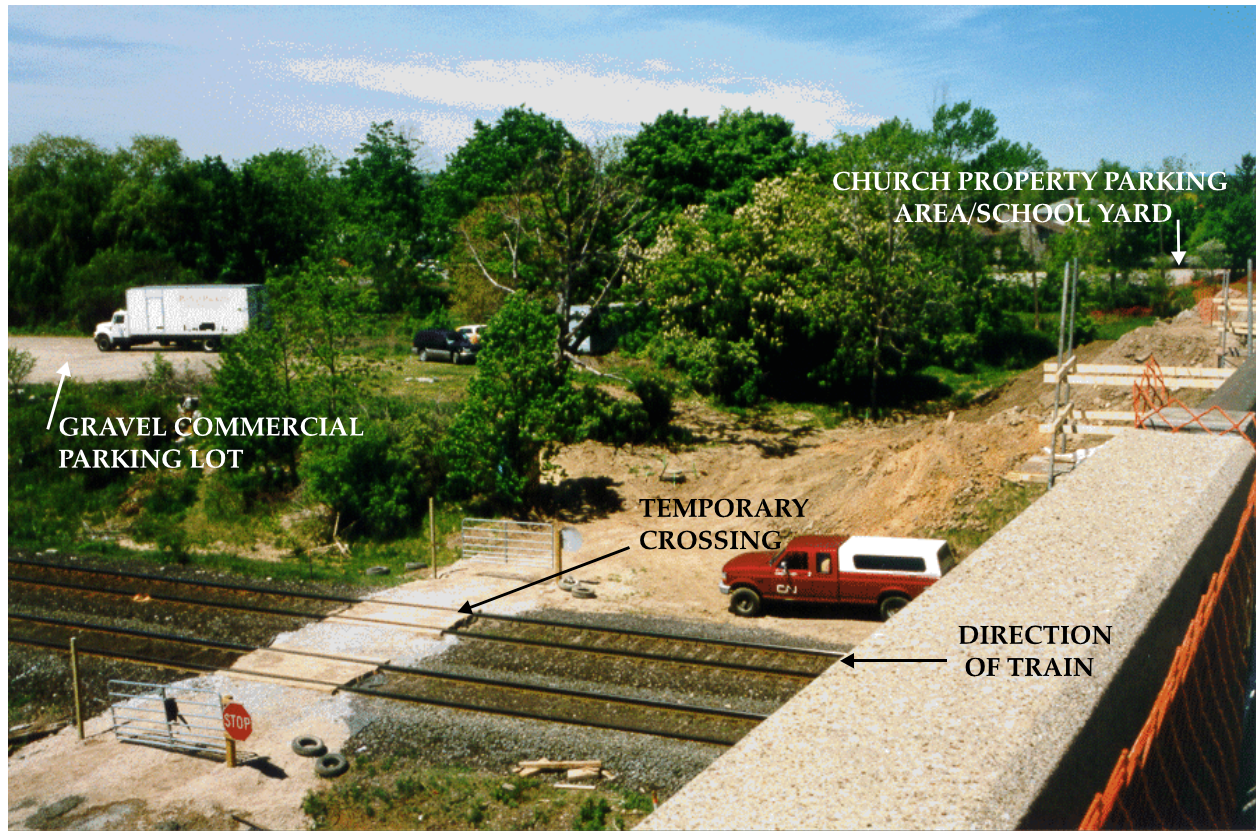
Although this area was not considered a high-trespass area, track workers had observed people traversing this area with their dogs to access the empty field on the south side. Some children in the church congregation had been there a few days before. Those children attended a nearby church school during normal weekday school hours. Figure 1 shows a view of the area.
