RAILWAY INVESTIGATION REPORT

R01W0007

DERAILMENT

CANADIAN PACIFIC RAILWAY

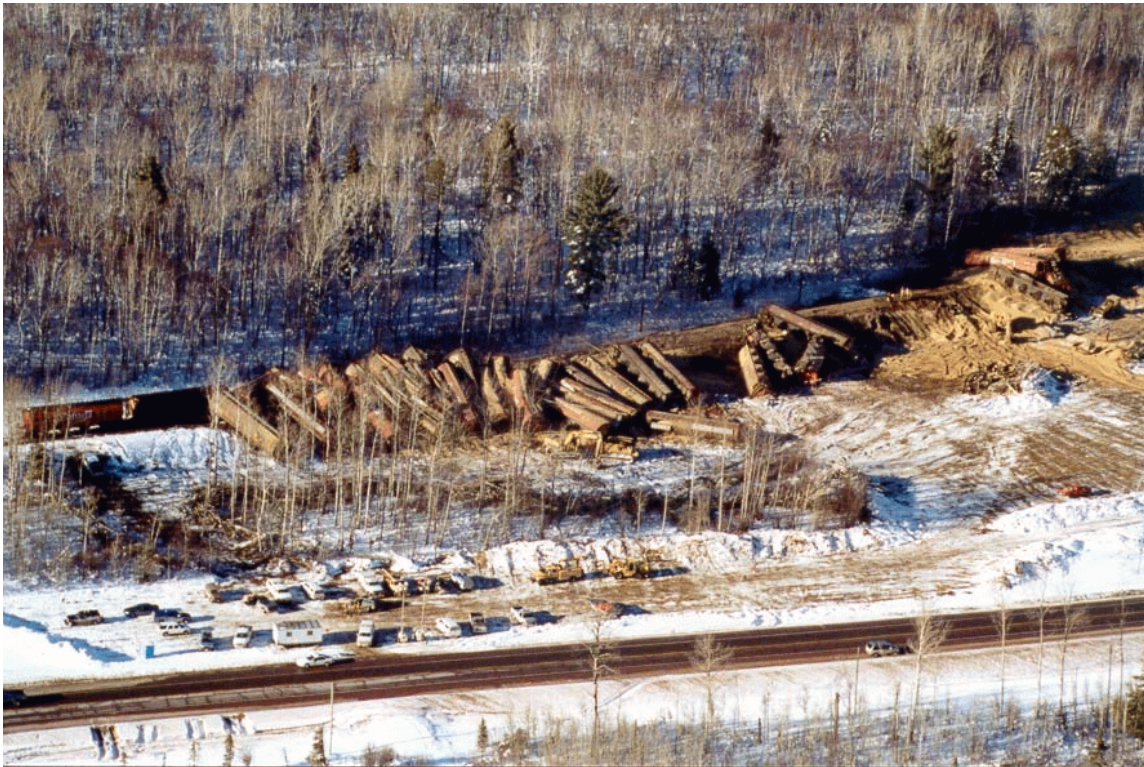
On 08 January 2001, Canadian Pacific Railway (CPR) train 308-001 (train 308) departed Thunder Bay, Ontario, Mile 132.9 of the Nipigon Subdivision, at 1050 eastern standard time.<sup>1</sup> At about 1330, the eastward train experienced a train-initiated emergency brake application at Mile 94.297 while descending a 0.55 per cent grade, west of Bowker, Ontario. The train was travelling at 64 mph in a maximum allowable speed zone of 50 mph. After emergency procedures were executed, inspection of the train revealed that a total of 59 cars had derailed, the 12th car and the 19th to 76th cars, inclusive. The north and south rails were fractured within a few metres of the initial point of derailment (POD) at Mile 94.65. Initial examination of the POD revealed that the track had spread, the high rail canted over and the wheels dropped between the rails, resulting in a derailment. The head end of the train, with 19 cars, travelled approximately 4500 feet after the derailment occurred. The 12th car and the 19th car were derailed and upright on the roadbed. The 20th to 24th cars were derailed and on their side to the south of the track, approximately 2000 feet behind the head end of the train. The 25th to 76th cars were derailed in an accordion fashion on the right-of-way for a distance of 1085 feet east of the POD (see Photo 1).

The derailment occurred when the lateral forces at the wheel-rail interface exceeded the lateral restraining ability of the track structure. This resulted in the outside, or high rail, of the curve canting over, allowing the wheels to fall within the widened gauge. The lateral restraining capability of the track was reduced by excessive gauge and poor tie conditions. However, the

train overspeed of 14 mph and the related increase in lateral force were probably the prime factor in influencing the rail rollover. The 20th car behind the locomotives was the first car to derail. The 12th car derailed due to in-train forces after the initial derailment.

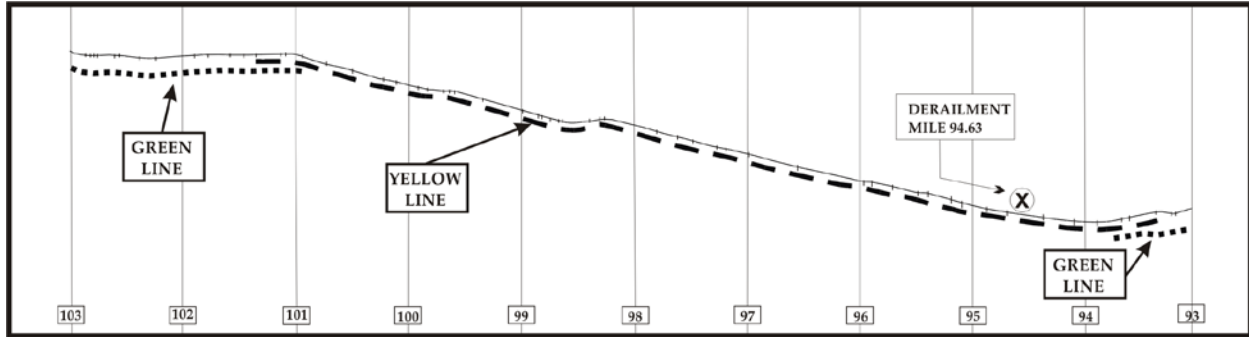
CPR provided train operating crews with a document entitled *Train Handling Guidelines Nipigon Subdivision*, which used colour-coded instructions to indicate the fuel-conserving method of train handling while travelling over the subdivision. The colour codes indicated green for throttle modulation, red for train air brakes, yellow for DB, or a combination of the colours for using a combination of these controlling methods (see Figure 1).

DB was indicated in the *Train Handling Guidelines Nipigon Subdivision* as the method to handle the train while descending Bowker Hill from approximately Mile 101.3 to approximately Mile 93.3. The guidelines were generic in that they did not apply to a specific type or size of train. Locomotive engineers may use the *Train Handling Guidelines Nipigon Subdivision* as a reference, but need to modify their train handling to account for differences in train make-up. New locomotive engineers were being trained to use DB wherever possible.

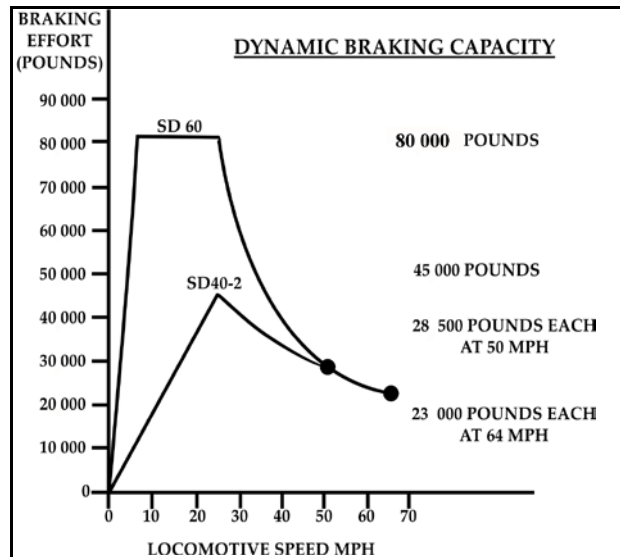
DB capacity is expressed in pounds of force (see Figure 2). DB is most effective at retarding a train under 25 mph. The combined DB capacity of the two locomotives declines from 125 000 pounds at 24 mph to approximately 57 000 pounds at 50 mph, and further declines to approximately 46 000 pounds at 64 mph.
