RAILWAY INVESTIGATION REPORT
R02M0007

YARD DERAILMENT

CANADIAN NATIONAL
0700 YARD ASSIGNMENT
MILE 12.15, DARTMOUTH SUBDIVISION
DARTMOUTH, NOVA SCOTIA
15 FEBRUARY 2002

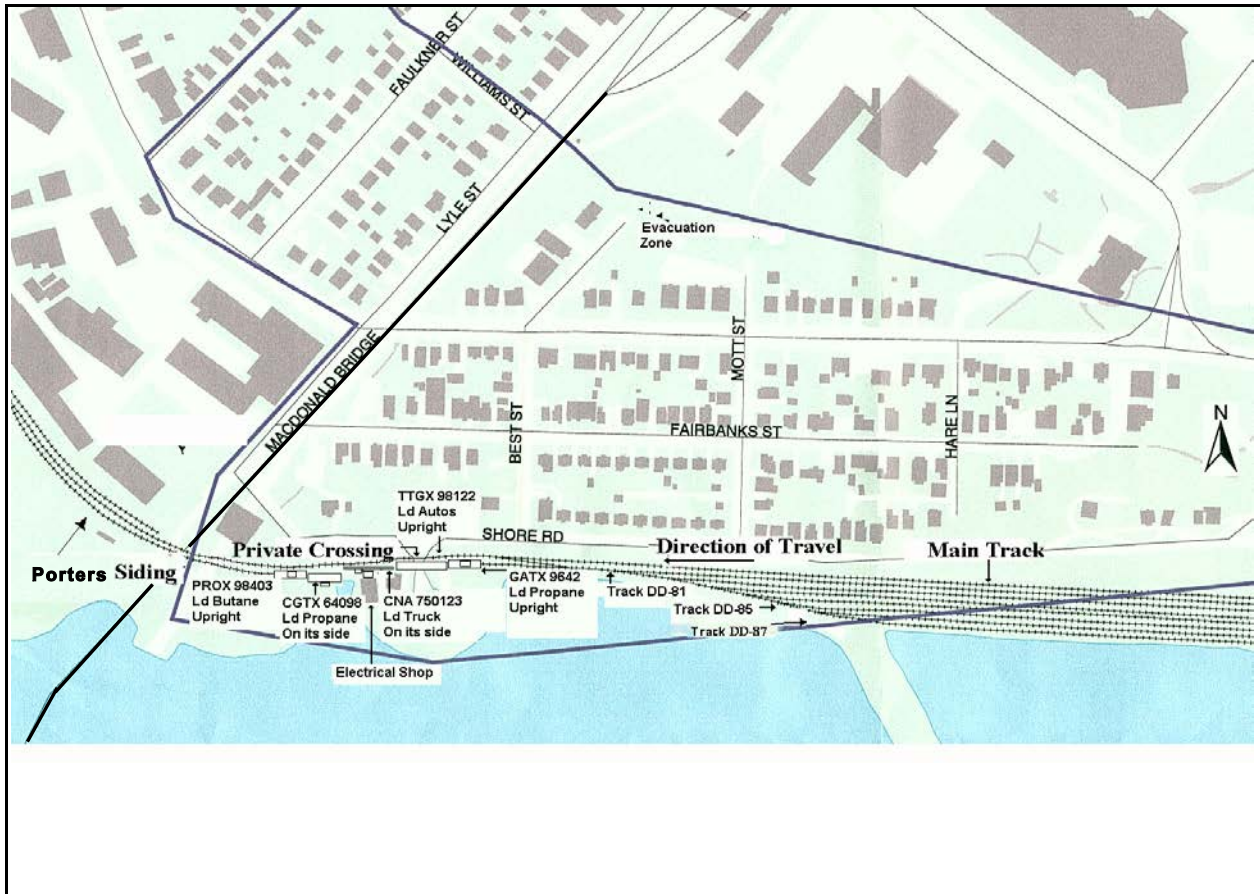
CGTX 64098 was damaged beyond economical repair. The stub sills on both ends of the car were torn and twisted away from the tank shell. The body bolsters were bent and the jacket had minor damage. The car was partially resting on shoreline rock, and there was a slight bend in the tank shell. Recovery efforts took into consideration the potential loss of integrity of the damaged car. Internal pressure readings were determined to be within acceptable limits. The wheels on the trailing truck, notably the wheel treads, flanges, and wheel plates, had numerous indications of contact with non-ferrous materials (e.g. ties and track ballast).

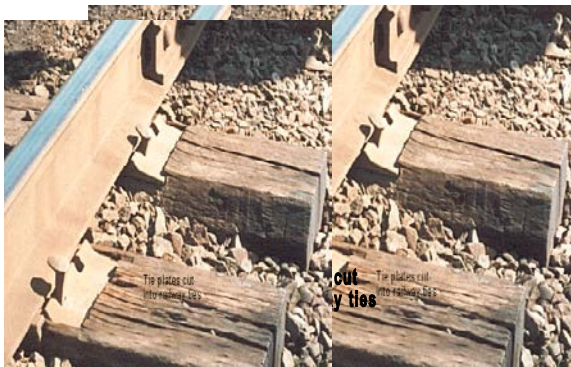
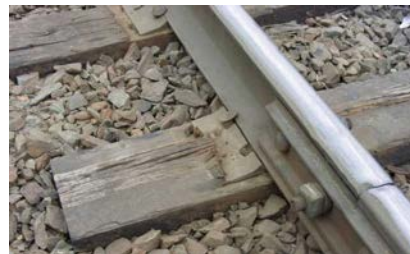
The first derailed wheel marks were noted on the base of the south rail at Mile 12.15, east of the private crossing. Between the yard lead and the private crossing, a distance of approximately 250 feet, a cluster of deteriorated ties was noted. The ties had differential plate-cutting² allowing lateral movement of the base of the rail, and loose track spikes were common (see Photos 1 and 2). Measurements of track gauge, elevation and rail wear, recorded in stations located approximately 19 feet 6 inches apart, were obtained from a main track crossover switch up to the location of the first derailed wheel mark and are shown in Appendix A. The maximum track gauge as measured under static conditions was 58 ¼ inches located in the area of the first derailed wheel mark. TC's TSR allow a maximum of 1 ¼ inches wide gauge from a nominal track gauge of 56 ½ inches (i.e. 57 ¾ inches maximum) for Class 2 track.

Photos 1 and 2. Track conditions near the initial point of derailment, including plate-cut ties and spikes.

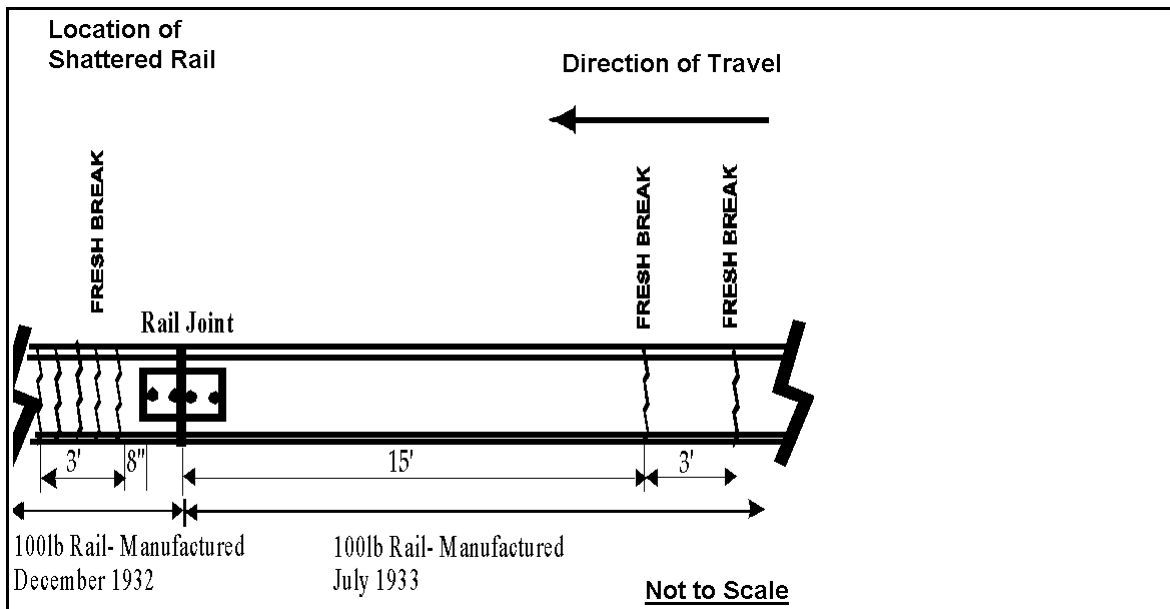
The south rail had multiple fractures at three locations within the private crossing. The fractures were located on two adjacent rails that were joined together with a four-bolt rail joint bar (see Figure 3). The rail on the west side of the rail joint had shattered into eight pieces. The west rail length was manufactured in December 1932;

- No signs of pre-cracking or pre-existing failures were observed.
- The fractures observed on the pieces of rail submitted were all considered to have occurred as a result of overstress failure.
- The overstress was likely induced by the gauge of the rails spreading, allowing the wheels to travel between the rails and generating an excessive lateral load on the rail.
- No material deficiencies were observed which could have been a contributory factor in the failure.

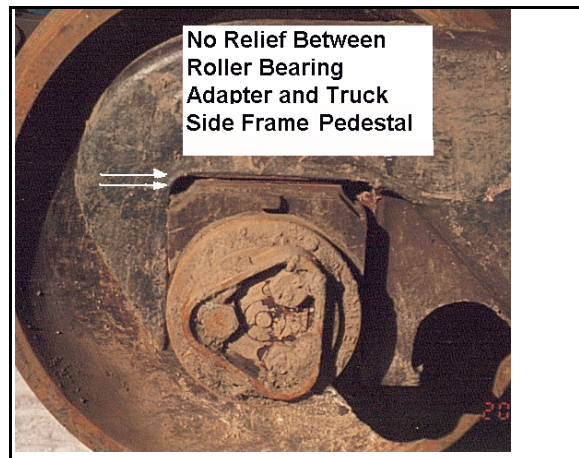
CGTX 64098, the second derailed car, was a specification DOT 112J340W pressure tank car with a load limit of 158 900 pounds, built in September 1970. The car was equipped with Barber S-2 trucks, with 36-inch diameter wheels and 6½ X 12-inch roller bearings. The trucks were furnished with D-3 springs, which have a spring travel of 2½ inches and provide a somewhat stiffer ride than cars with longer travel springs (e.g. D-5 springs with 3¾ inches of spring travel). There were bright marks on the rim of the centre plate bowl on the leading truck, where the top portion was in contact with the body centre plate casting. These marks were not due to the short distance that the car travelled derailed. Association of American Railroads (AAR) standards require cars to have a minimum of 1/16 inch clearance in this area. There was no visible relief between the roller bearing adapters and the ceiling of the truck side frame pedestals on the lead truck, and at one location on the trailing truck (see Photo 3) due to wear on the roller bearing adapter or truck side frame. The car last received a safety inspection by a certified car inspector on 12 February 2002 when the car was on train CN 454 at Moncton, New Brunswick. No defects were identified at that time.

The worn conditions of the centre plate and roller bearing adapters on tank car CGTX 64098 would tend to affect rotational movement of the car in two ways: by inhibiting the lateral movement of the wheels within the lead truck and the rotational movement of the lead truck relative to the car body. Because the car was loaded, it was transmitting relatively high vertical loads to the truck centre plates, and ultimately to the axles through the truck sides. Loaded cars with stiff, and short, suspension systems subject both the car and the rail to increased loads when encountering deficiencies in the track infrastructure. Since rotational movement is initiated by wheel flange contact with a curved rail, and the worst wide gauge conditions existed at the curved portion of Porter's Siding, the stiffer than normal rotational movement of the tank car exacerbated the wide gauge conditions. Because the loaded tank car of propane had insufficient clearance at the centre plate area, higher than normal lateral loads were induced onto the track. The weak track structure did not provide sufficient lateral resistance resulting in further dynamic gauge-widening, beyond safety limits.
