RAILWAY INVESTIGATION REPORT

R02Q0041

DERAILMENT

LÉVIS, QUEBEC

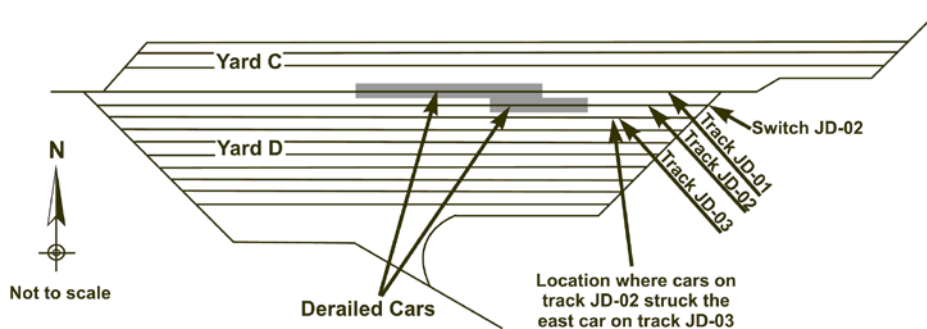
On 22 July 2002 at approximately 2000 eastern daylight time (EDT),¹ the Joffre Yard crew, operating yard assignment No. 1600, went back to work following a break during severe weather conditions. Using a belt pack-controlled yard locomotive, several short cuts of cars were sorted onto track JD-02 (see Figure 1) through the west switch, shoved eastward to couple onto a cut of 30 cars, then pulled and brought to a controlled stop. As the cars stopped, the crew heard a loud noise and observed the cars they were coupled to, as well as the cars on the adjacent track, JD-01, rolling over and derailed. They advised the yard supervisor of the accident and performed the necessary emergency procedures. The crew determined that 34 tank cars on track JD-01, and 17 tank cars and 1 bulkhead flatcar on track JD-02, were derailed. The tank cars, all equipped with permanently locked shelf couplers, were lying on their side; the bulkhead flatcar was upright. There were no injuries and no product was spilled.

An inspection of the accident site revealed fresh wheel rim markings on the JD-02 east switch frog and on the ties beginning at the heel block of the JD-02 east switch and continuing westward for about 830 feet along the lead track through the JD-03 east switch and into track JD-03. The switch points of the JD-02 east switch showed signs of having been run-through. The ballast between track JD-02 and track JD-03 was disturbed. A roller from a truck side bearing was found approximately 60 feet west of the JD-02 east switch frog.

The damage observed to the rolling stock and track is consistent with that of cars running through a switch and derailed. Furthermore, the distance from the damaged switch to the east end of the derailed cars on track JD-02 corresponds to the recorded distance the cut of cars was pulled by yard assignment No. 1600. Therefore, it is likely that the cut of 30 cars on track JD-02 travelled through the JD-02 east switch, and then was pulled, in a westward direction, back over the switch by yard assignment No. 1600. The two easterly cars derailed either when they travelled eastward through the switch or when they reversed their direction and travelled back over the switch. The derailed cars were pulled between track JD-02 and track JD-03 until they struck the most easterly car on track JD-03. They rolled over northward and caused the other tank cars on track JD-02 to derail northward. The derailed cars on track JD-02 struck the cars on track JD-01 and caused them to derail northward.
